# The Coast of Crystal Cove Orange County, California

CE Ref #03-21

Headwaters to Oceans Conference

# Crystal Cove

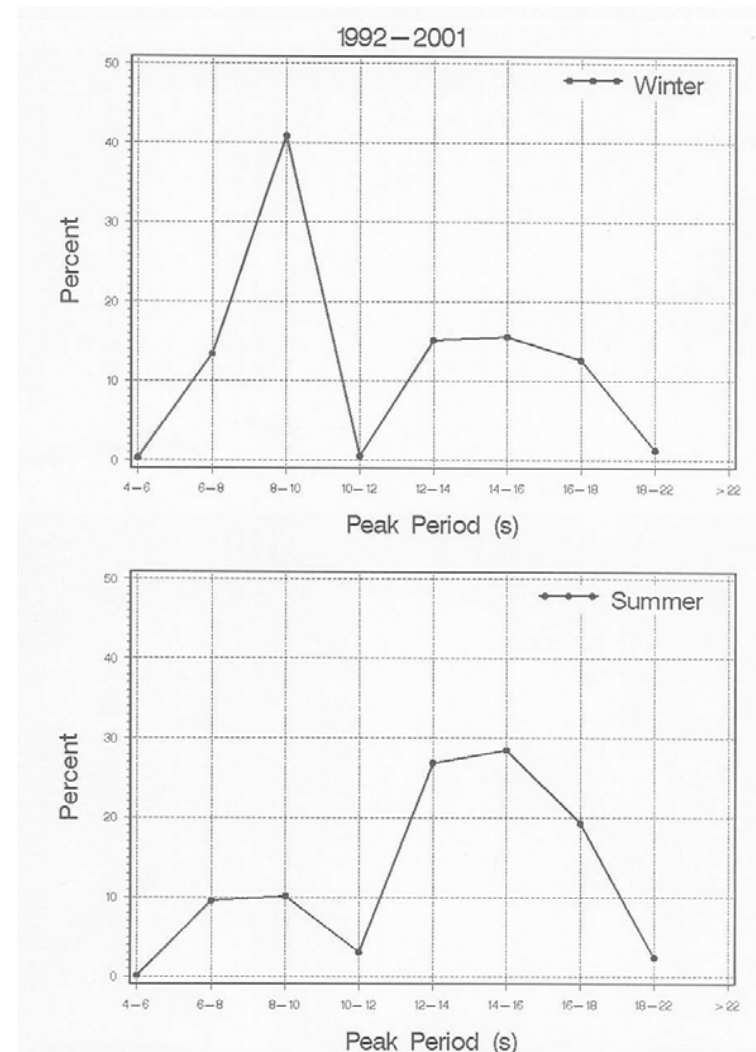
# Winter/Summer Comparison of Peak Wave Periods at Crystal Cove

- Wave period generally shorter during winter (8-10 sec.) than during summer (12-16 sec.)

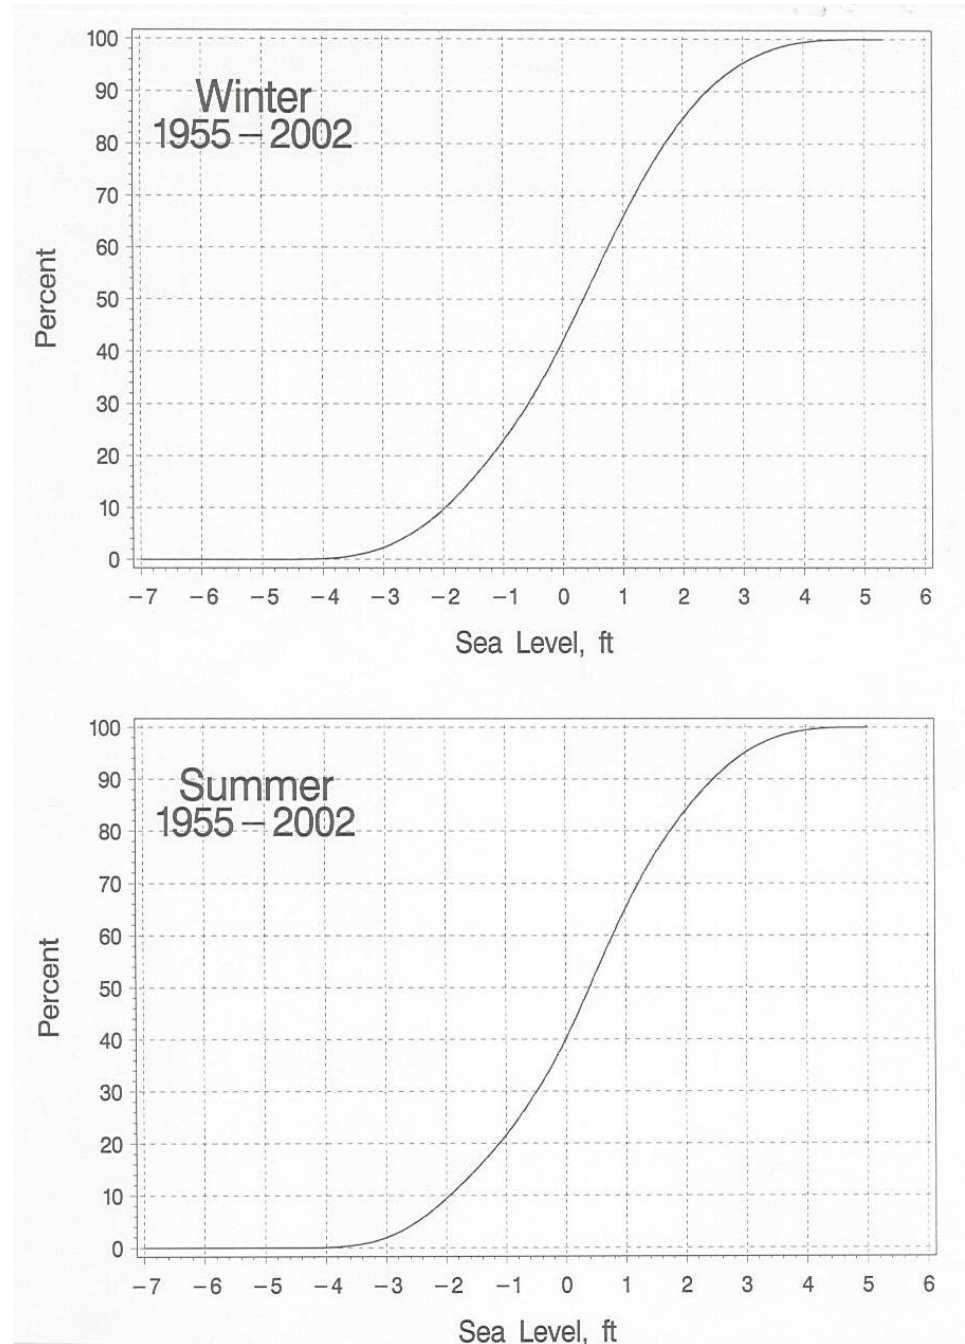
# Tide Levels

- Similar tidal regime during summer and winter.
- 95% of the time, tide level is less than 3 ft, above mean sea water level.

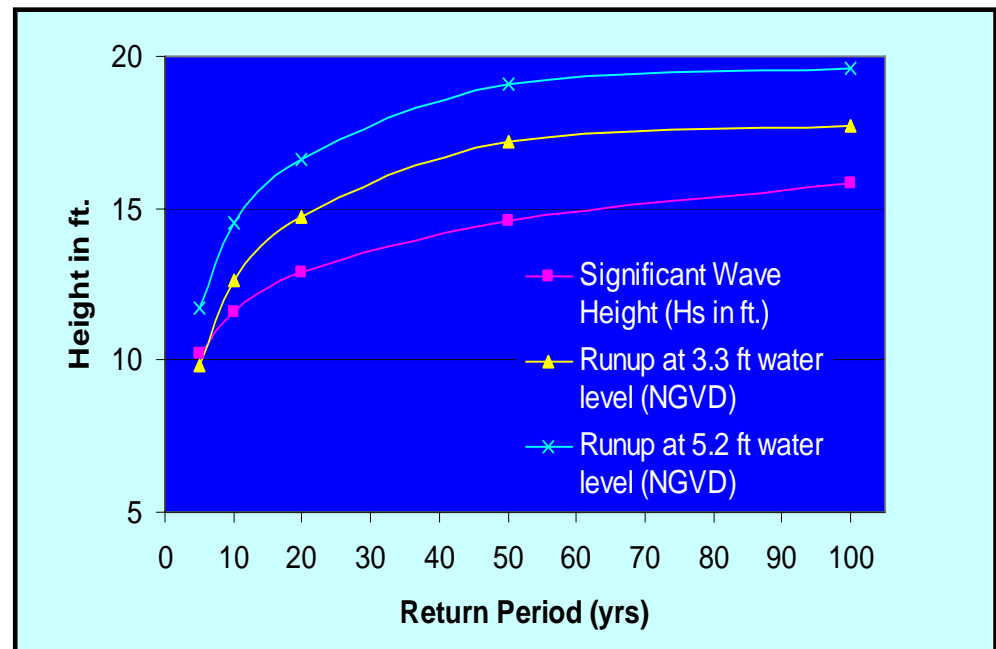
# Run-up Analysis for Extreme Conditions

- Run-up/overtopping analysis is based on worst-case scenario of smooth impermeable surface.
- Overtopping may occur for design waves with a return period  $> 10$  years.

- The location of Crystal Cove near Newport Beach Canyon provide additional protection from wave storms.
- Run-up and overtopping analysis show that there will be some overtopping with wave conditions having a return period  $> 10$  years. 50- and 100-year design waves could cause some damage to the cottages.

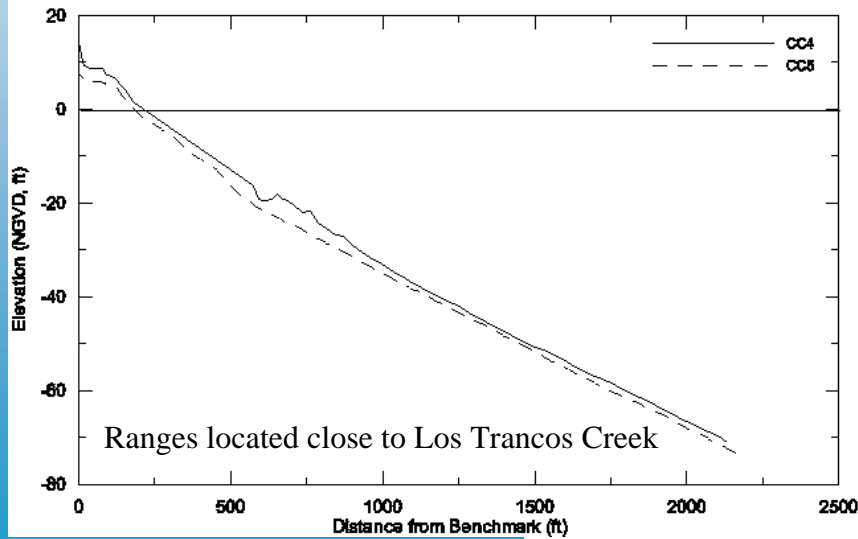
# Beach Profiles

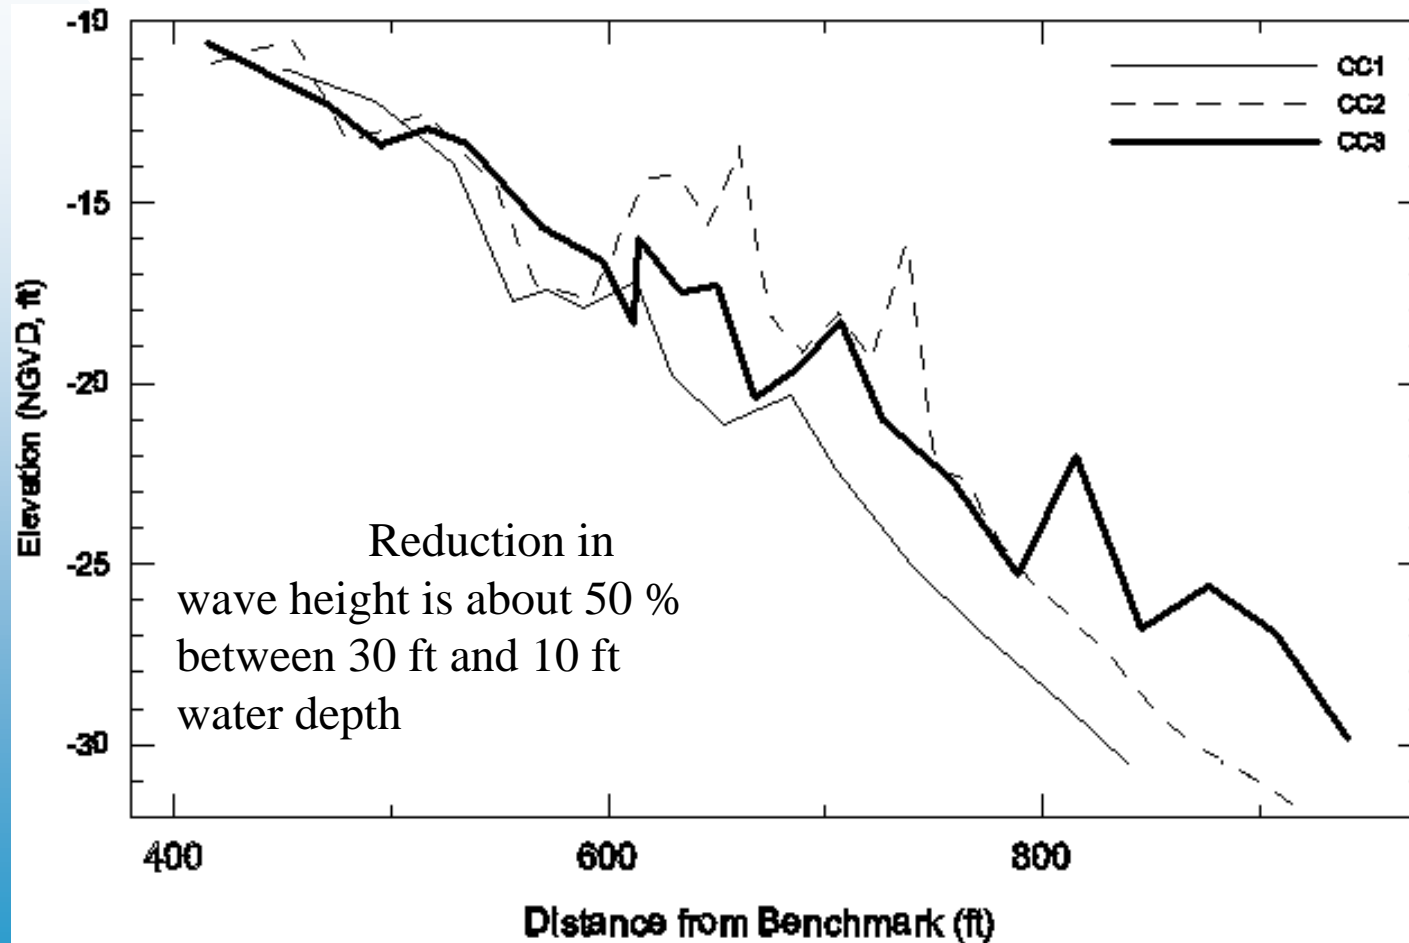
# Details of Outcroppings along Beach Profiles

- Rugged nearshore topography (with reliefs of 3-4 ft) acts as a natural submerged breakwater and provides the cottages with valuable protection during wave storms. They are the extent of the inshore topography.

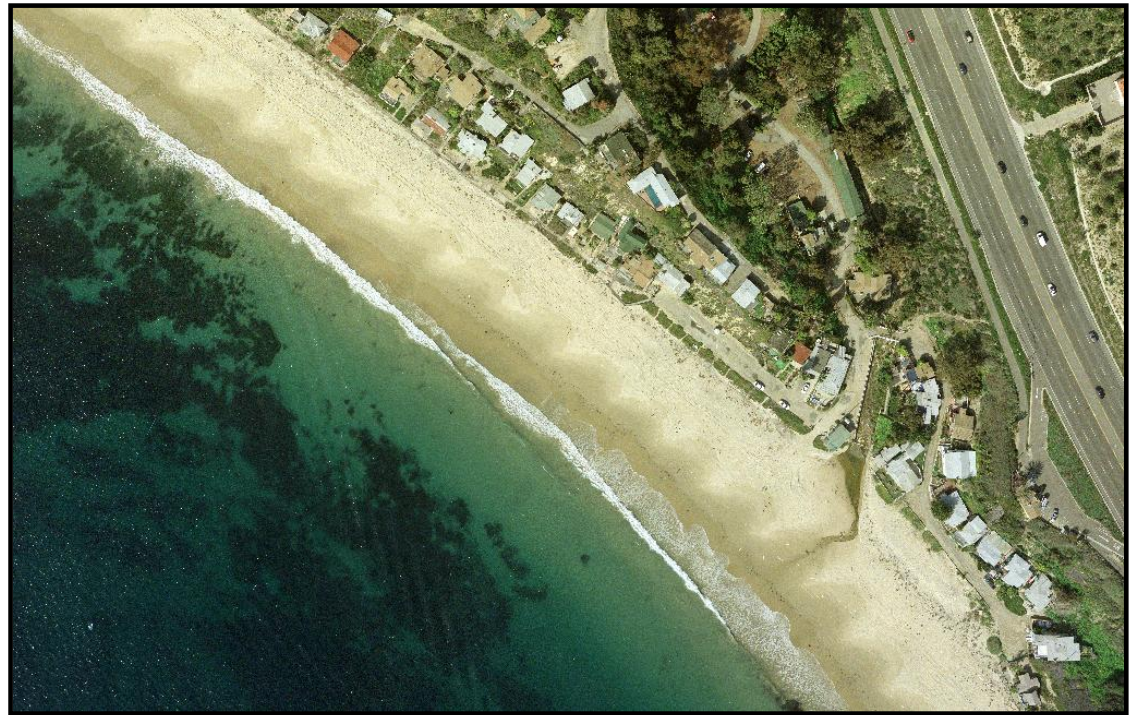
# Historic Shoreline Changes

- Analysis of aerial photos from as early as 1927 until the present show little shoreline change (Everts Coastal, 1997; Inman et al., 2000; and Jenkins & Wasyl, 2000).

**Notice nearshore hard substrate.**
