LOW-COST AERIAL SURVEY METHODS

Hany Elwany, Ph.D.
Richard McCreight, M.Sc.

Coastal Environments

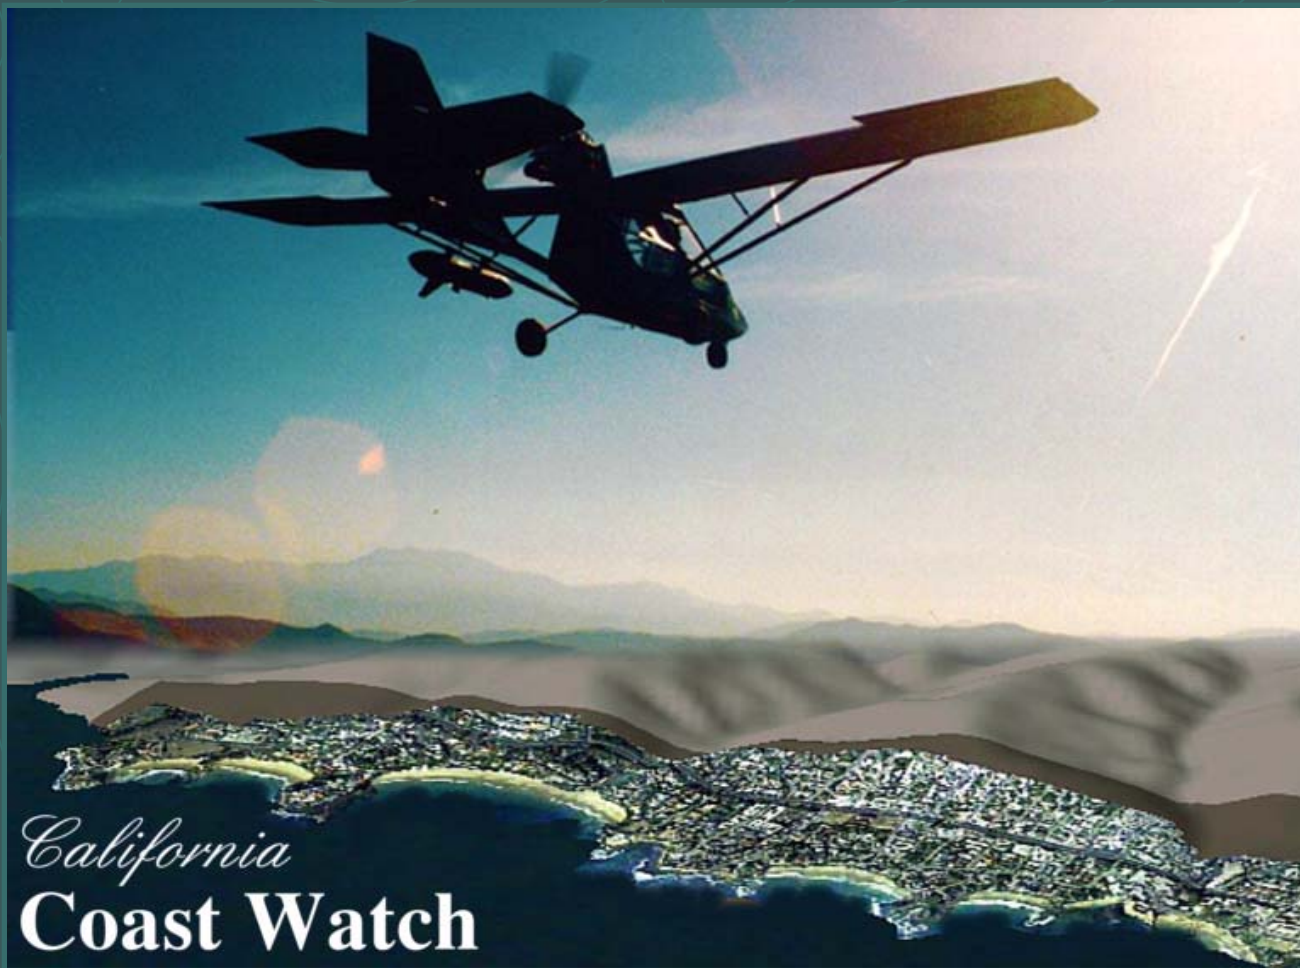
Ultra-Lite Aircraft

GT500 Model.

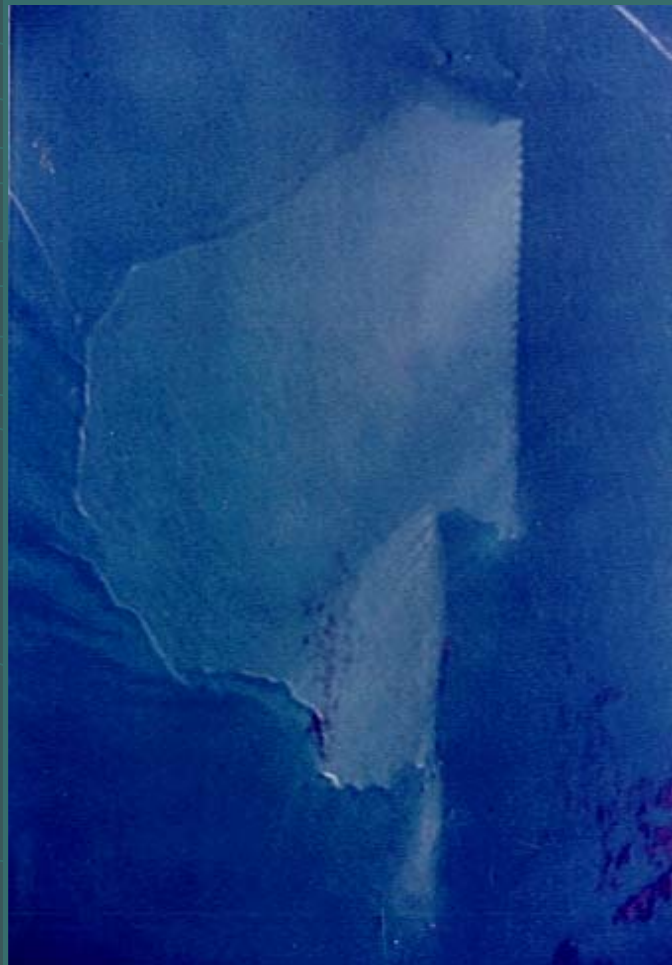
Case 1: Upcoast Plume (North Current)

Aerial photograph taken in August 1986, showing upcoast plume with sharp boundaries from diffusers of Units 2 and 3.

- Photos synoptically documented turbidity plume (*surface shape, location, and extent of plume*).
- Provided insight into discharge interaction with other nearshore oceanographic parameters (water temperature and stratification).

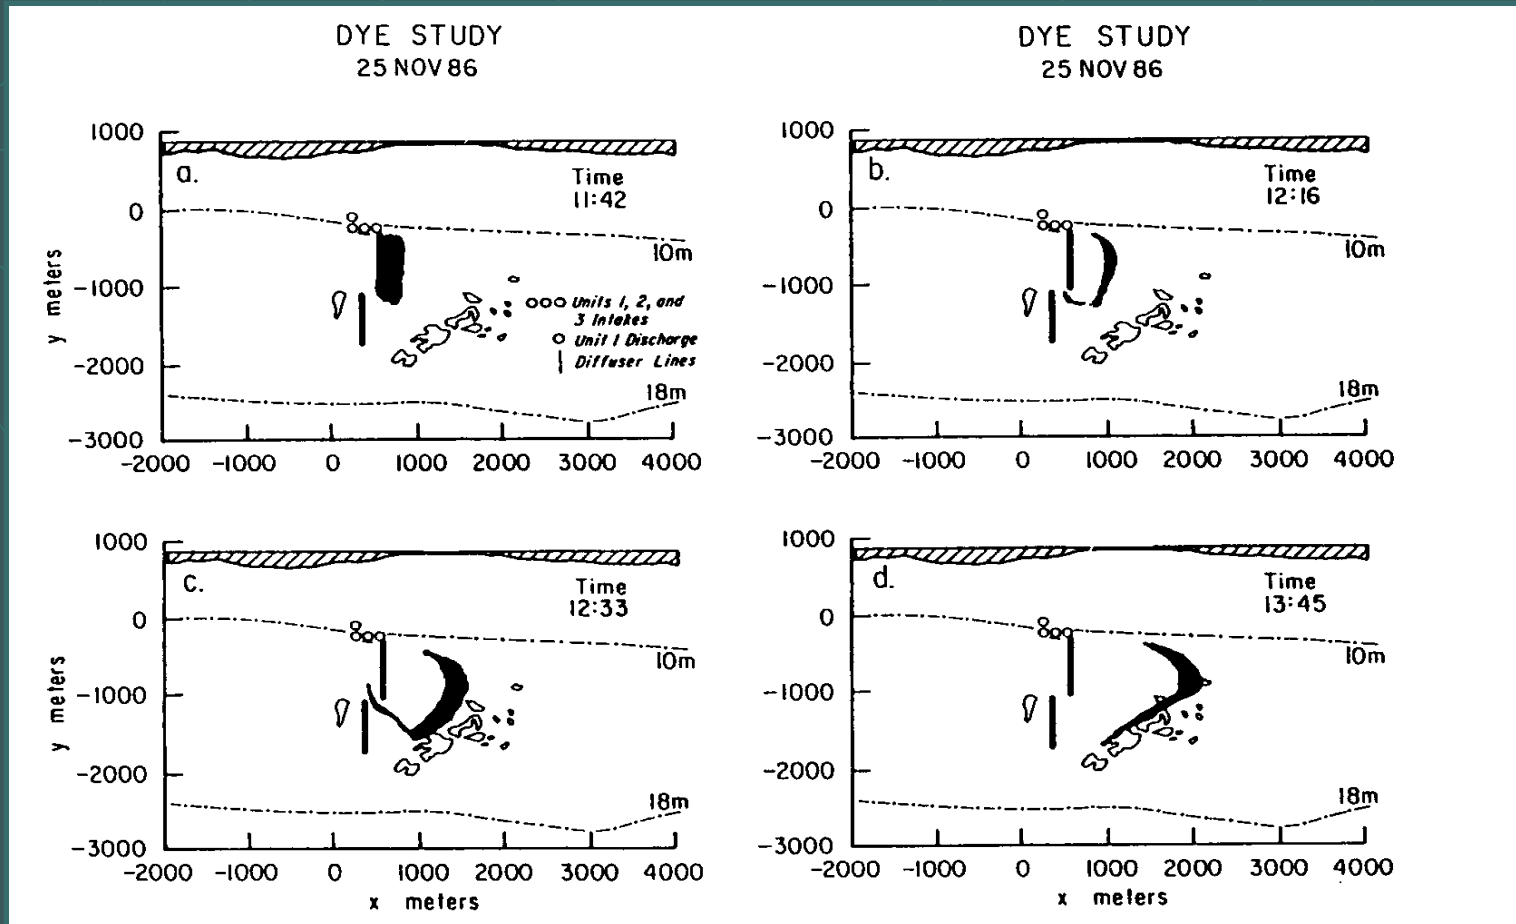
Case 1: Downcoast Plume (South Current)

Location of 25 November 1986 dye stripe as moved alongshore.

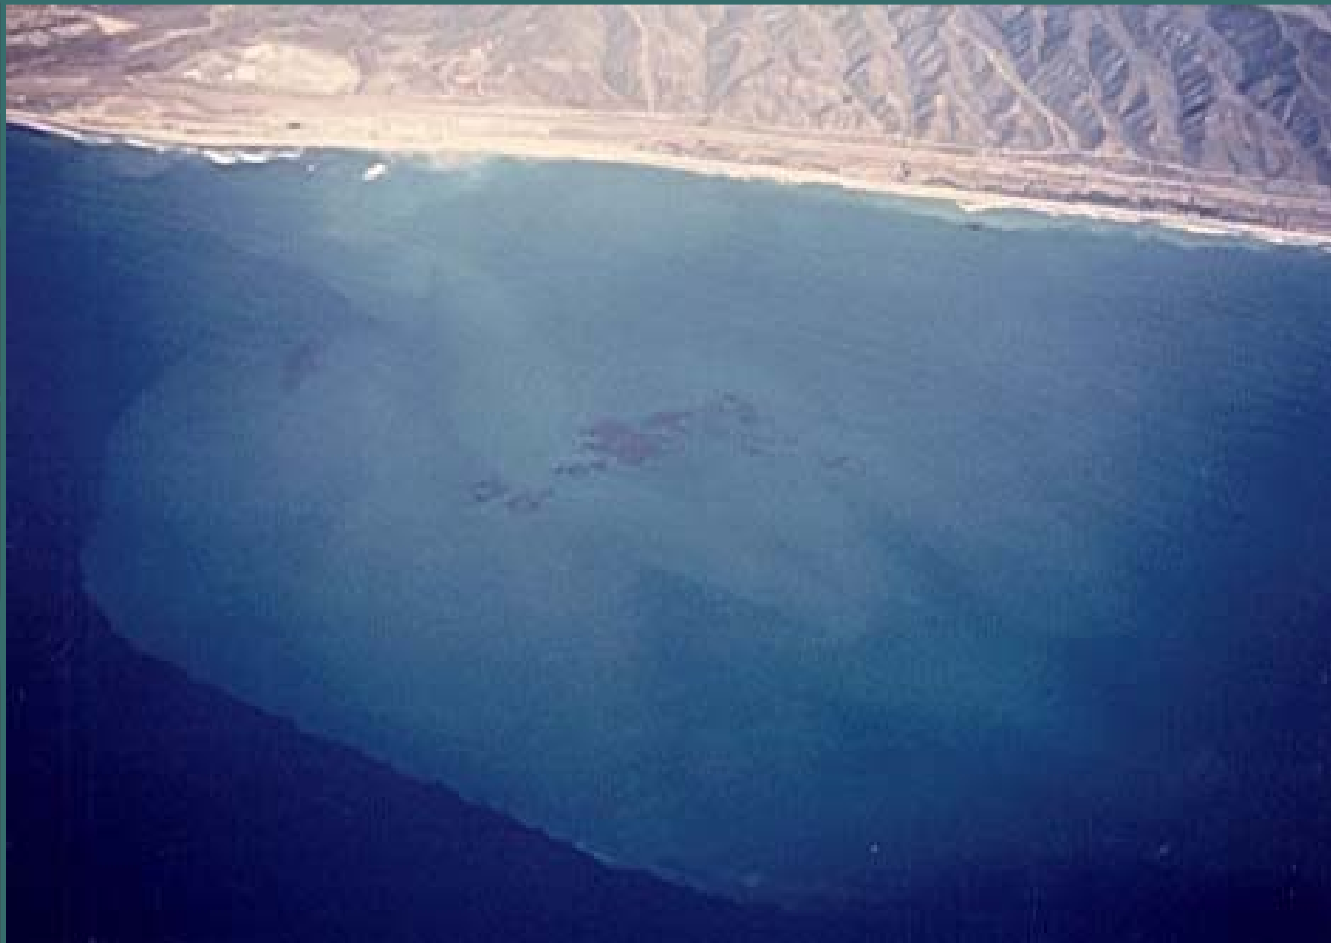
Case 1: Interaction of Down Coast Plume with Nearshore Turbidity

Aerial photograph taken in December 1986, showing downcoast plume with nearshore turbidity extending offshore.

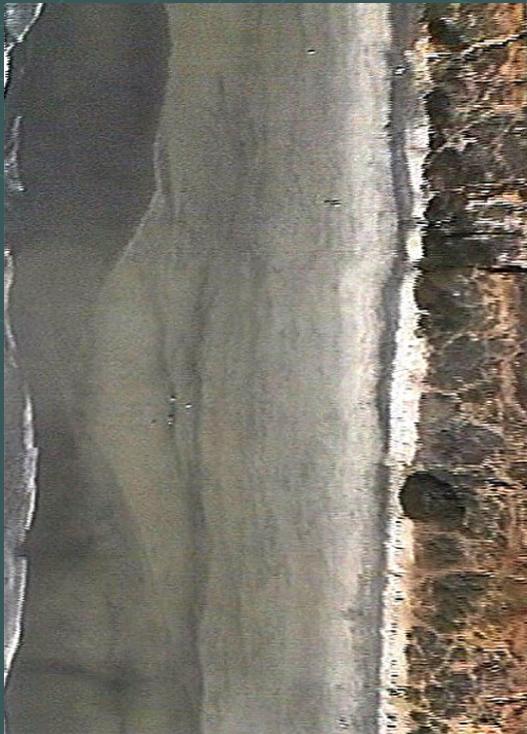
Case 2: South Carlsbad Beach Before, Immediately After, and 2 Years Later

Photograph showing South Carlsbad Beach before and after 260,000 yd³ of sand placement on the beach in April 2001.

- Residence time of Sand on the beach was addressed using aerial photos that provided data showing a rough estimate of beach width change over a large area at more frequent intervals and at a more reasonable cost.

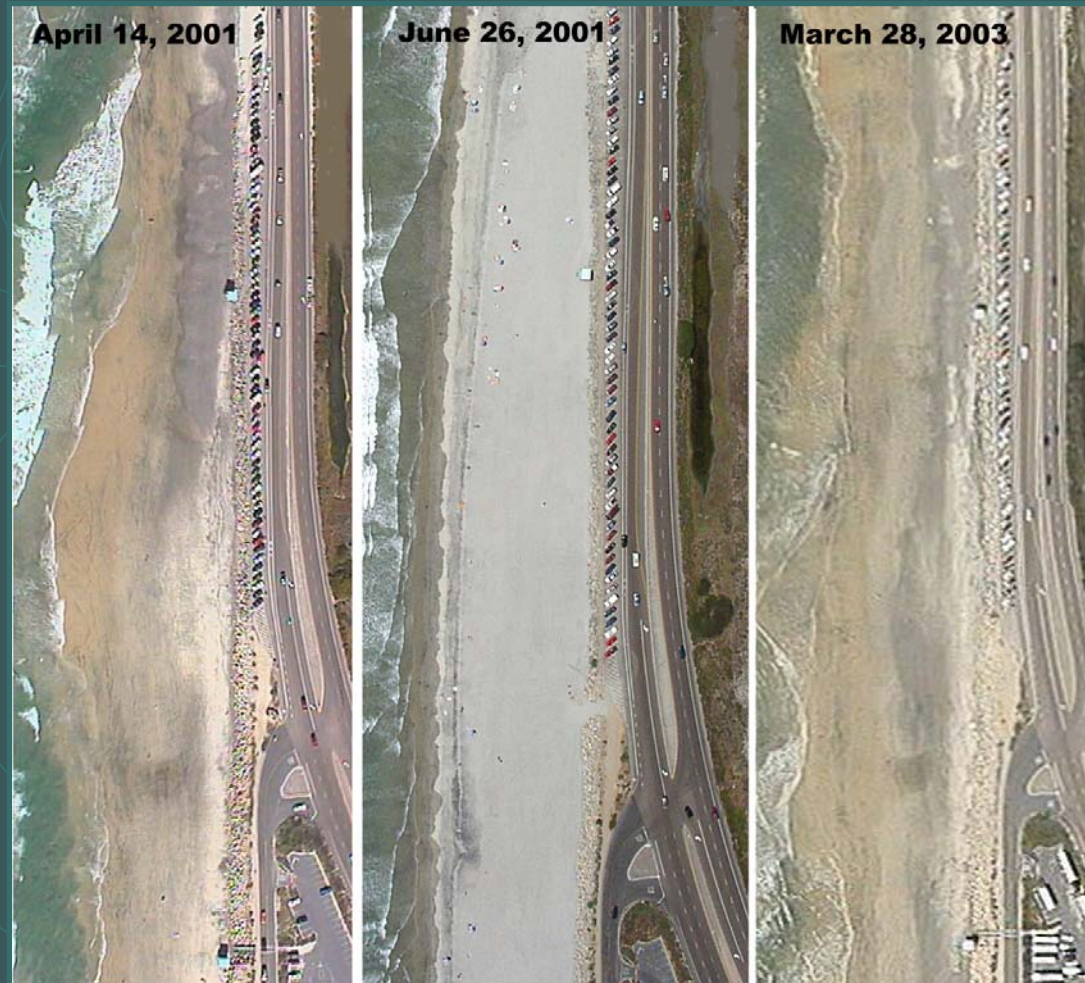
Case 2: Torrey Pines Beach Before, Immediately After, and 2 Years Later

Photograph showing Torrey Pines Beach before and after 260,000 yd³ of sand placement on the beach in April 2001.
