SAN DIEGUITO WETLANDS RESTORATION PROJECT

**8 OCTOBER 2013 BEACH PROFILES
CITY OF DEL MAR, CALIFORNIA**

Data Report

21 October 2013
CE Reference No. 13-18

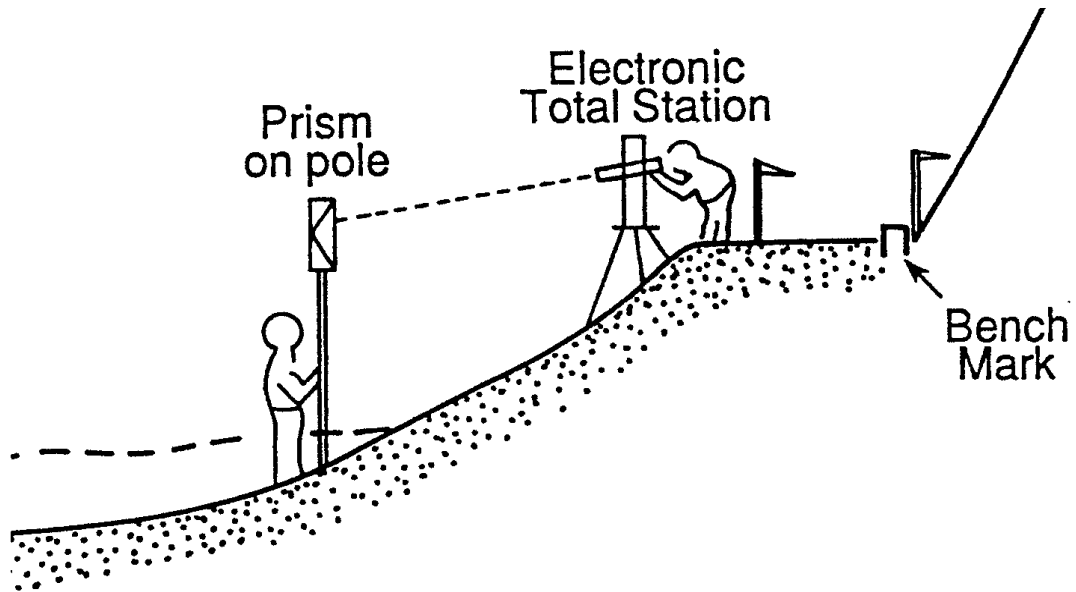
Figure 1. Schematic illustration of the survey method.

The beach and surf zone were surveyed using an electronic total station and survey rod. The total station was used to determine the position and elevation of the beach at each location occupied by the rod. A Sokkia Set-5A total station and SDR-33 electronic field data logger were utilized to collect the nearshore portion of the profile, providing an accuracy of approximately 2-4 cm both horizontally and vertically. The total station method reflects an infrared beam sent from the device to a prism atop a fixed-length pole, where the instrument measures the slant distance and horizontal and vertical angles to the target (Figure 1). An electronic field data logger is used to store the data, which can then be set to known positions using permanent local benchmarks. Each transect was surveyed from the back beach seaward through the surf zone until the rod no longer protruded above the water surface.

The offshore portion of the beach profile was acquired with a digital acoustic echo sounder operated from a 27-ft shallow-draft survey vessel. A DGPS receiver was used to determine the position of each sounding. To improve the accuracy of each position, differential corrections transmitted in real time from U.S. Coast Guard beacons were utilized. All systems were interfaced to a laptop computer using the Hypack survey package.

At each transect, the boat traveled from the offshore limit to the surf zone guided by DGPS navigation system. Soundings were acquired on a near-continuous basis (approximately four to five per second). Vessel positions were recorded at 1-second intervals and merged with the soundings using Hypack bathymetric survey software. The calibration of the echo sounder was checked at the beginning and end of each survey session using a standard “bar check” procedure.

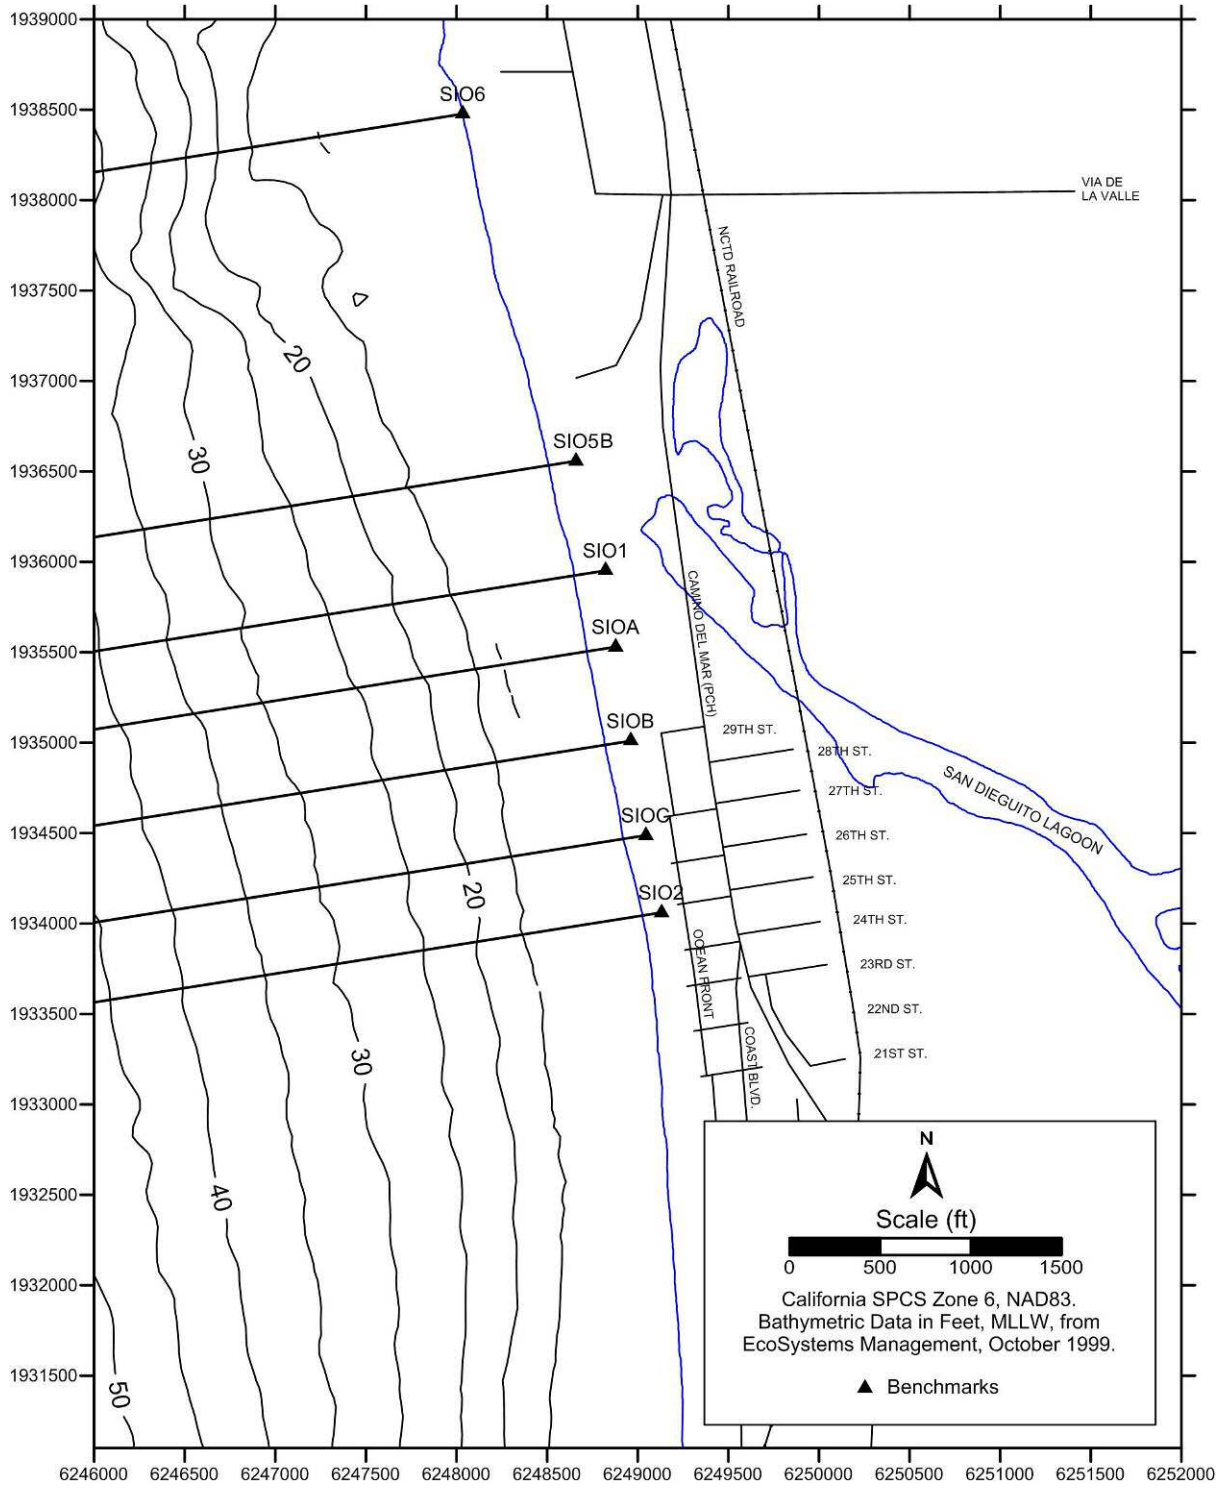
Figure 2. Beach profiles surveyed on 8 October 2013.

The 2013 beach profile surveys were performed on 8 October 2013, along the four historic and three newly established profiles (Figure 2). The beach profiles are presented in Appendix A. The beach width for each of the profiles is presented in Appendix B.

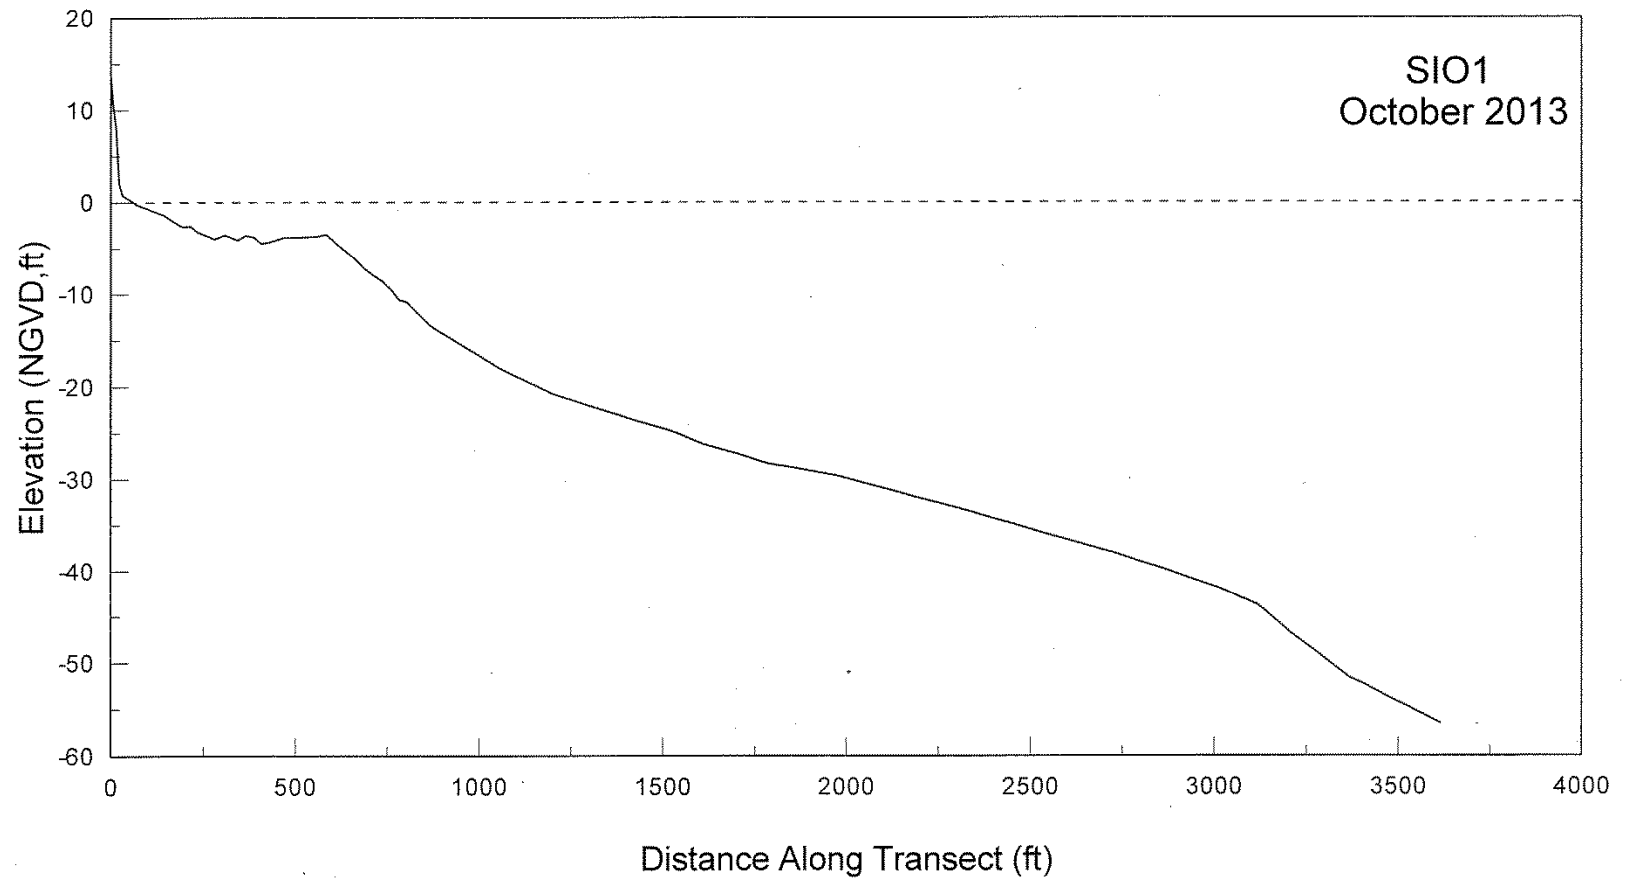
Figure A-1. Beach profile for SIO1 surveyed in October 2013.

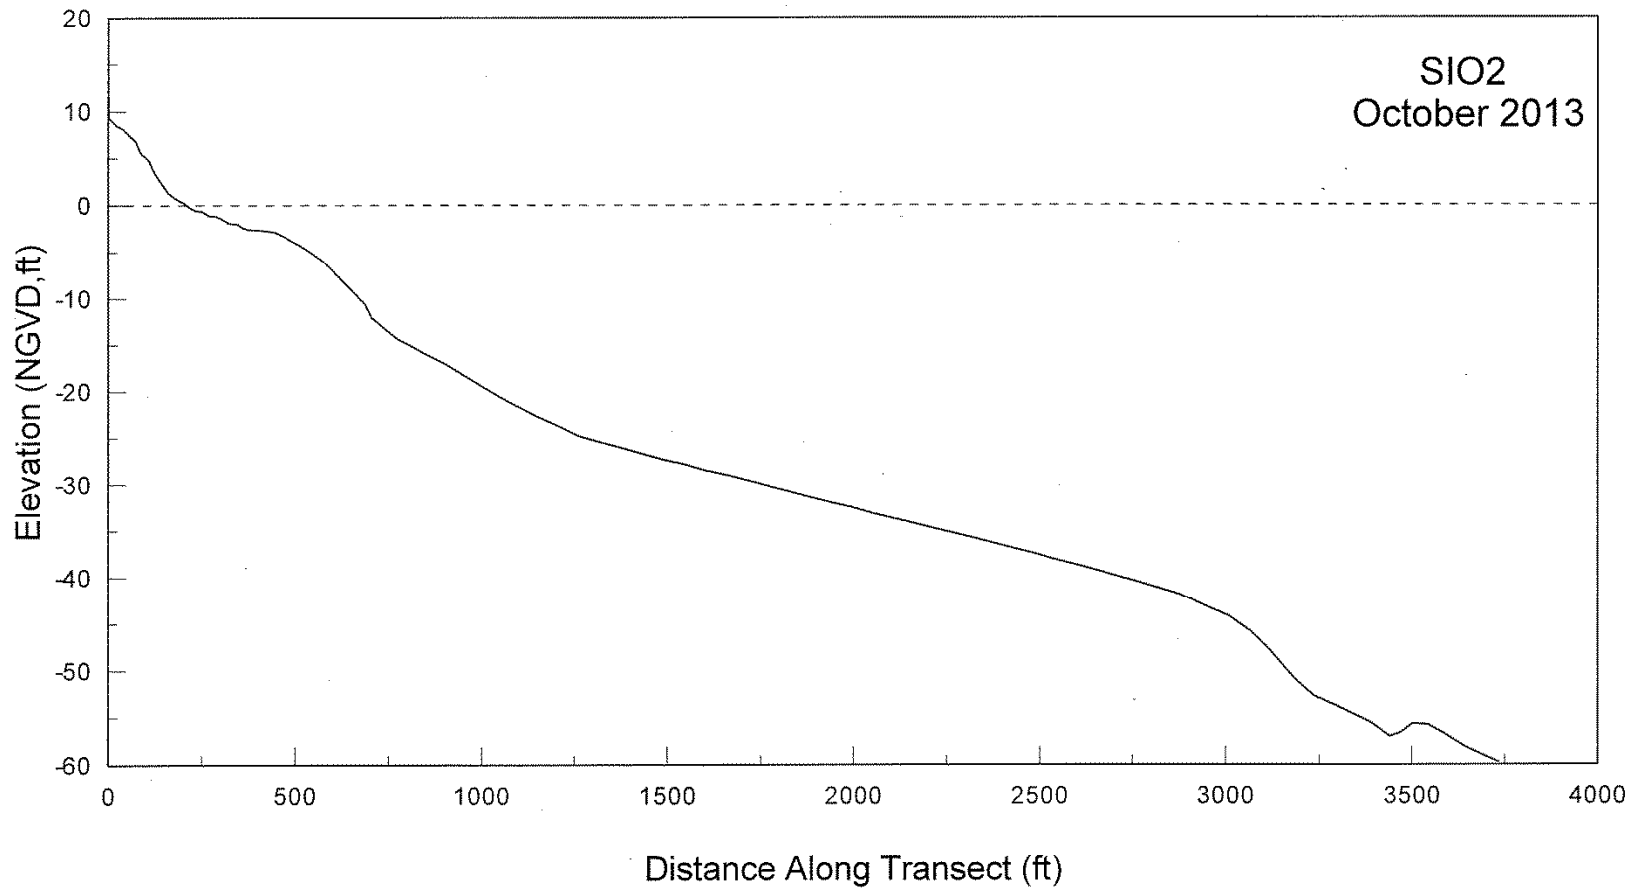
Figure A-2. Beach profile for SIO2 surveyed in October 2013.

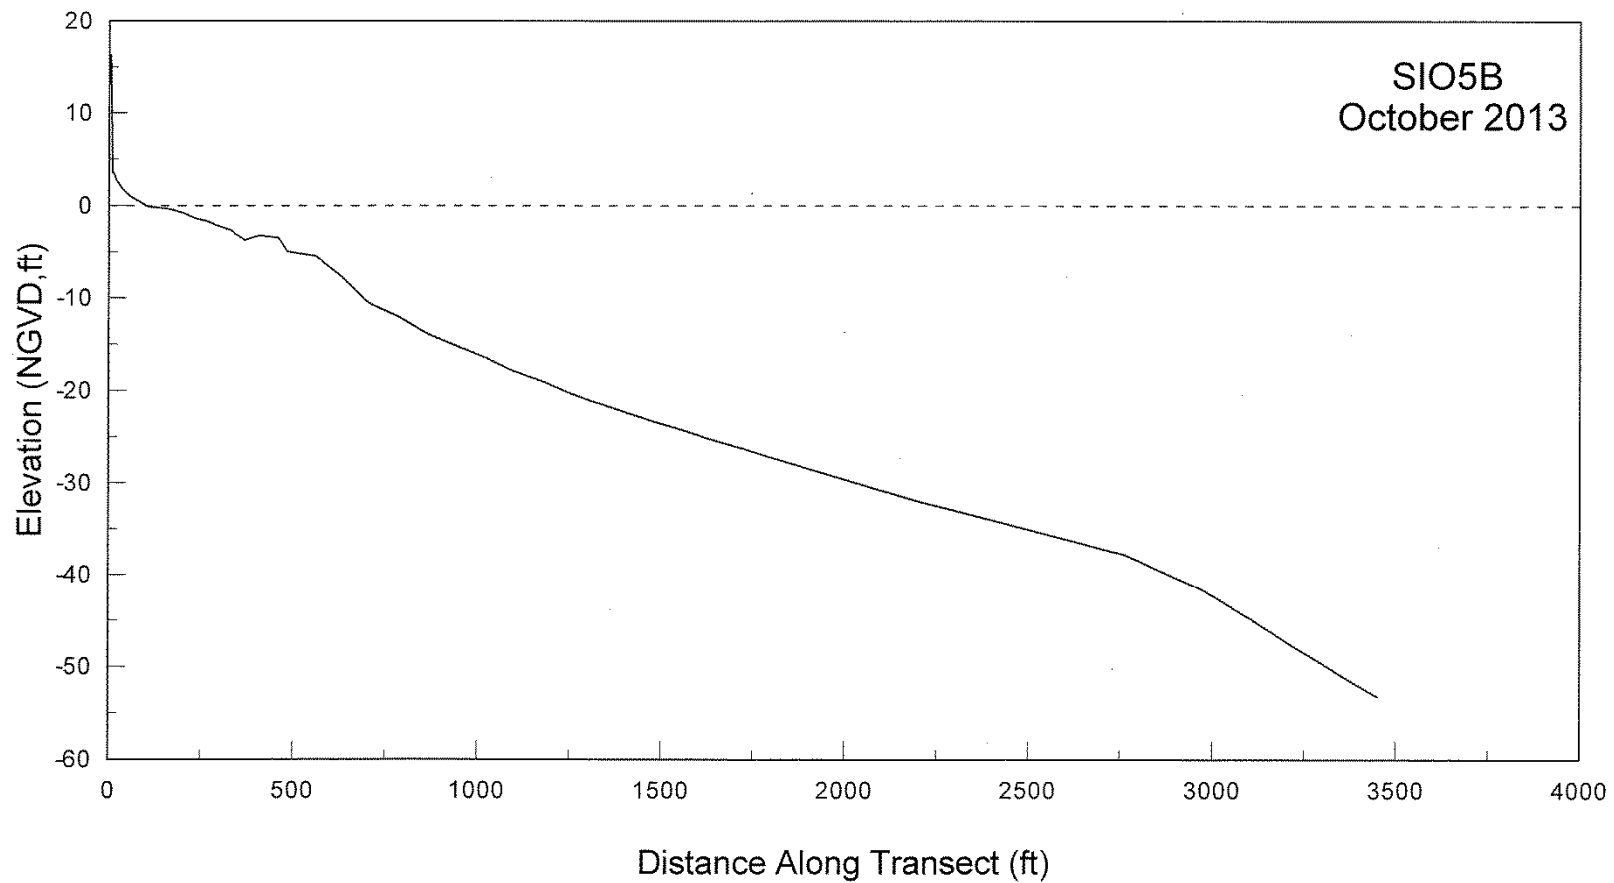
Figure A-3. Beach profile for SIO5B surveyed in October 2013.

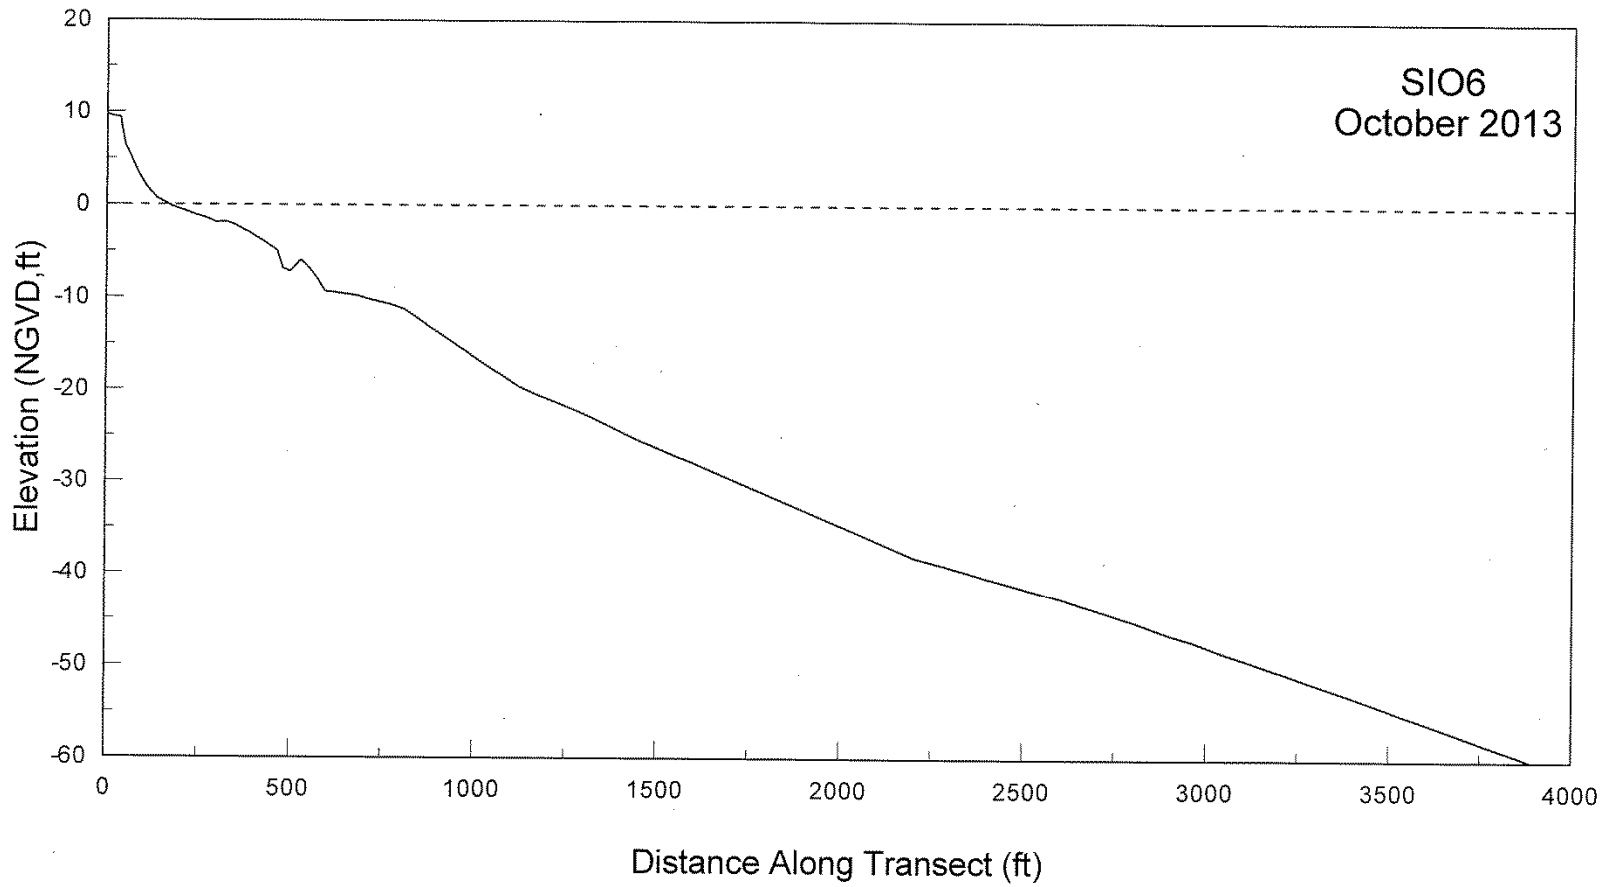
Figure A-4. Beach profile for SIO6 surveyed in October 2013.

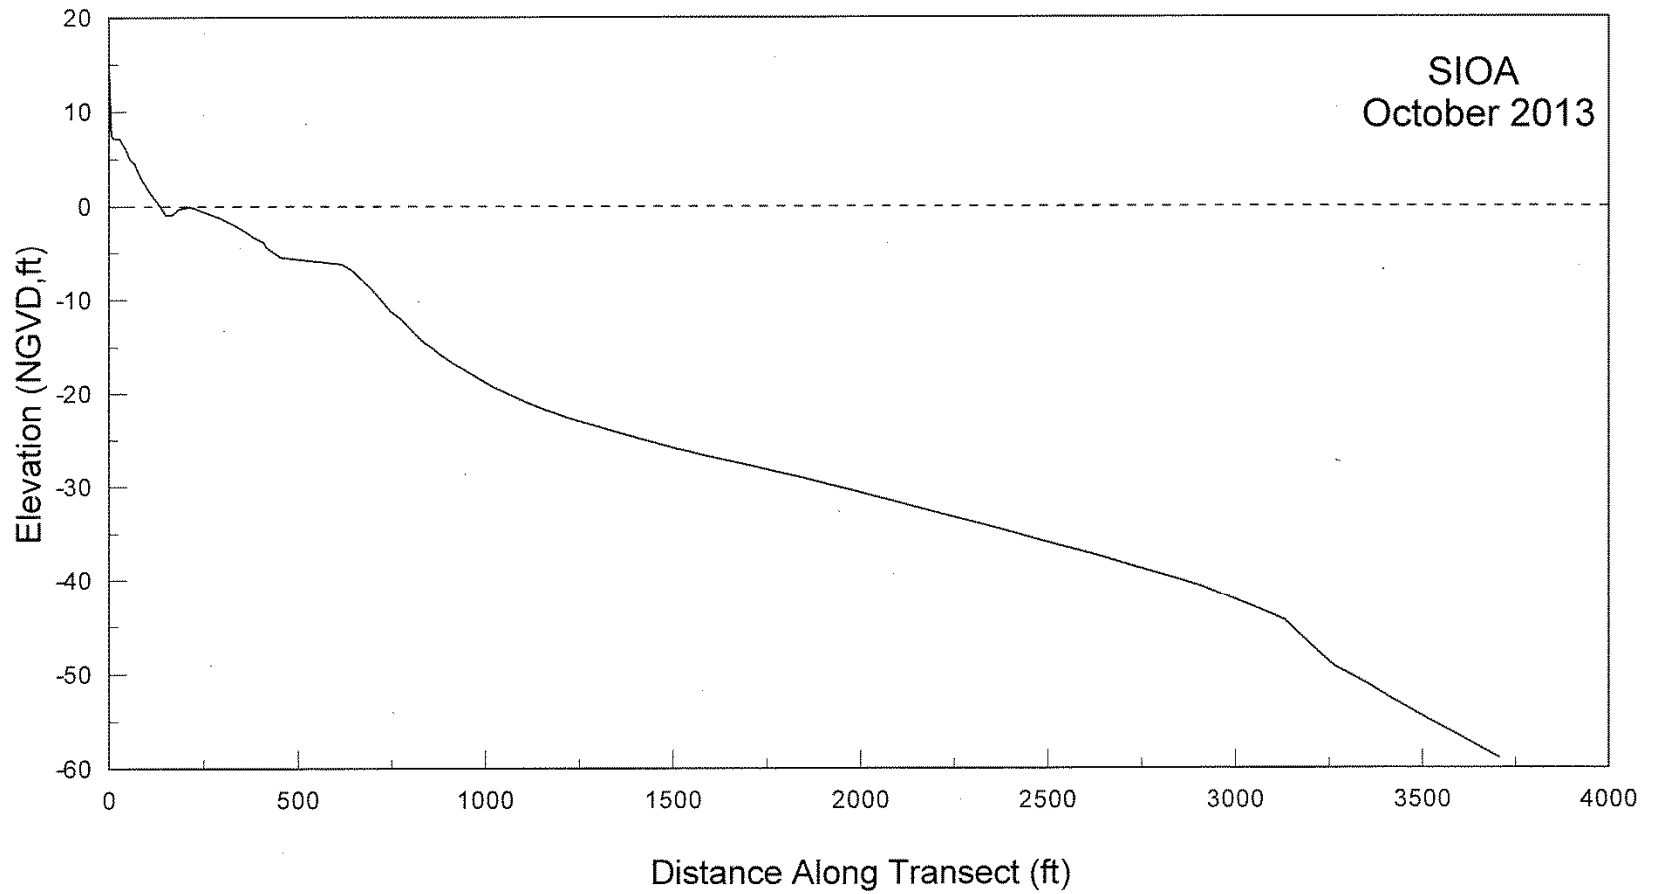
Figure A-5. Beach profile for SIOA surveyed in October 2013.

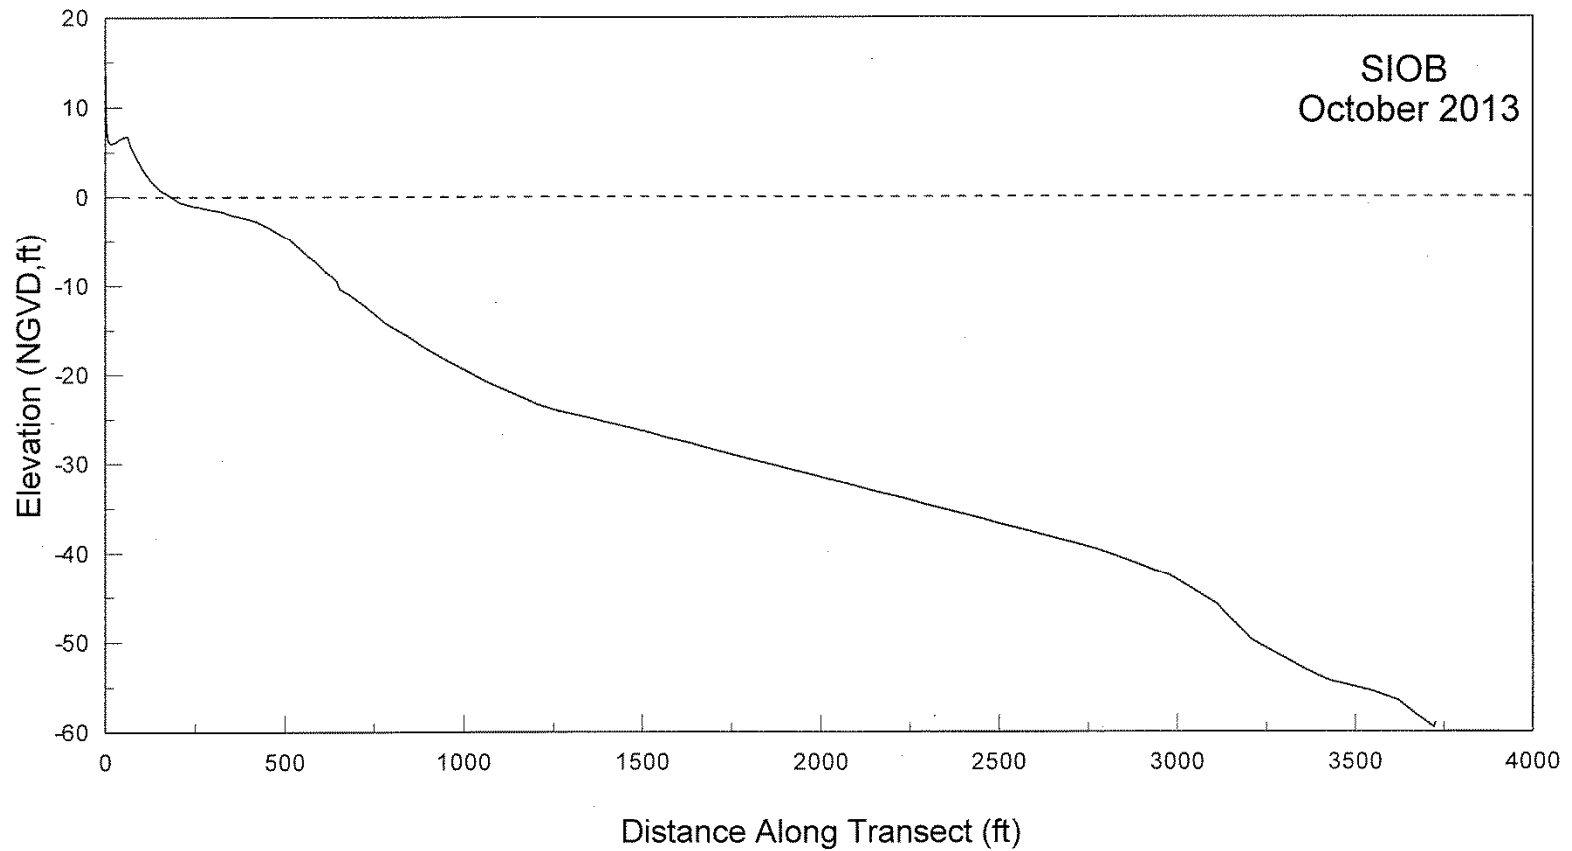
Figure A-6. Beach profile for SIOB surveyed in October 2013.

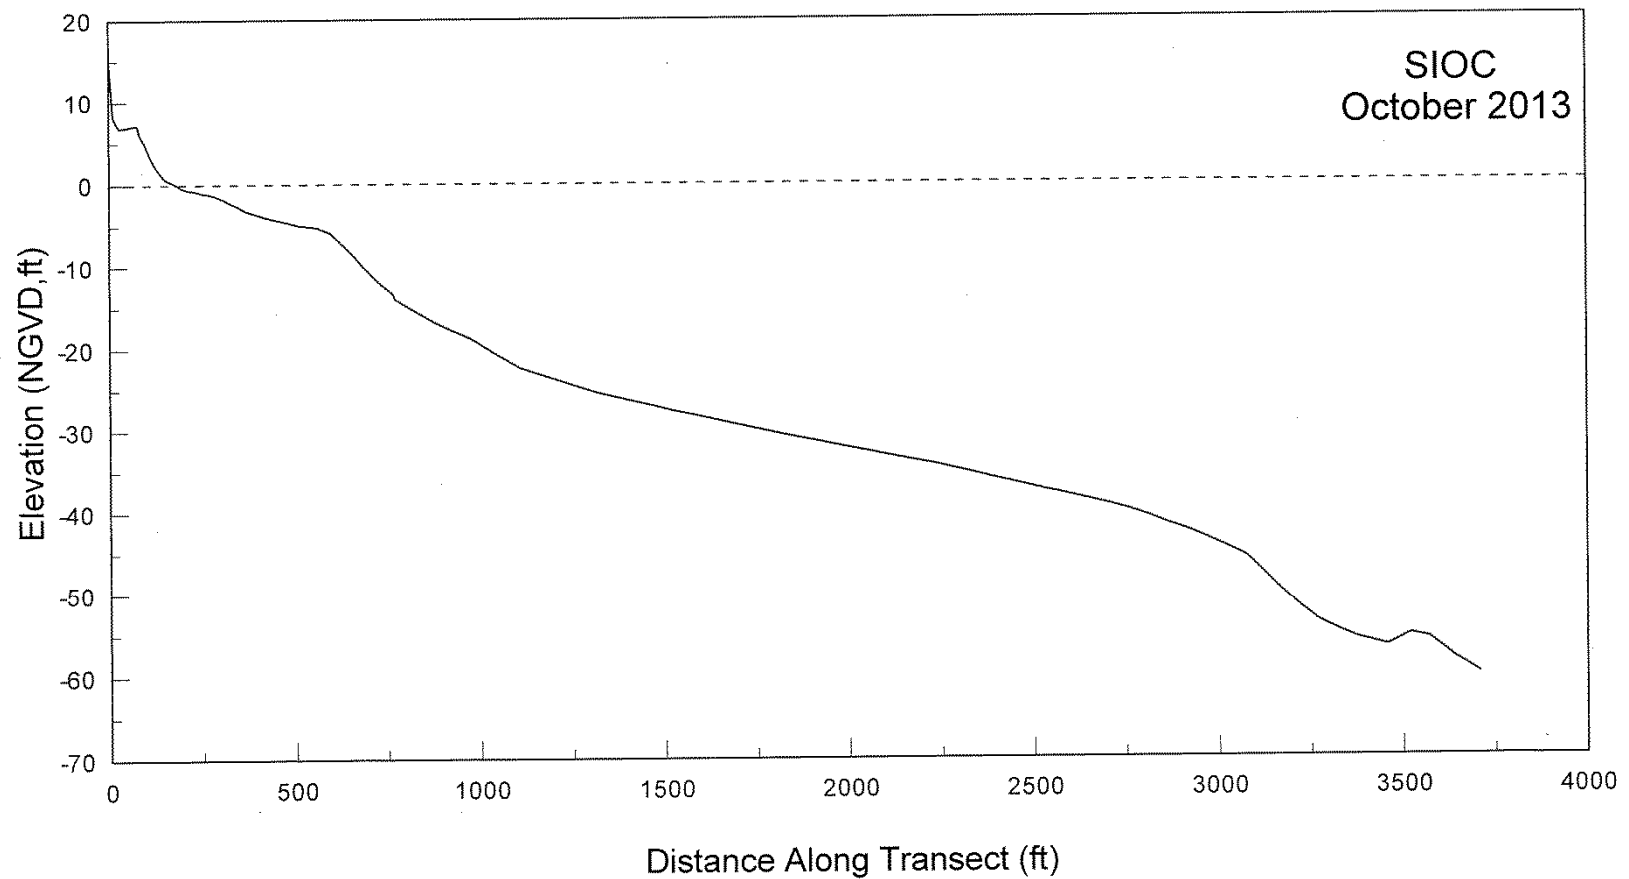
Figure A-7. Beach profile for SIOC surveyed in October 2013.

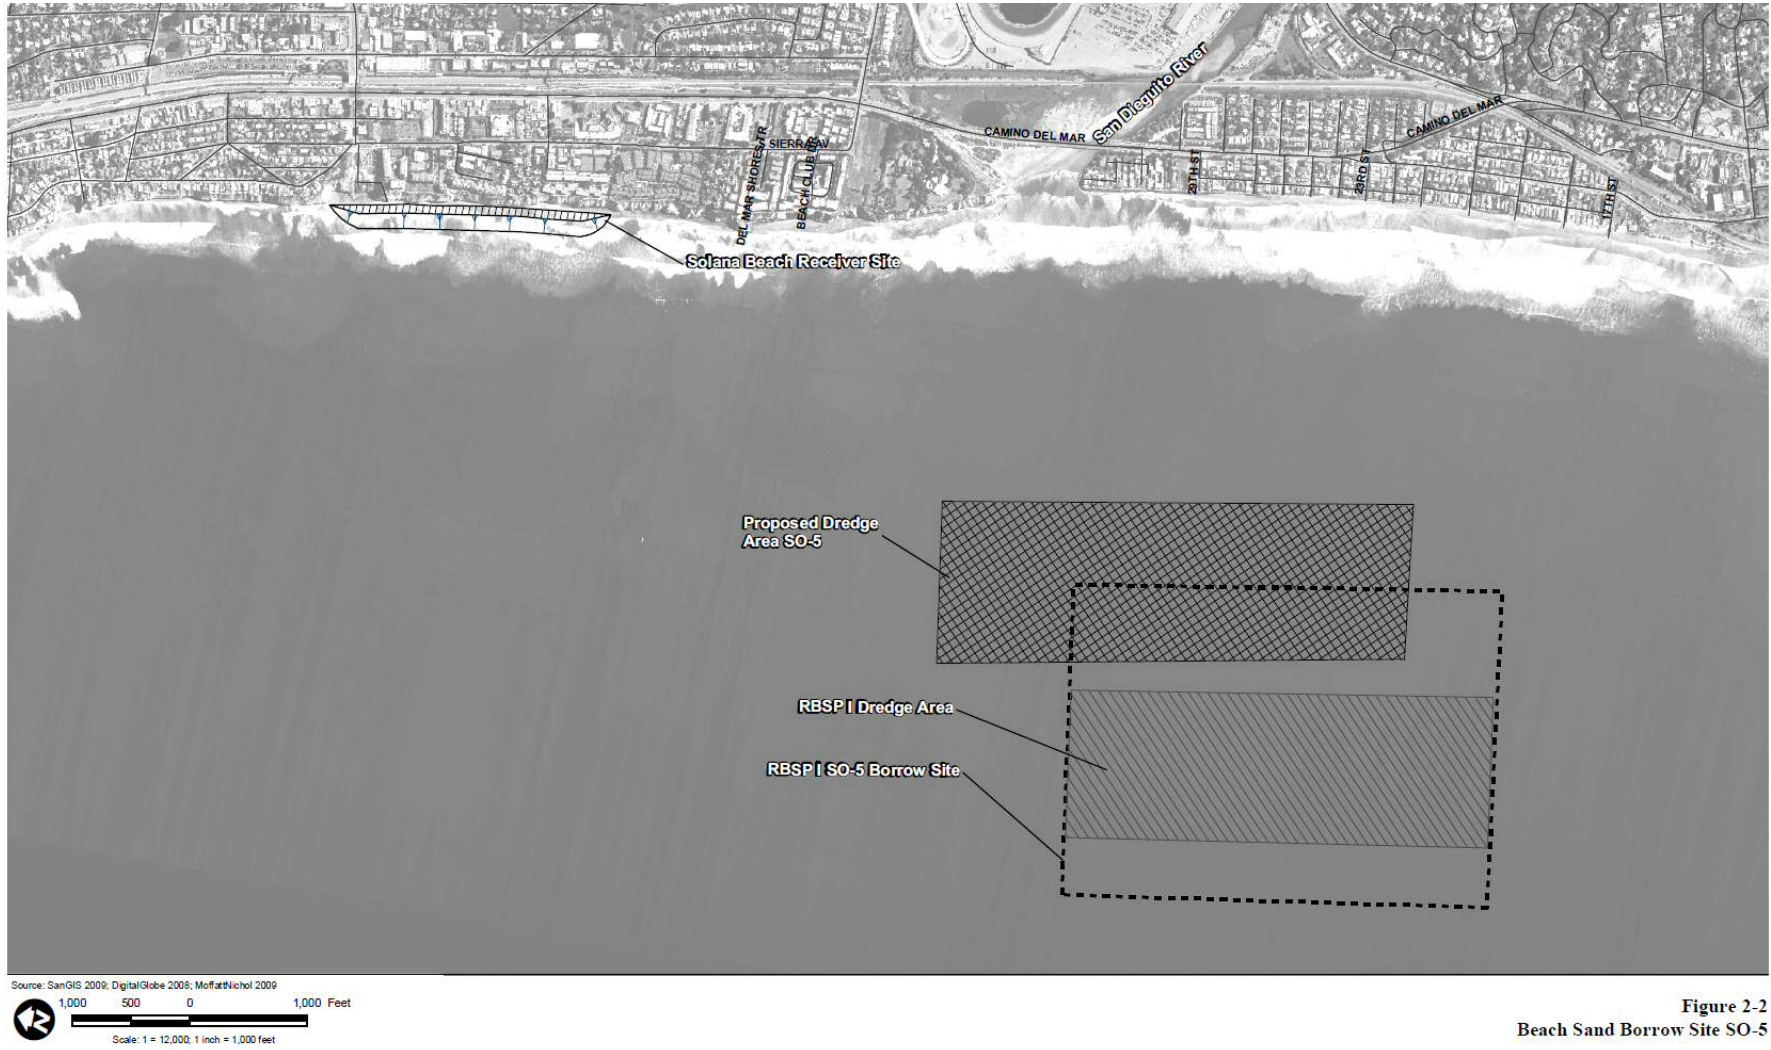
Figure 2-2
Beach Sand Borrow Site SO-5

Figure C-1. SANDAG Beach Sand Borrow Site SO-5, adapted from the Regional Beach Sand Project II Final EIR.

SANDAG recently completed a beach sand replenishment project along the coast of San Diego County during the end of 2012. Sand source borrow site SO-5 was located offshore of the San Dieguito Wetlands Restoration Project (see Appendix C), within the footprint of the surveyed transects. Per the EIR plan (AECOM, 2011), the maximum dredge depth was -60 ft, MLLW. The results of the Summer 2013 survey presented in Appendix A show the elevation changes due to the borrow site at the offshore end of the profiles (with exception to SIO6, which was not in the dredge footprint).

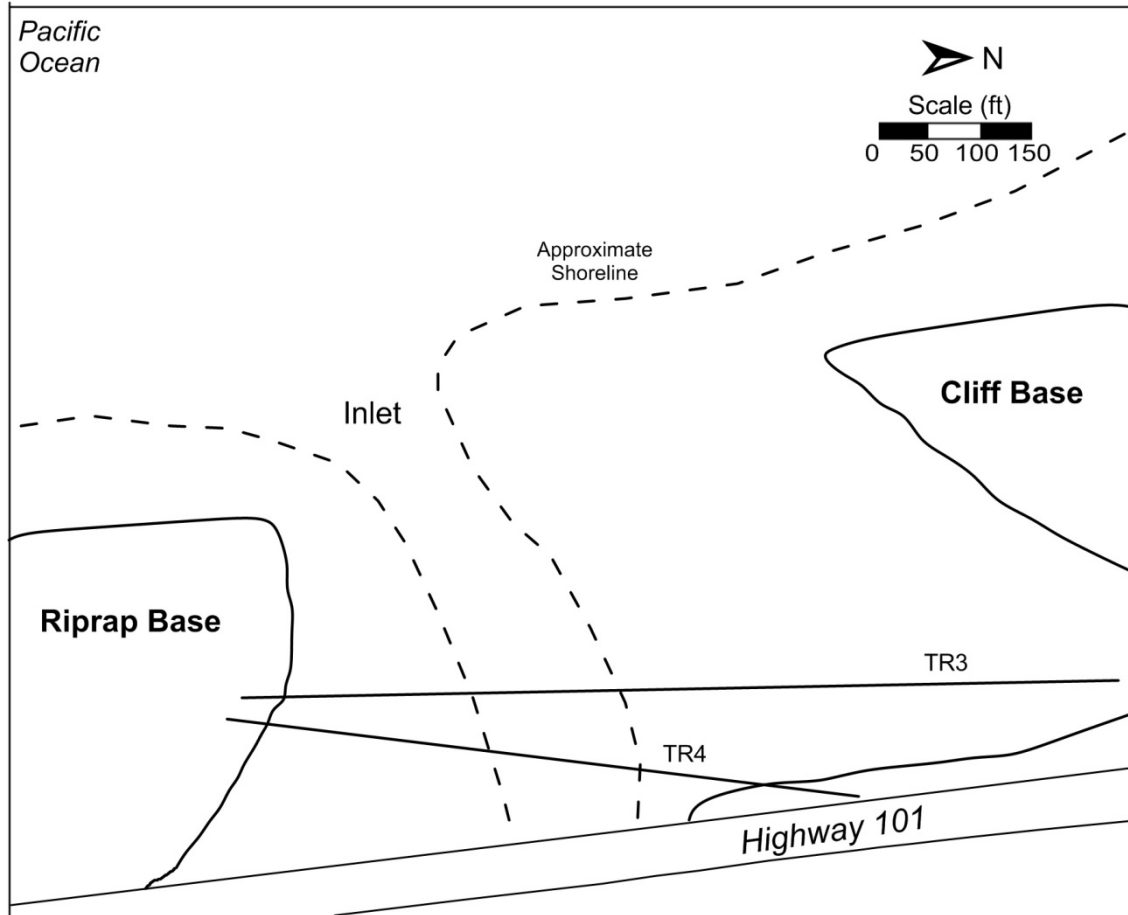
Figure D-1. Plan view of transects surveyed at the San Dieguito Lagoon inlet west of Highway 101.

Additional surveys were also performed on 17 October 2013 at transects 3, 4, 7, and 8, which are located in the inlet channel, both west (transects 3 and 4) and east (transects 7 and 8) of Highway 101. Figures D-1 and D-2 show the locations of these transects. Figure D-3 shows the elevation data for these transects.

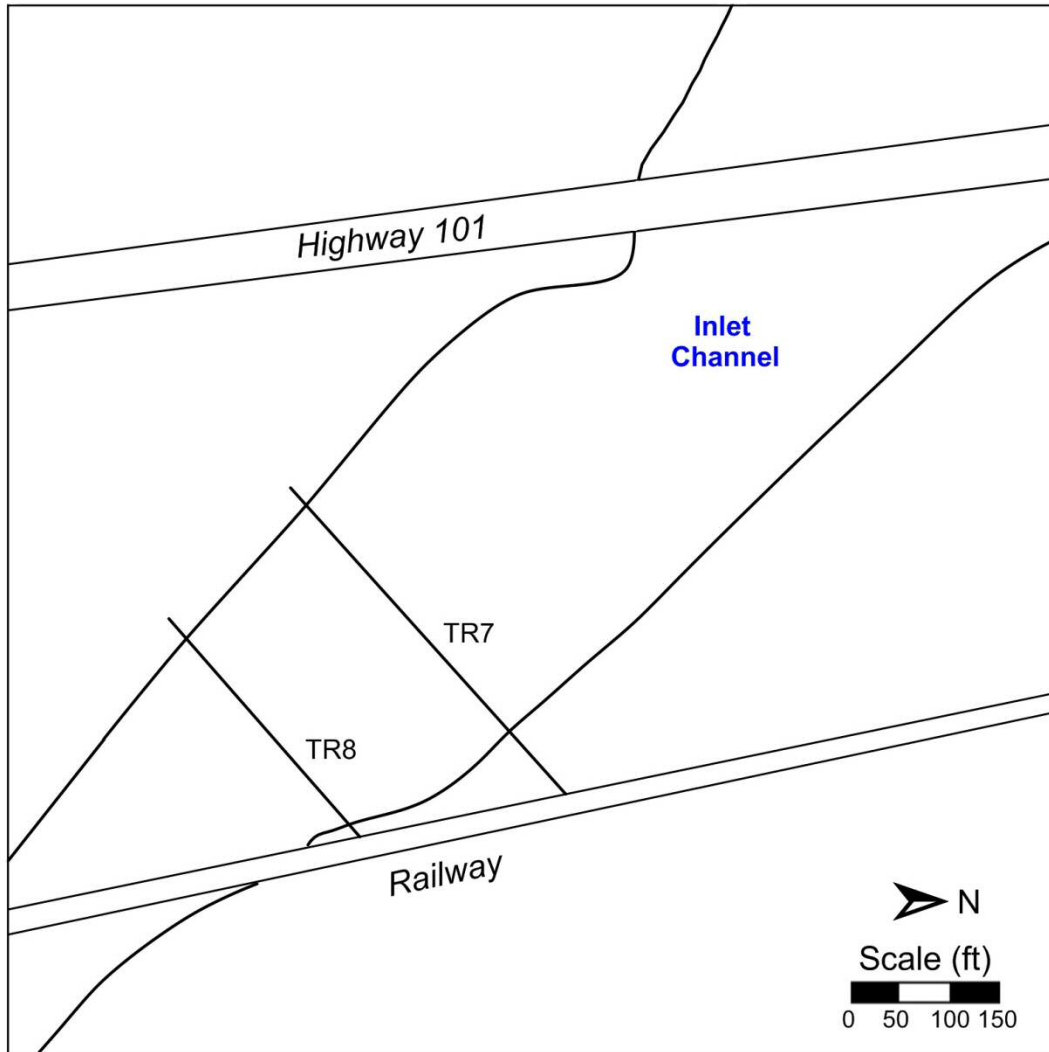
Figure D-2. Plan view of transects surveyed at the San Dieguito Lagoon inlet east of Highway 101.

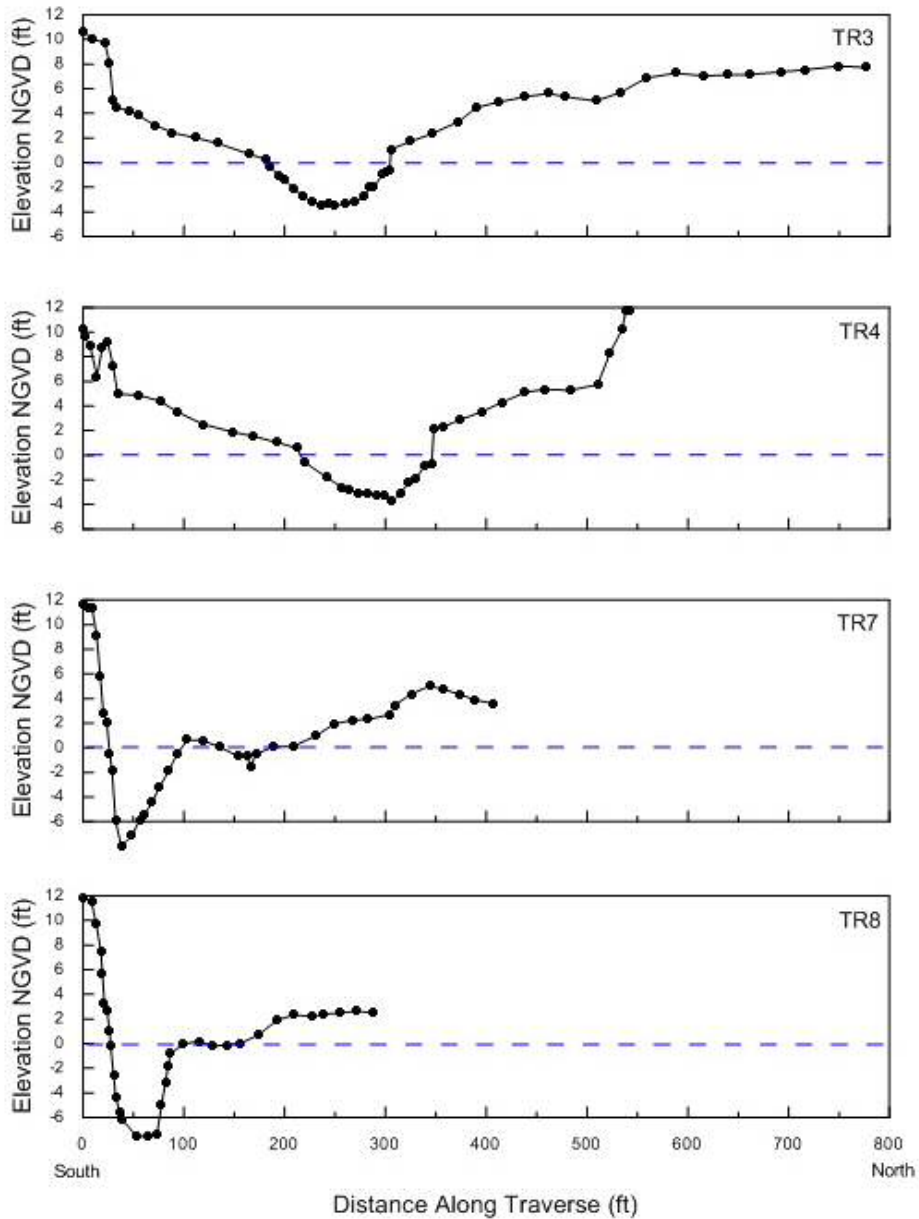
Figure D-3. Transects TR3 and TR4 west of Highway 101 and TR7 and TR8 east of Highway 101.
