SAN DIEGUITO WETLANDS RESTORATION PROJECT

**23 JANUARY 2013 BEACH PROFILES
CITY OF DEL MAR, CALIFORNIA**

Data Report

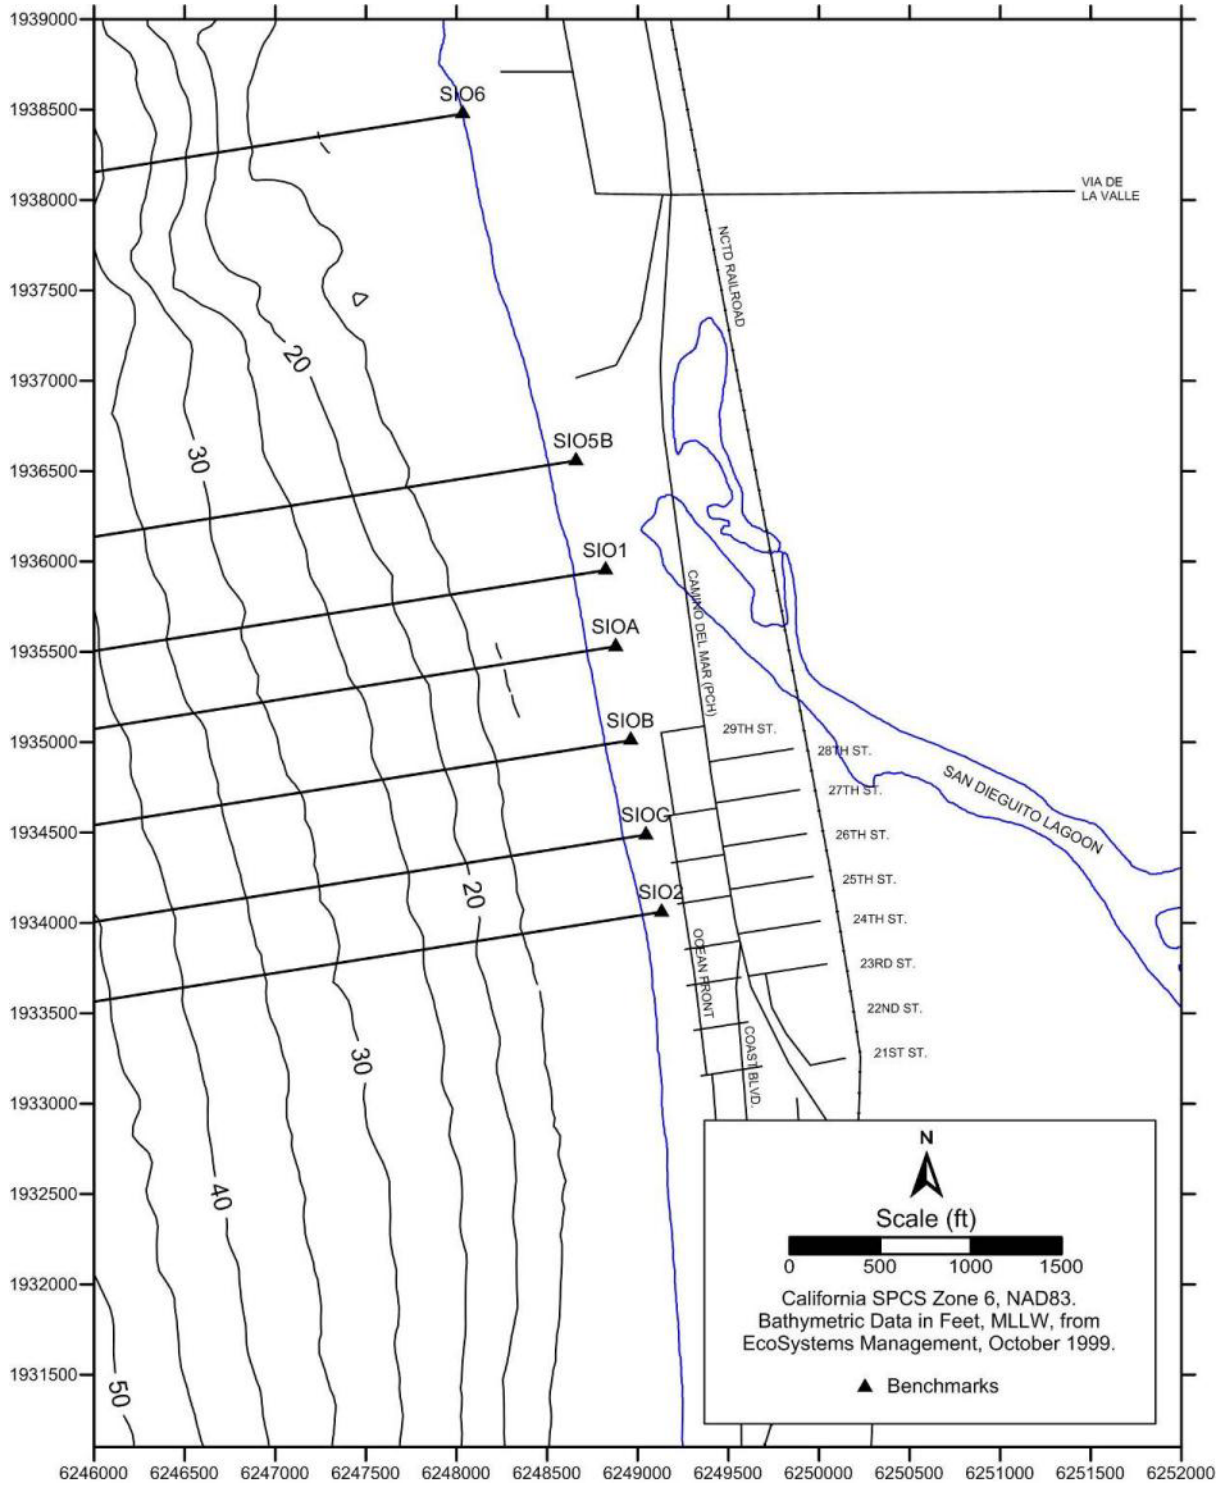
Figure 2. Beach profiles surveyed on 23 January 2013.

The 2013 beach profile surveys were performed on 23 January 2013 along the four (4) historic and three (3) newly established profiles (Figure 2). The cross-sections of the survey profiles are presented in Appendix A. The beach width for each of the profiles is presented in Appendix B.

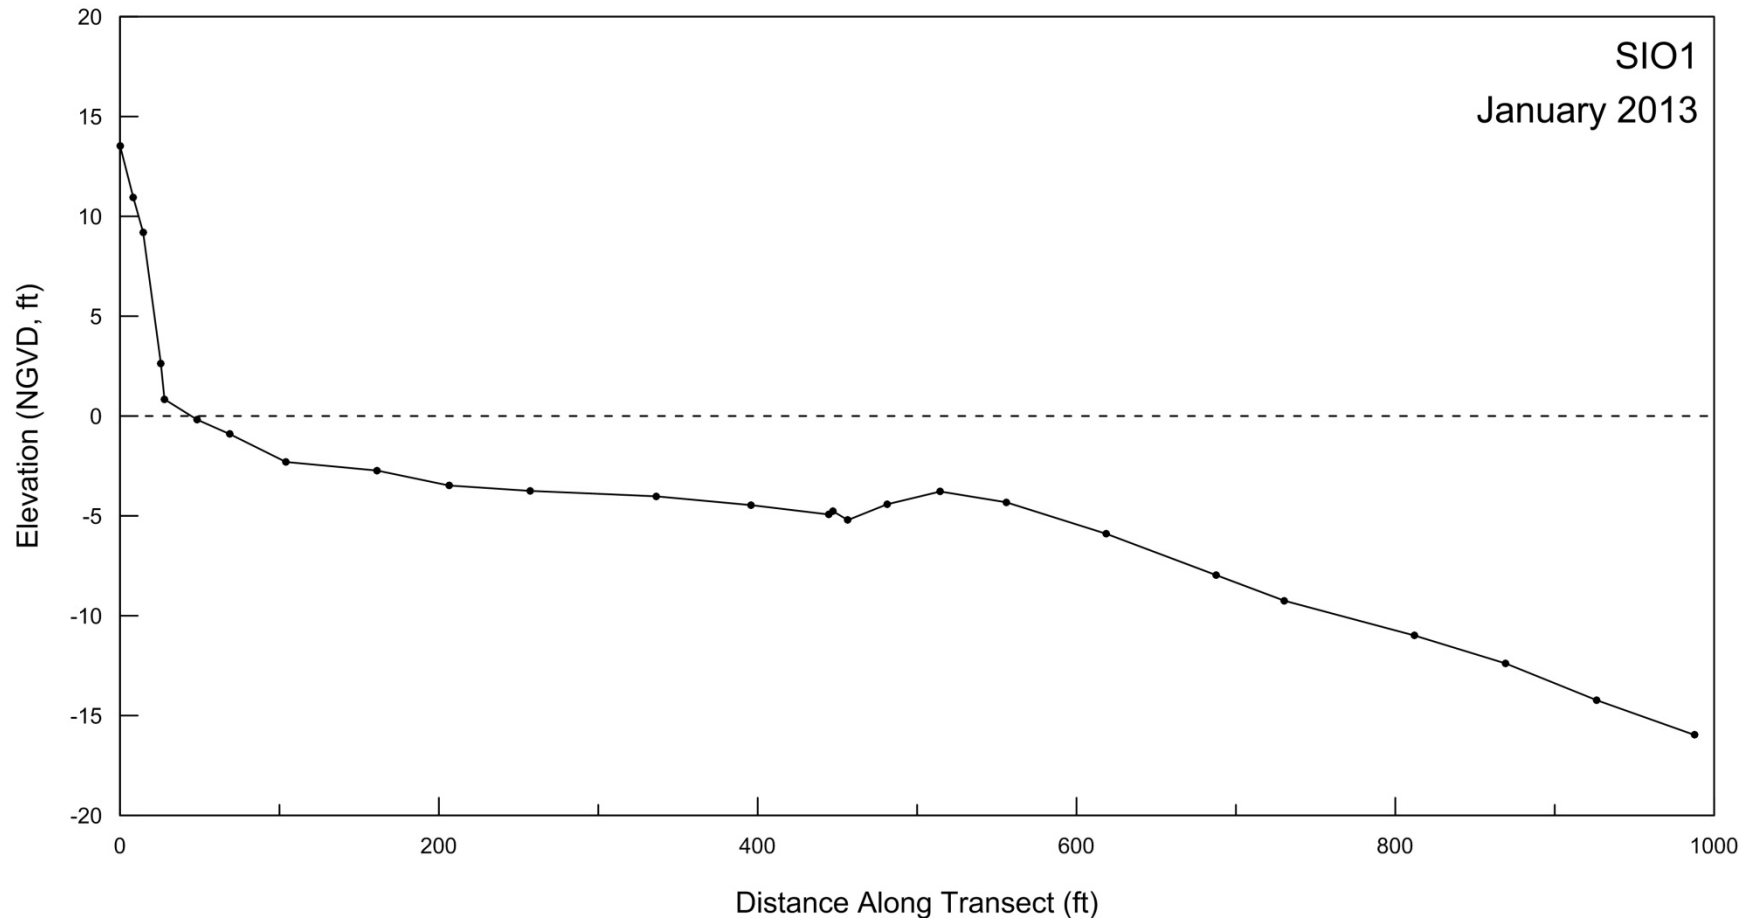
Figure A-1. Beach profile for SIO1 surveyed on 23 January 2013.

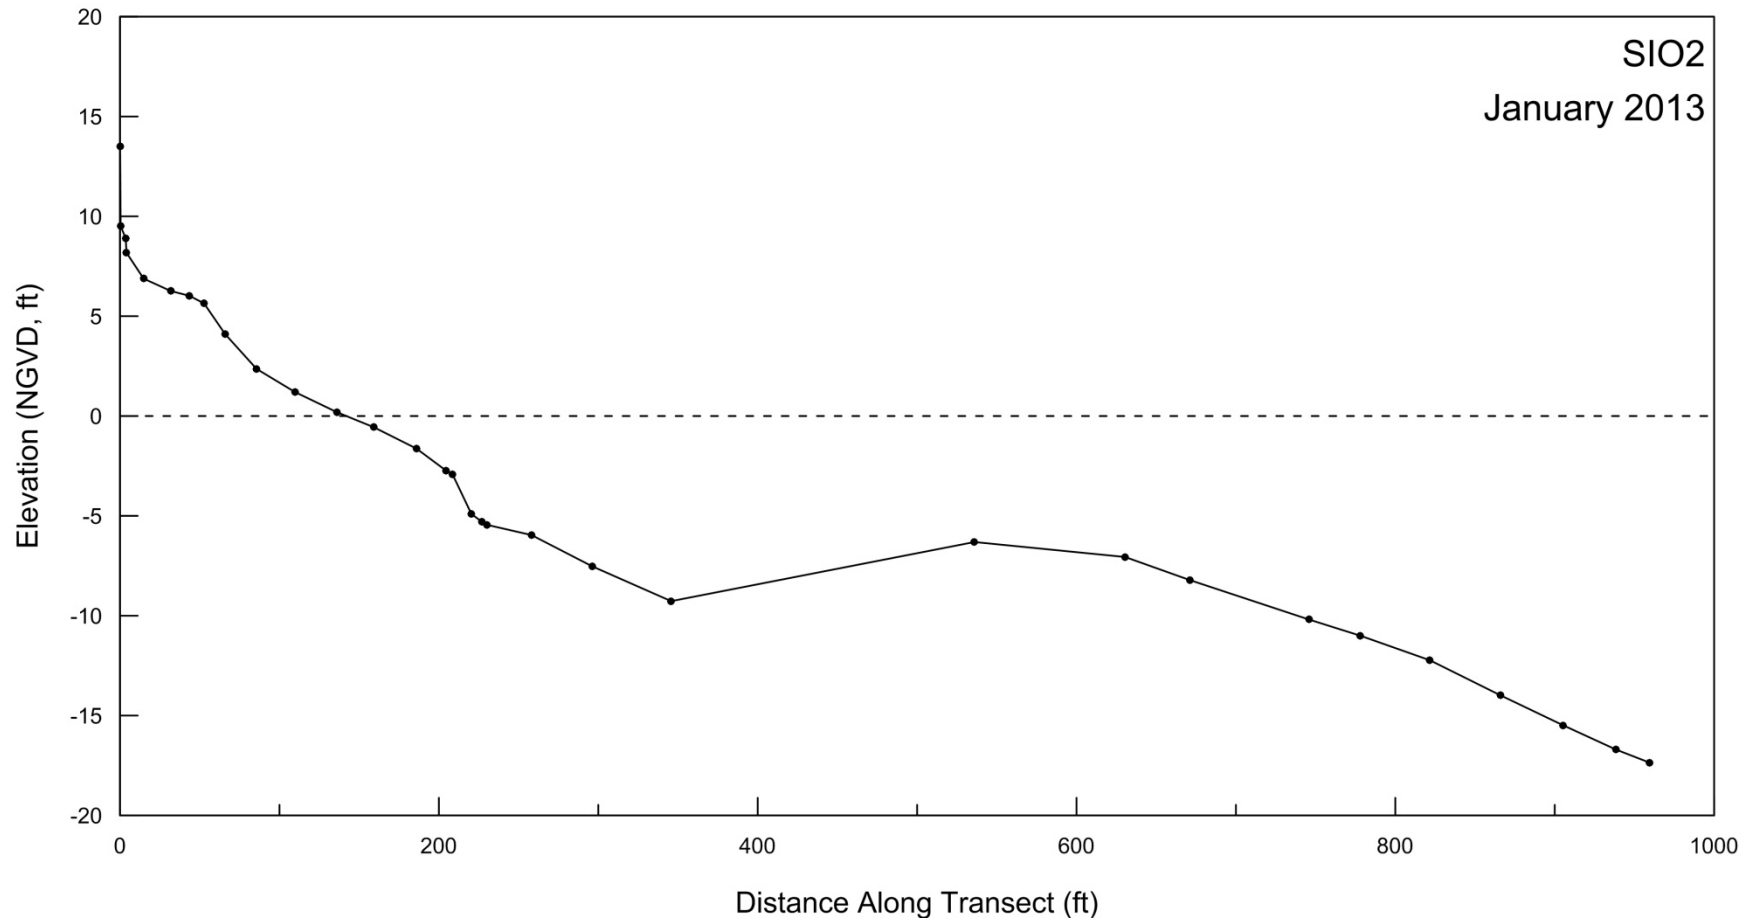
Figure A-2. Beach profile for SIO2 surveyed on 23 January 2013.

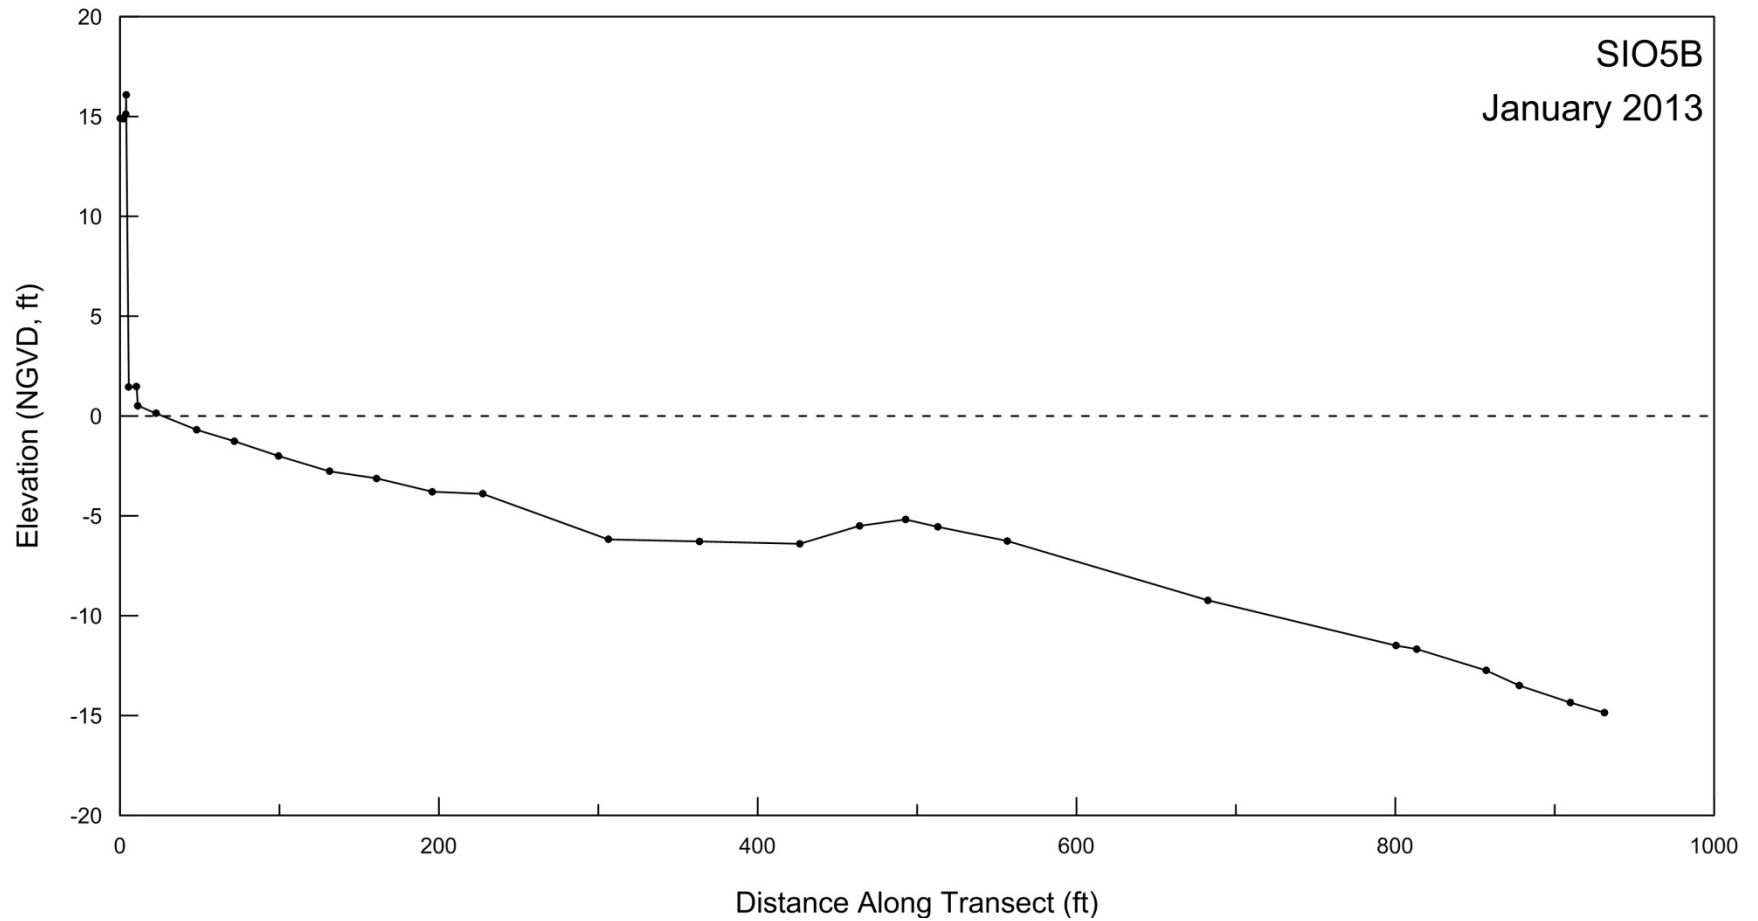
Figure A-3. Beach profile for SIO5B surveyed on 23 January 2013.

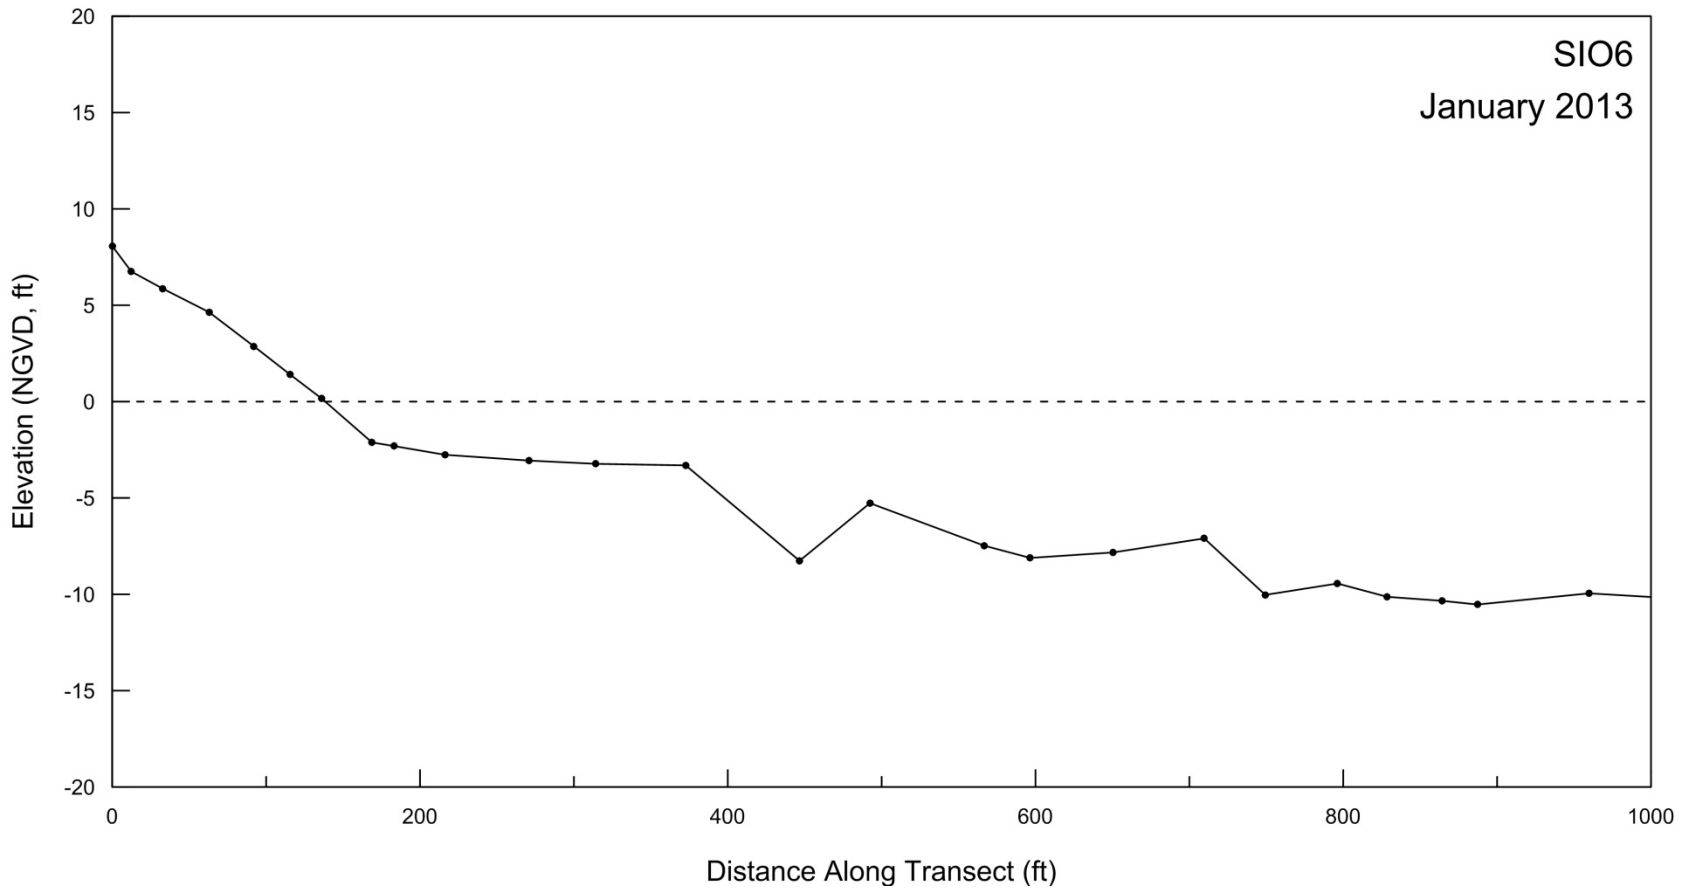
Figure A-4. Beach profile for SIO6 surveyed on 23 January 2013.

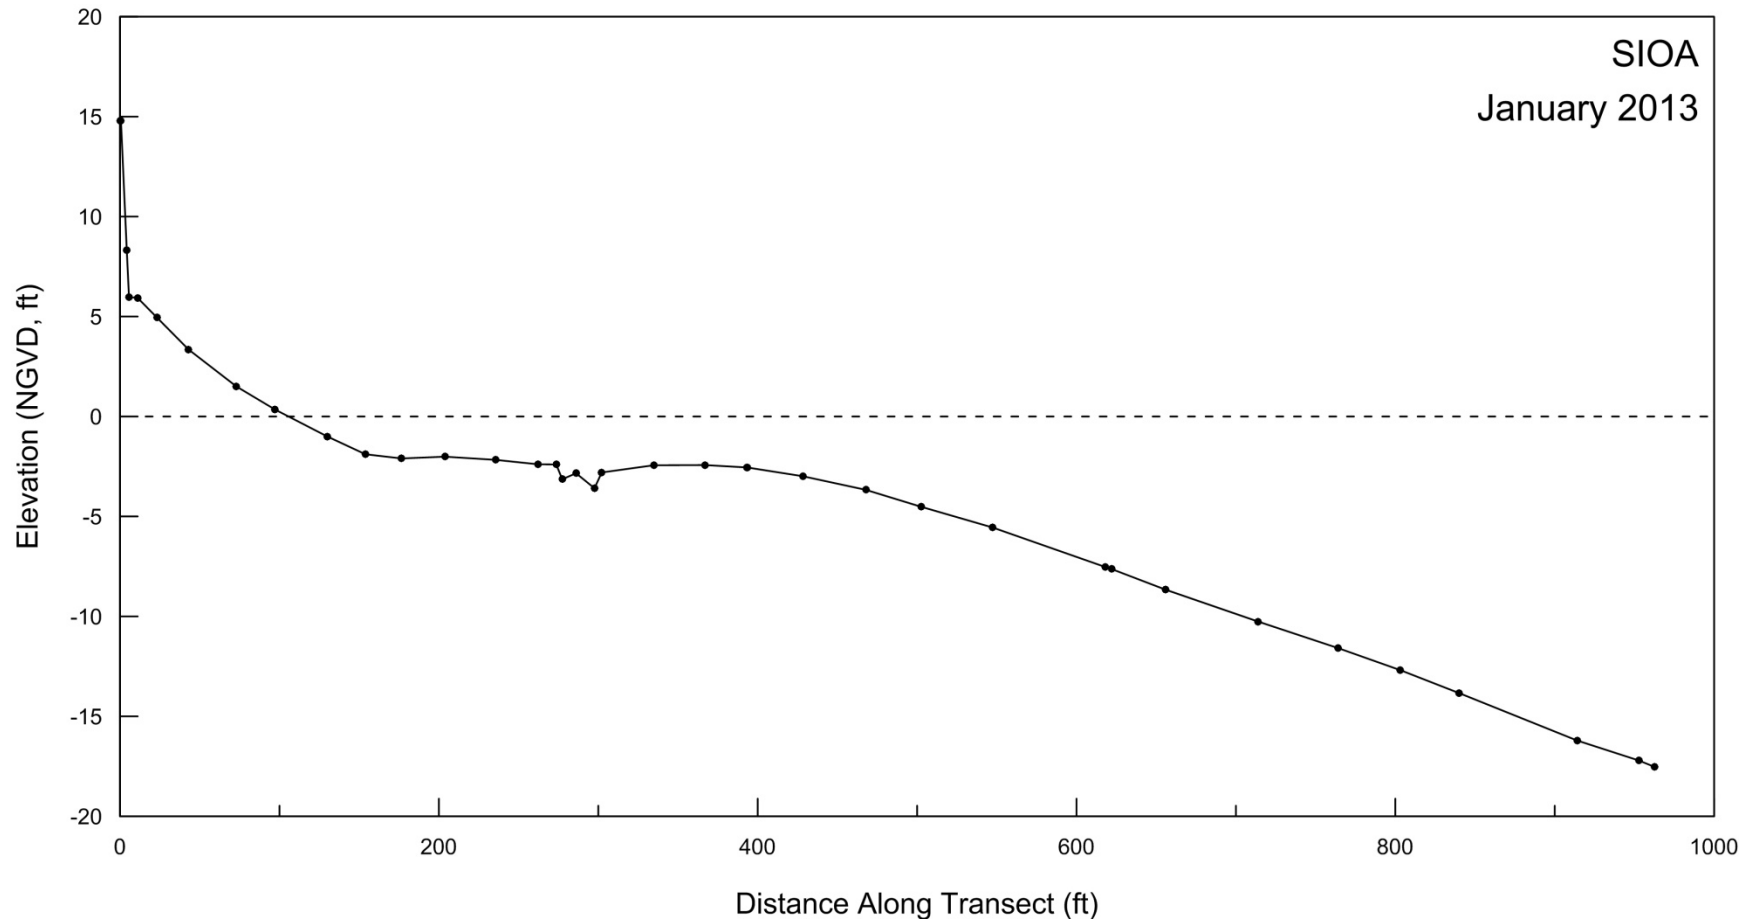
Figure A-5. Beach profile for SIOA surveyed on 23 January 2013.

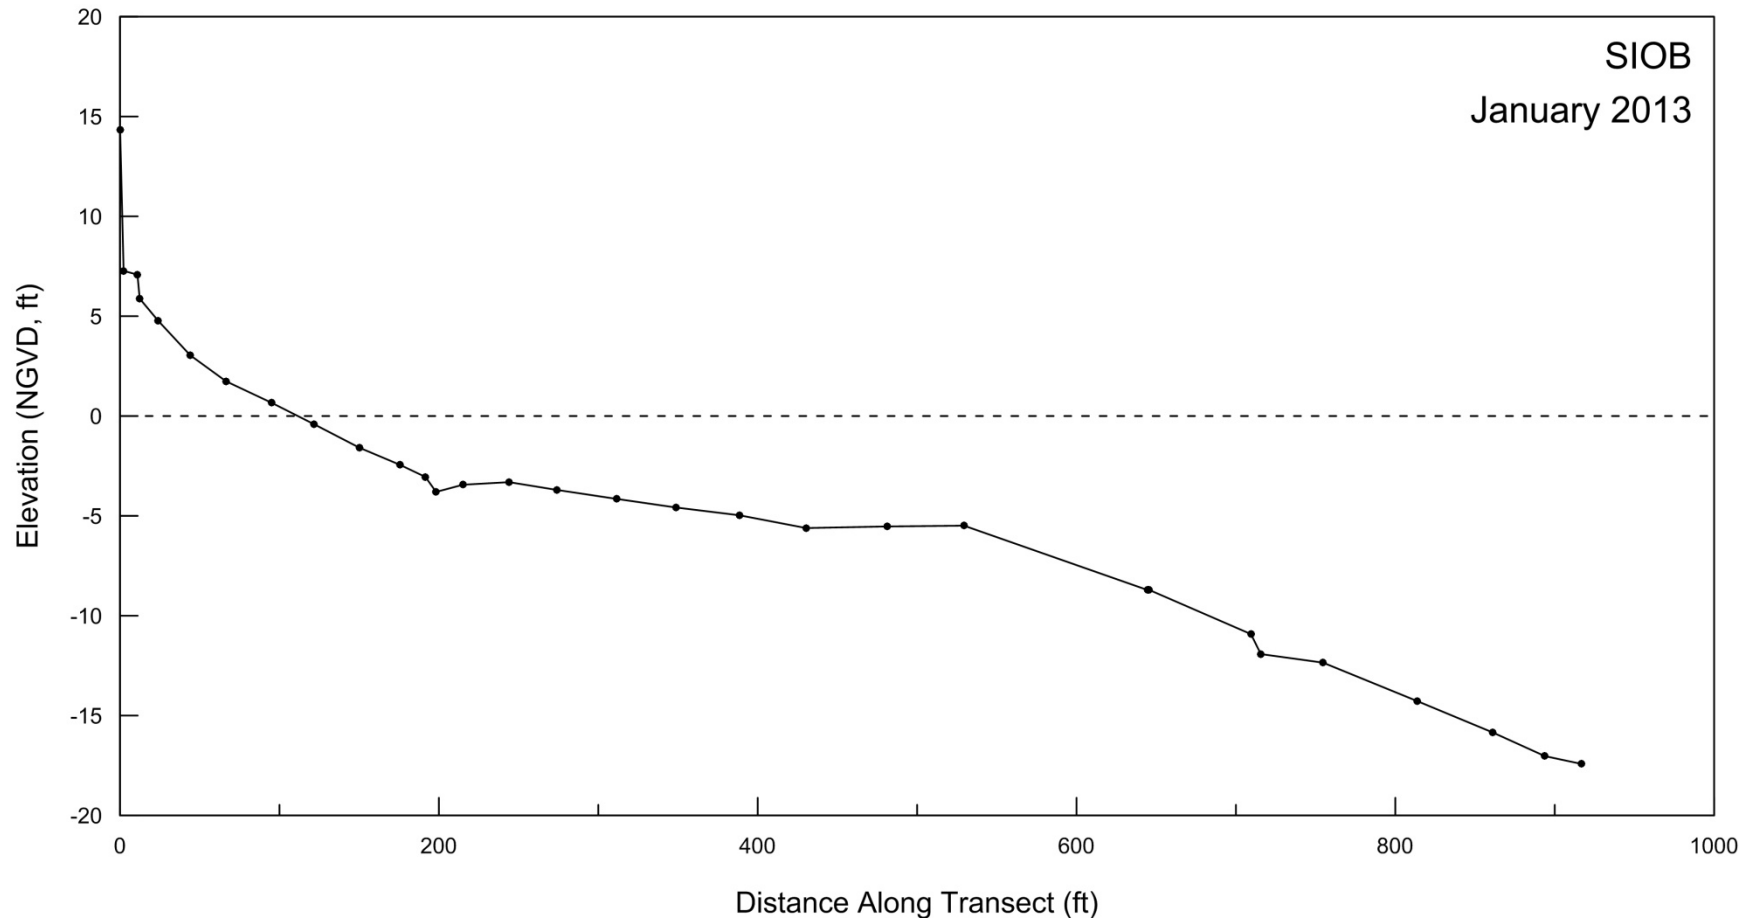
Figure A-6. Beach profile for SIOB surveyed on 23 January 2013.

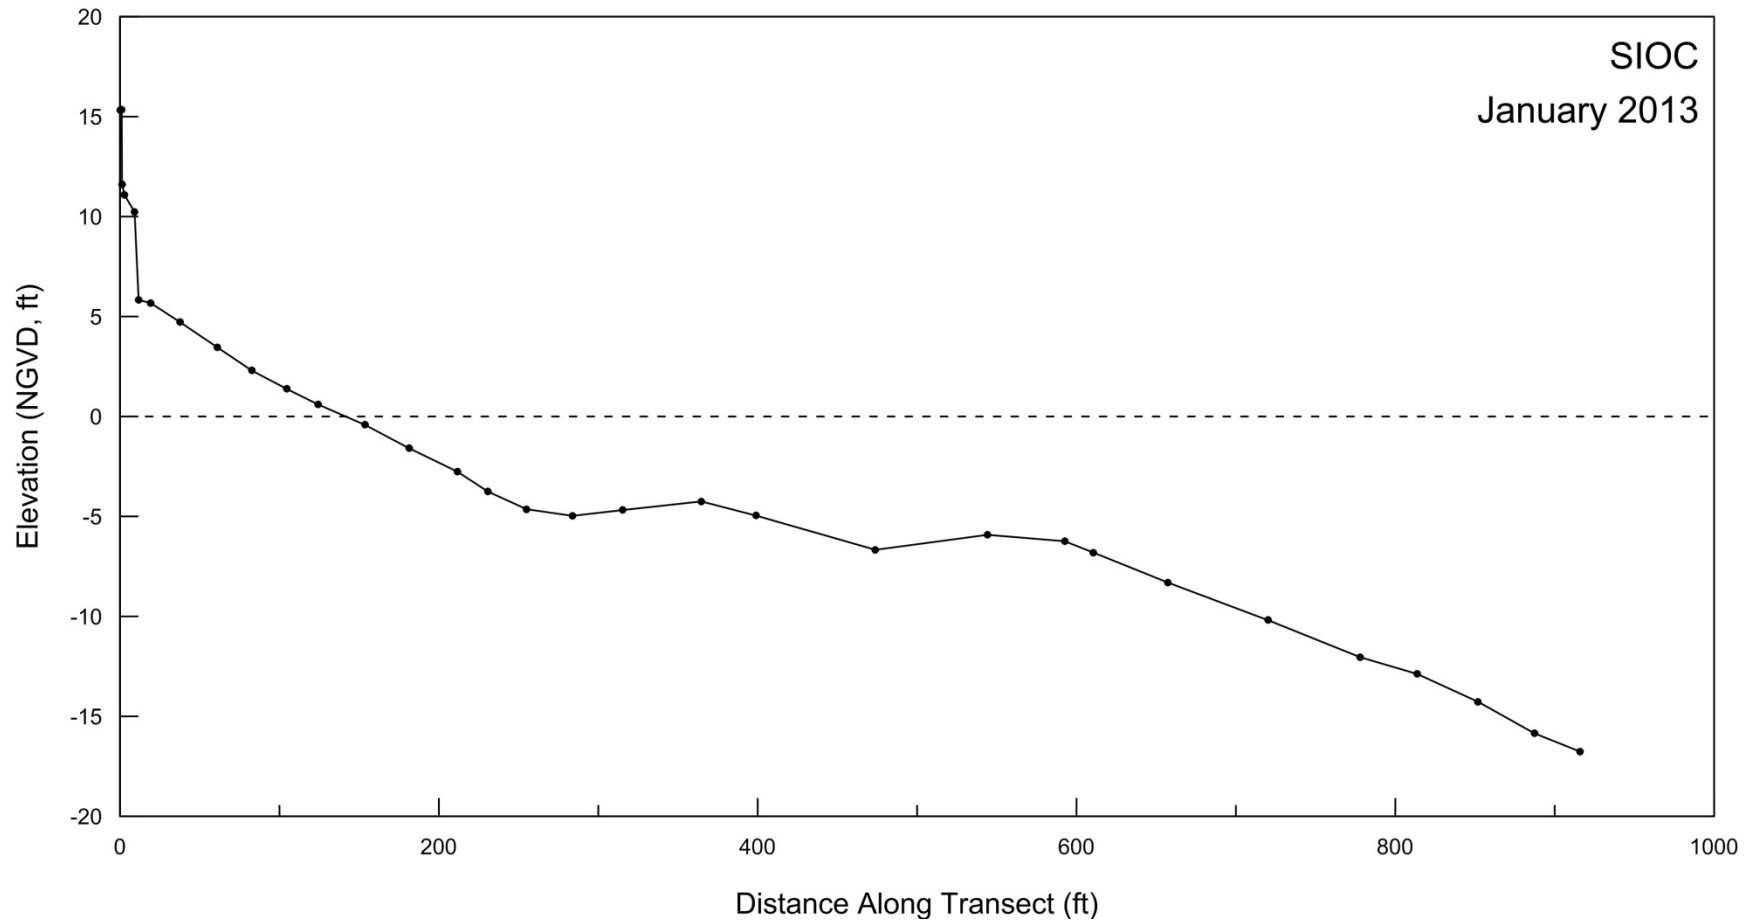
Figure A-7. Beach profile for SIOC surveyed on 23 January 2013.
