SAN DIEGUITO WETLANDS RESTORATION PROJECT

26 APRIL 2013 BEACH PROFILES CITY OF DEL MAR, CALIFORNIA

Data Report

30 April 2013
CE Reference No. 13-09

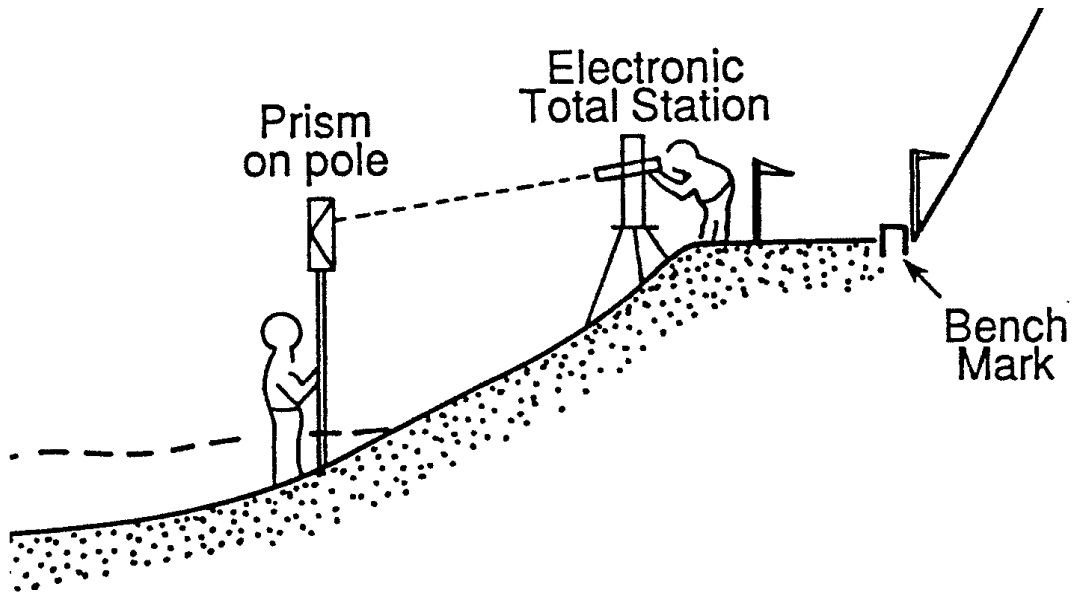
Figure 1. Schematic illustration of the survey method.

The beach profiles were conducted from the benchmarks to wading depth by total station and prism. Data were acquired along each transect from the survey marker to an offshore limit below MLLW (Mean Lower Low Water). Each survey marker (benchmark) was located at the back beach at a fixed point, primarily along a protective seawall. Data were collected at least to the depth of closure indicated by prior survey data (SANDAG, 2009).

The beach and surf zone were surveyed using an electronic total station and survey rod. The total station was used to determine the position and elevation of the beach at each location

occupied by the rod. A Sokkia Set-5A total station and SDR-33 electronic field data logger were utilized to collect the nearshore portion of the profile, providing an accuracy of approximately 2-4 cm both horizontally and vertically. The total station method reflects an infrared beam sent from the device to a prism atop a fixed-length pole, where the instrument measures the slant distance and horizontal and vertical angles to the target (Figure 1). An electronic field data logger is used to store the data, which can then be set to known positions using permanent local benchmarks. Each transect was surveyed from the back beach seaward through the surf zone until the rod no longer protruded above the water surface.

The offshore portion of the beach profile was acquired with a digital acoustic echo sounder operated from a 27-ft shallow-draft survey vessel. A DGPS receiver was used to determine the position of each sounding. To improve the accuracy of each position, differential corrections transmitted in real time from U.S. Coast Guard beacons were utilized. All systems were interfaced to a laptop computer using the Hypack survey package.

At each transect, the boat traveled from the offshore limit to the surf zone guided by DGPS navigation system. Soundings were acquired on a near-continuous basis (approximately four to five per second). Vessel positions were recorded at 1-second intervals and merged with the soundings using Hypack bathymetric survey software. The calibration of the echo sounder was checked at the beginning and end of each survey session using a standard “bar check” procedure.

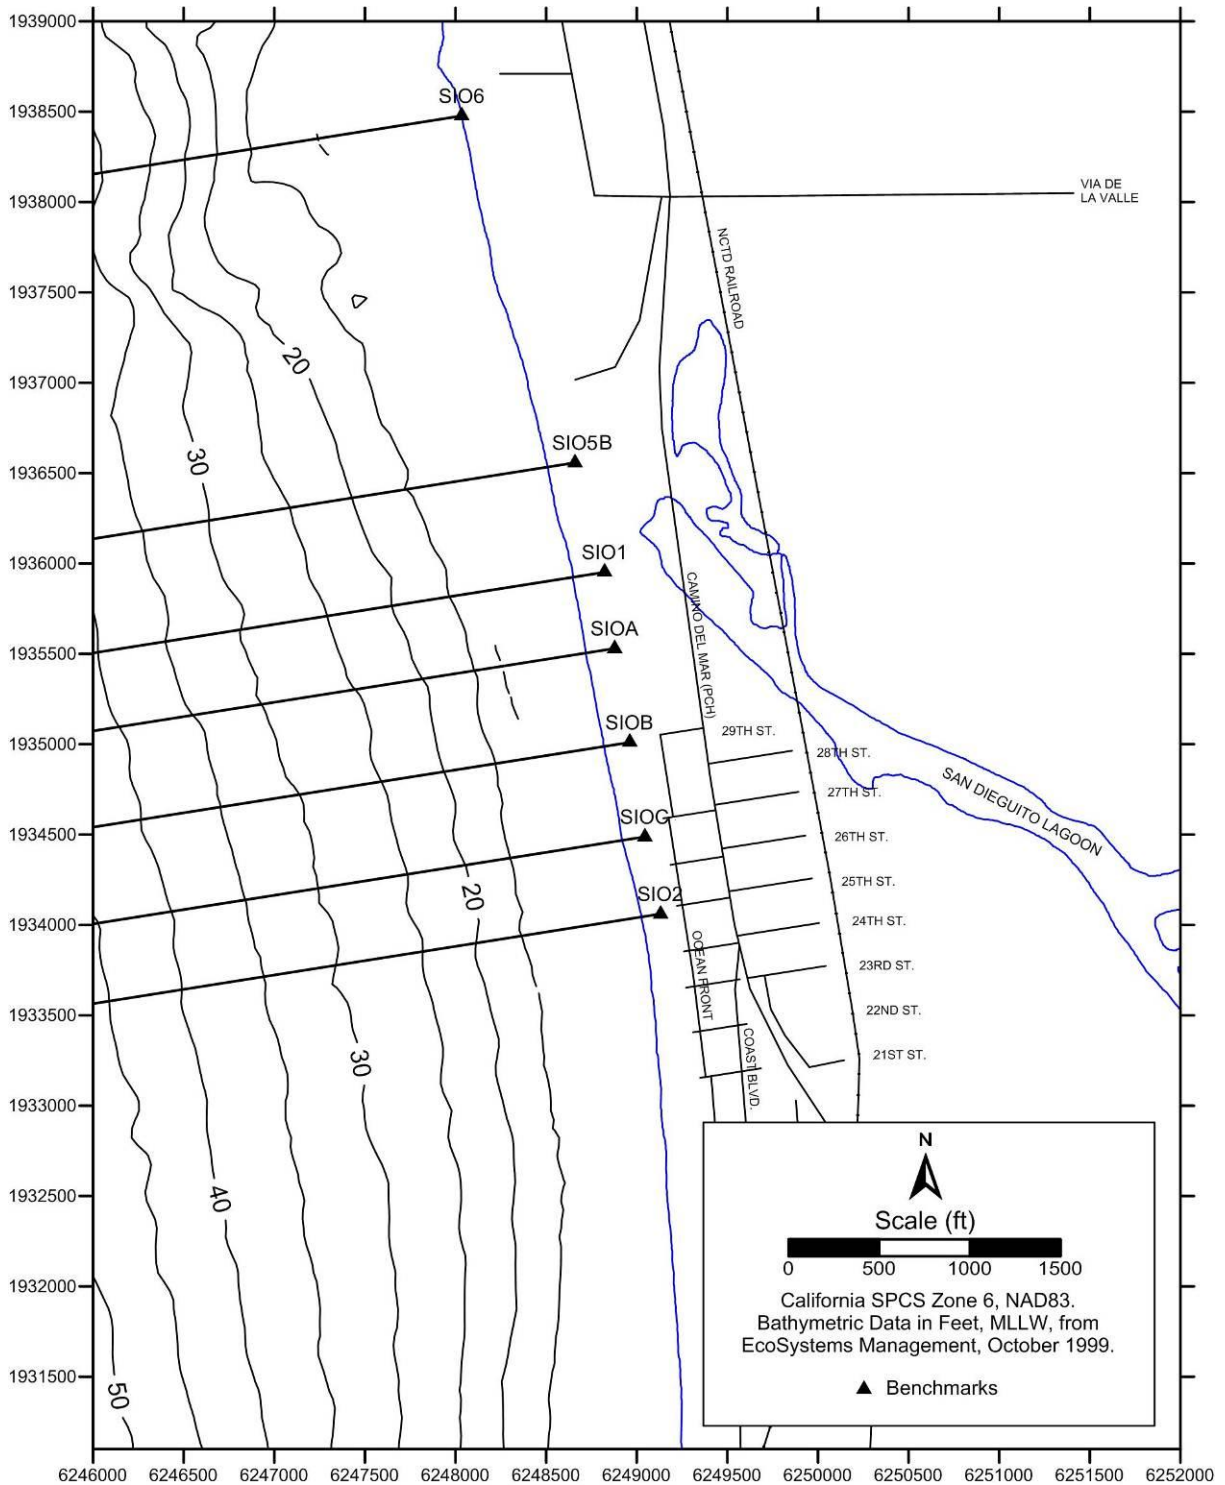
Figure 2. Beach profiles surveyed on 26 April 2013.

The 2013 beach profile surveys were performed on 26 April 2013, along the four historic and three newly established profiles (Figure 2). The beach profiles are presented in Appendix A. The beach width for each of the profiles is presented in Appendix B.

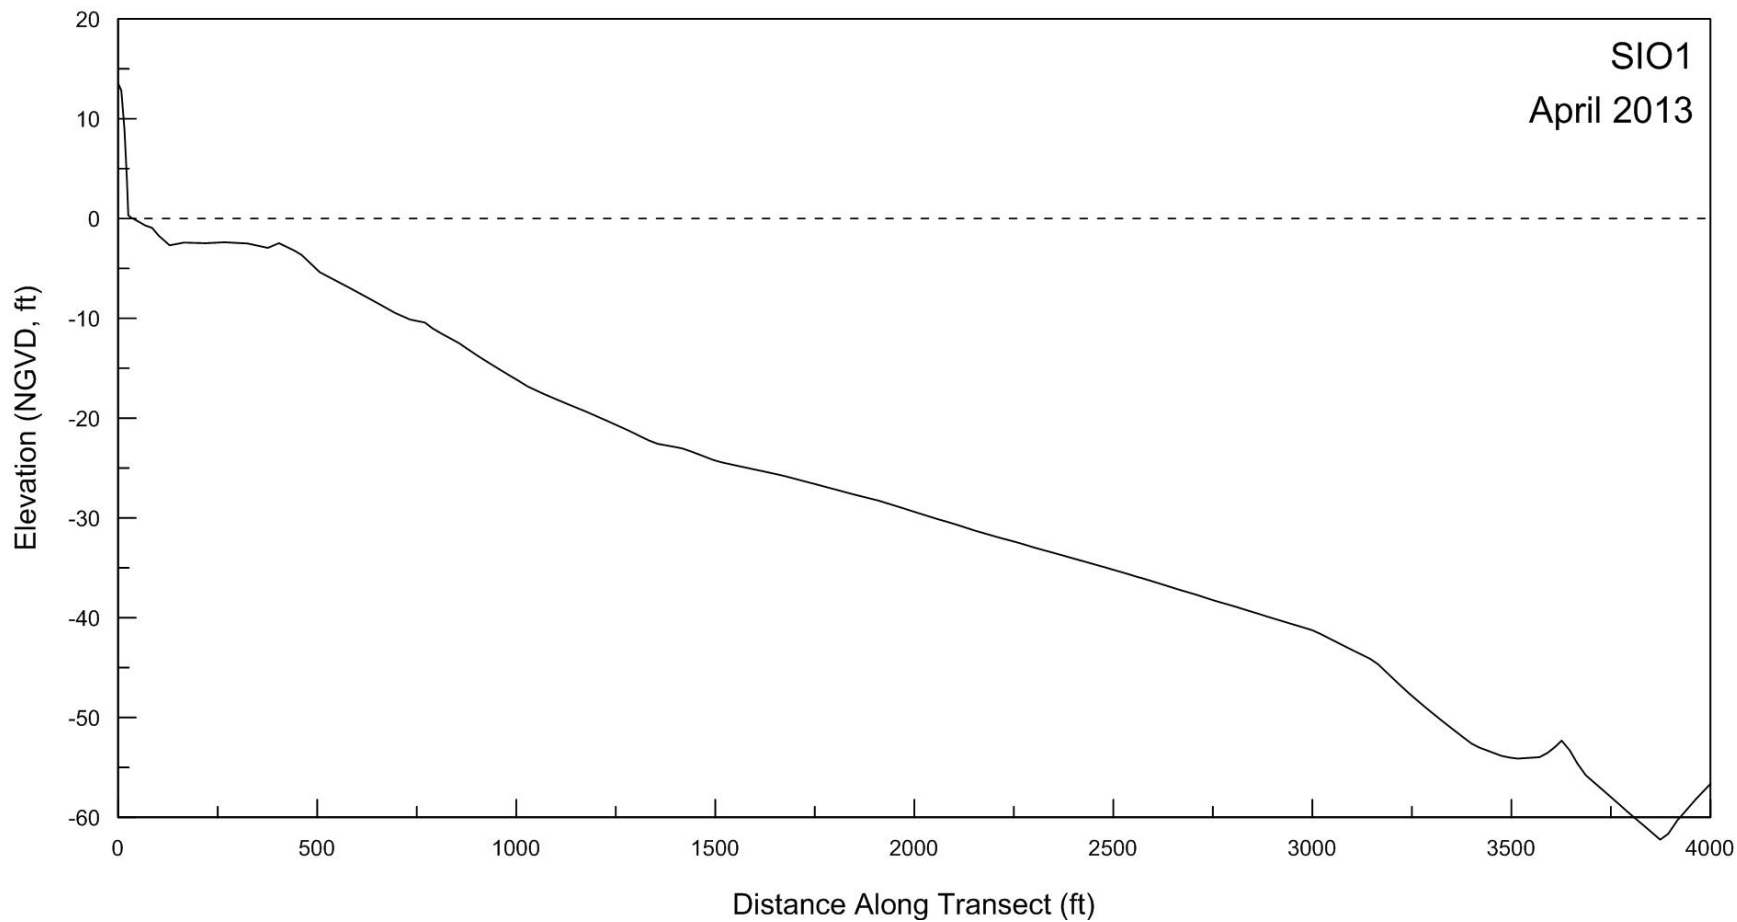
Figure A-1. Beach profile for SIO1 surveyed in April 2013.

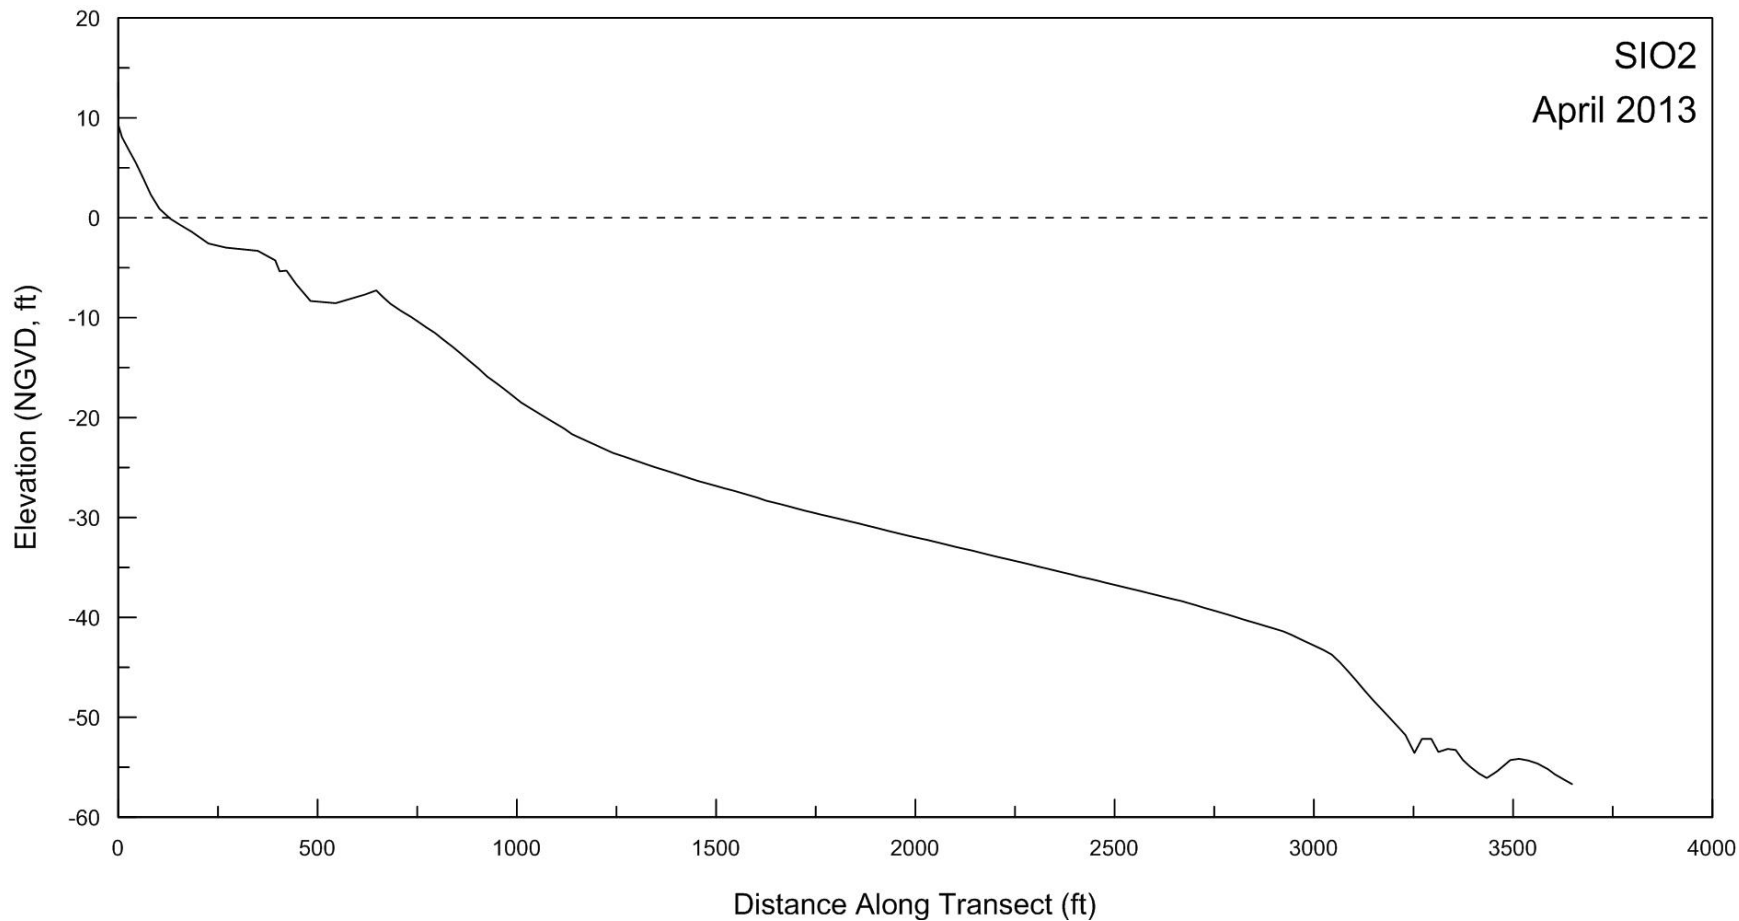
Figure A-2. Beach profile for SIO2 surveyed in April 2013.

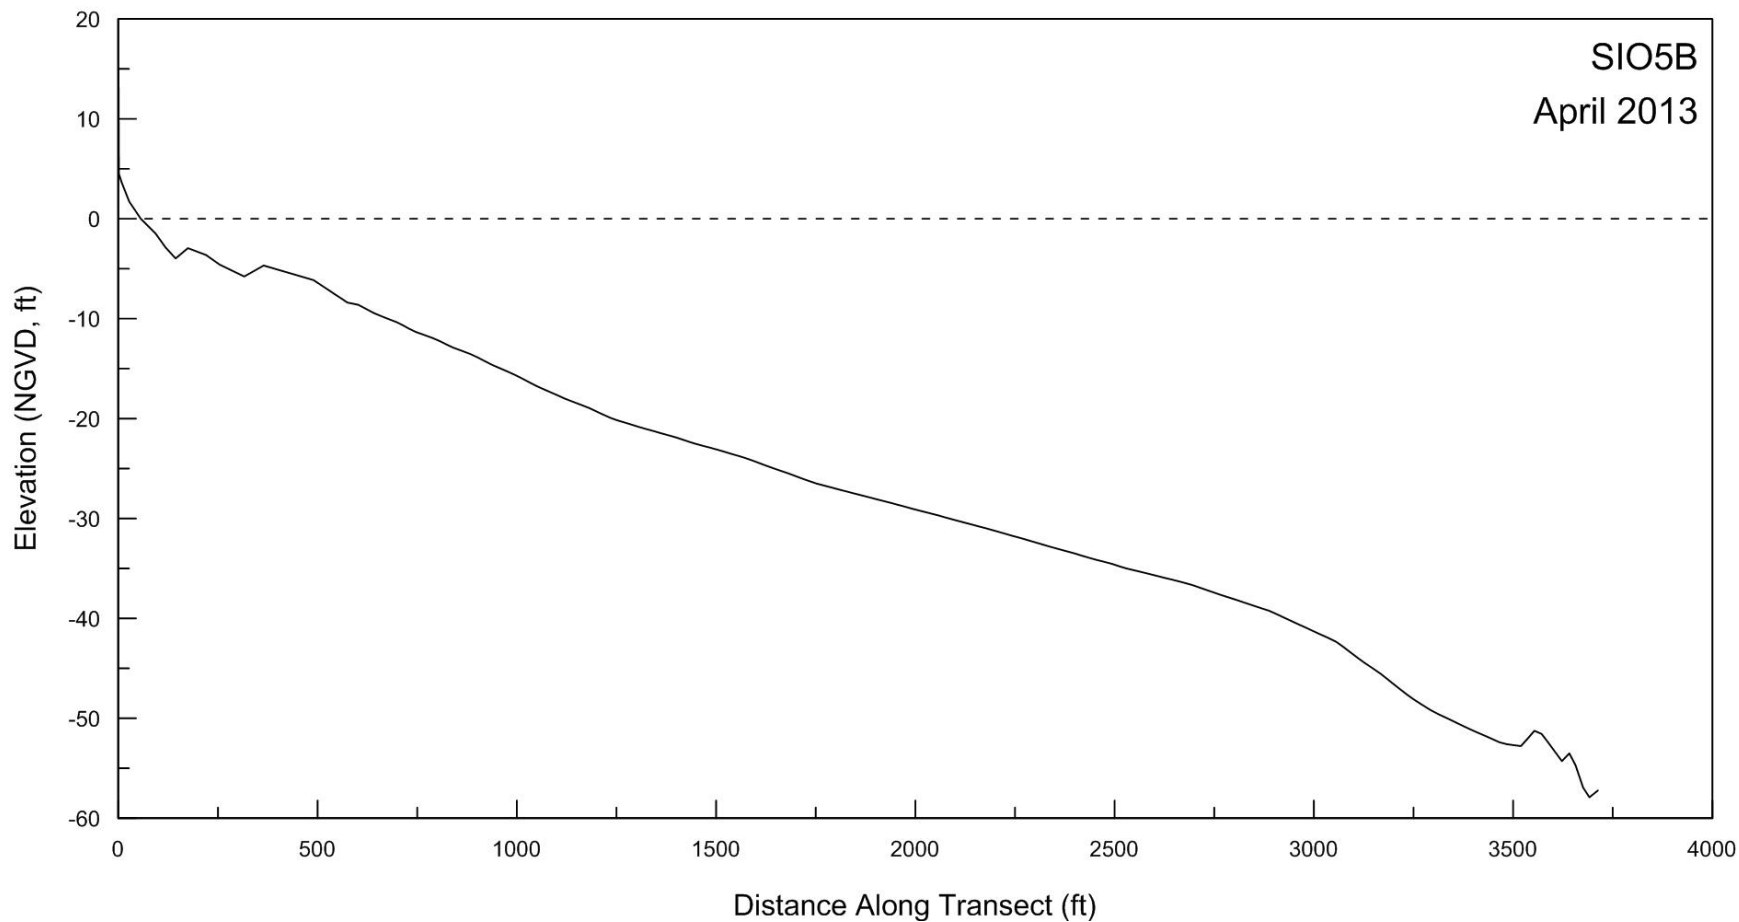
Figure A-3. Beach profile for SIO5B surveyed in April 2013.

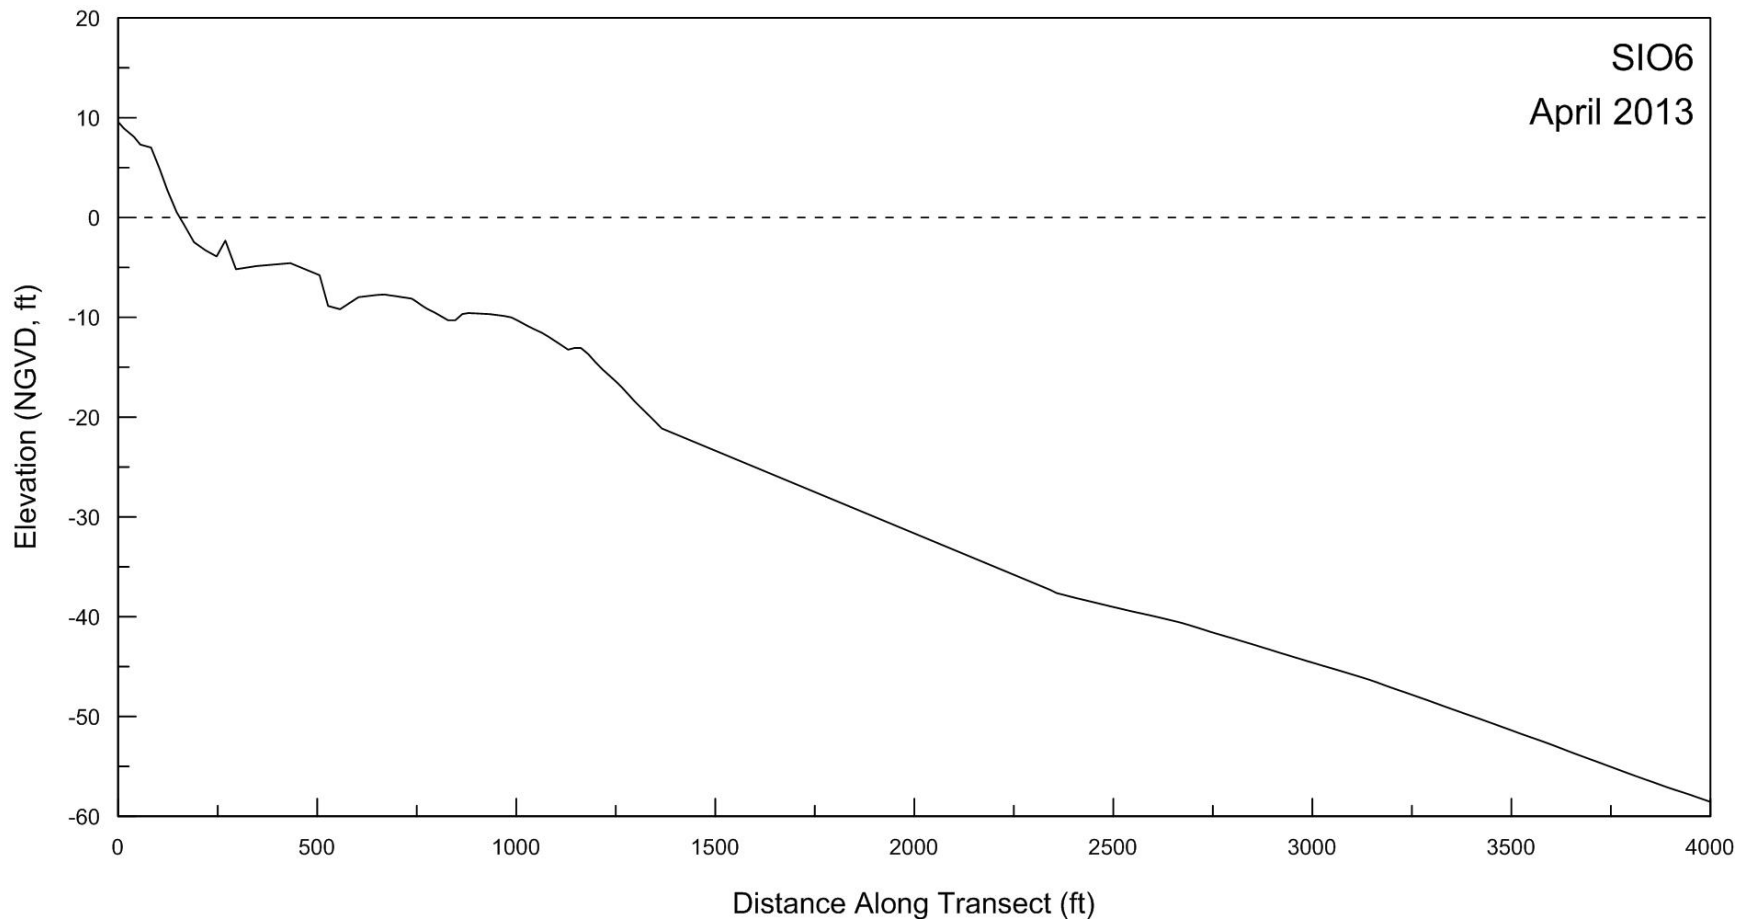
Figure A-4. Beach profile for SIO6 surveyed in April 2013.

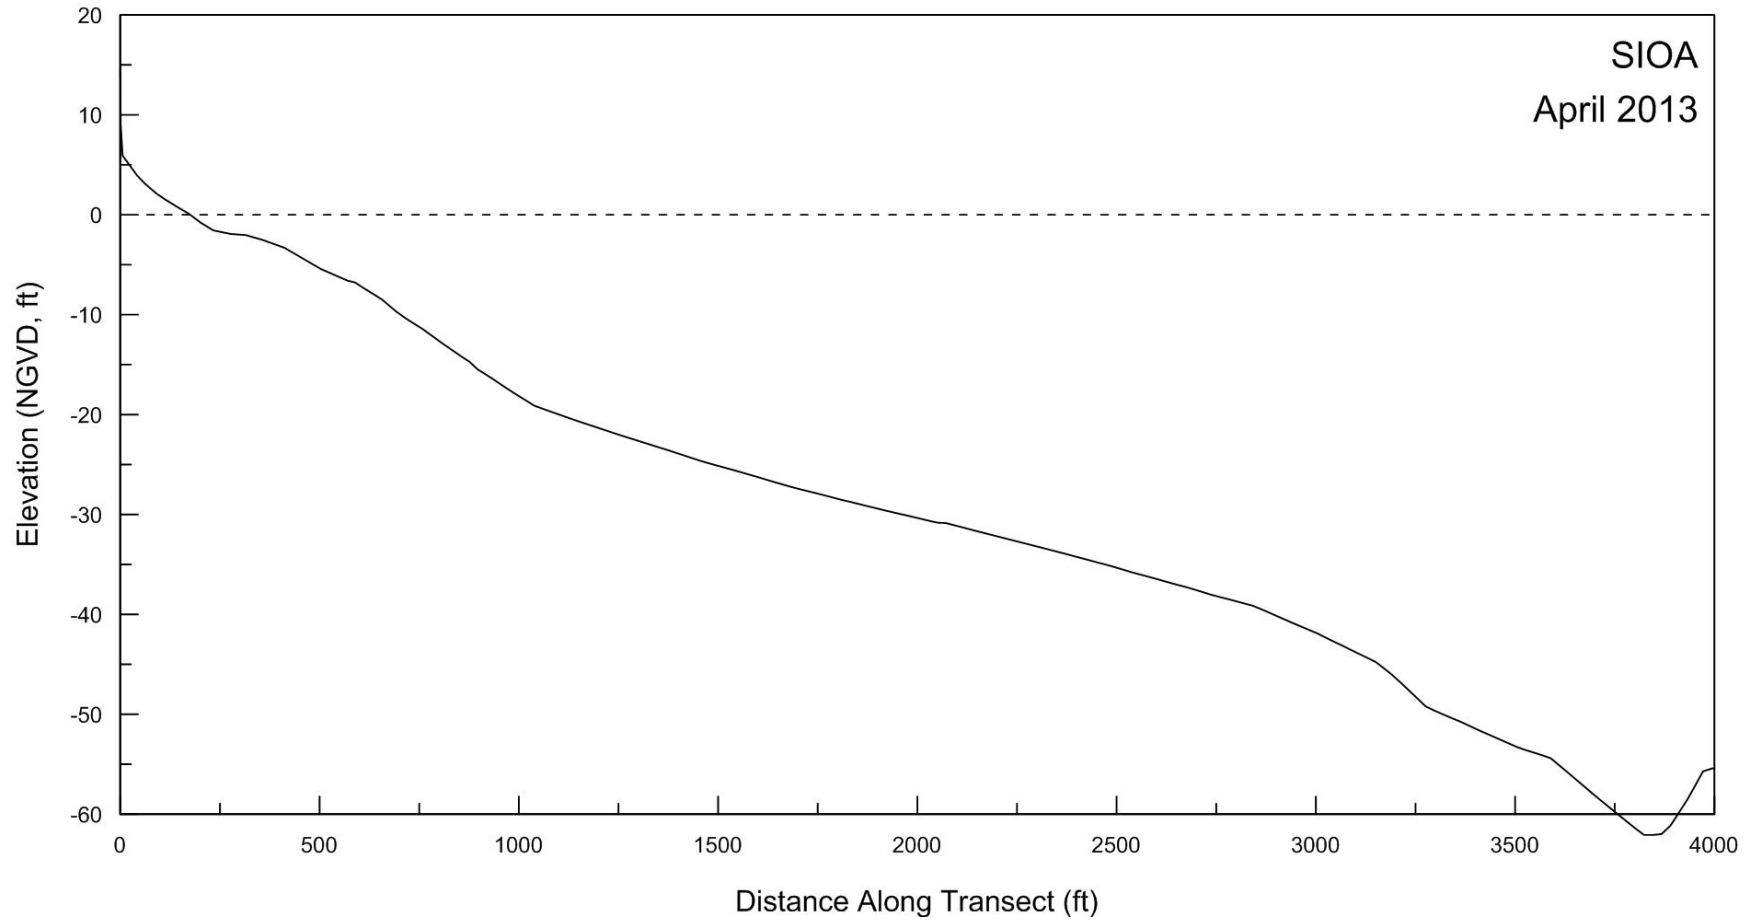
Figure A-5. Beach profile for SIOA surveyed in April 2013.

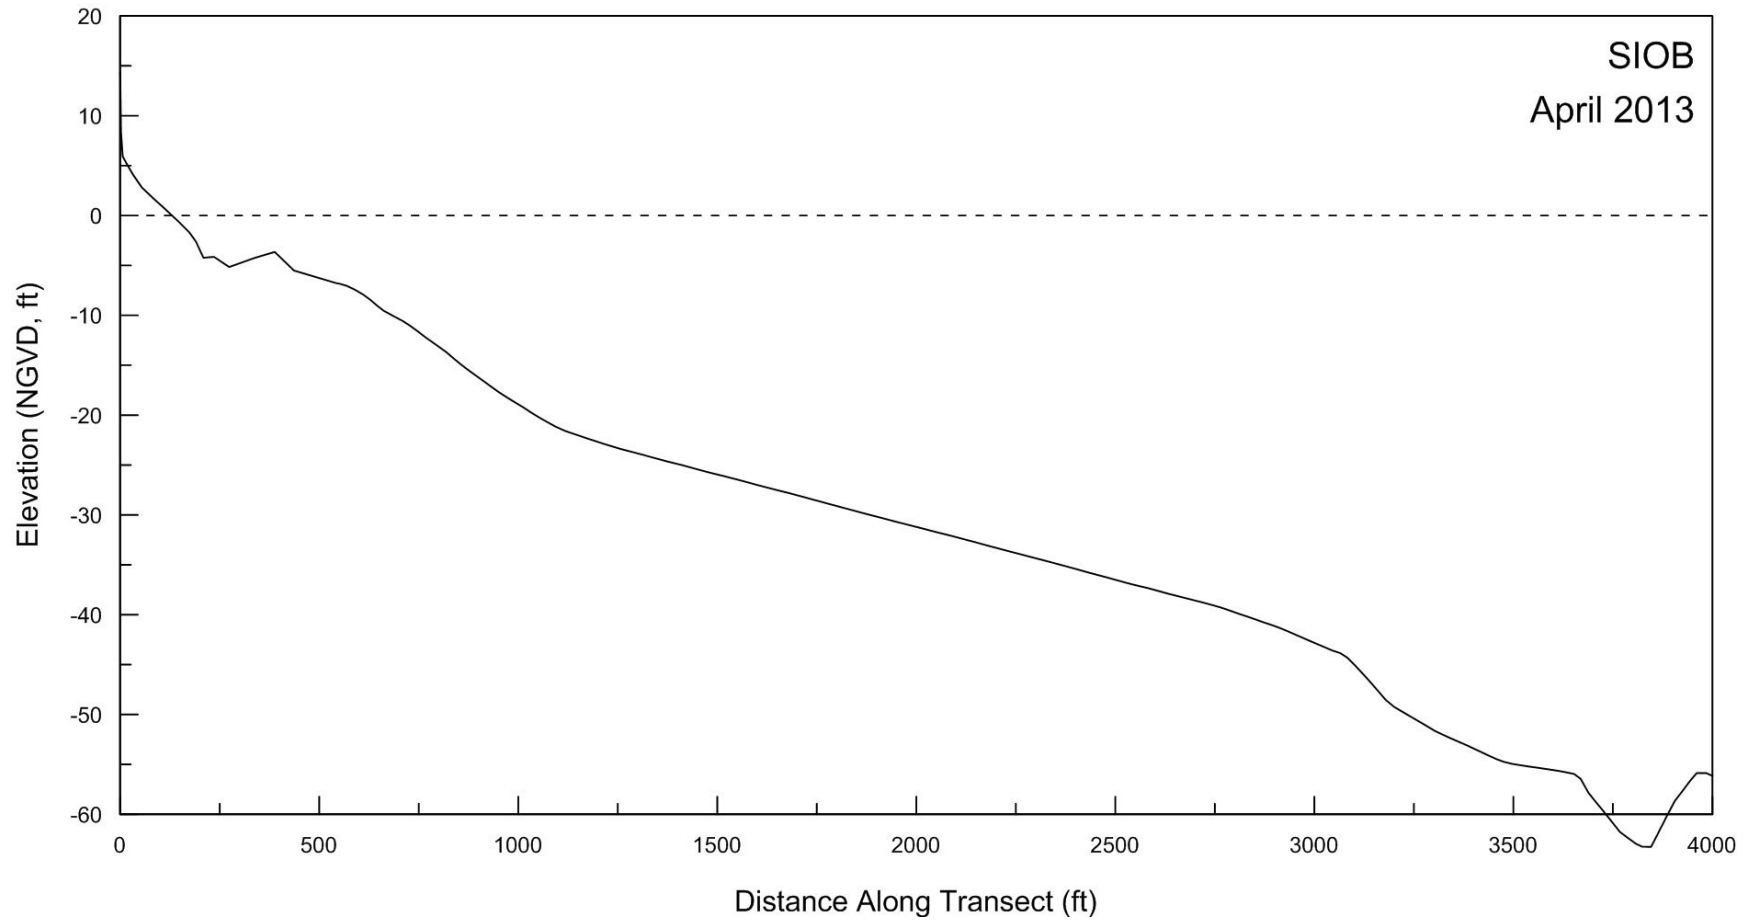
Figure A-6. Beach profile for SIOB surveyed in April 2013.

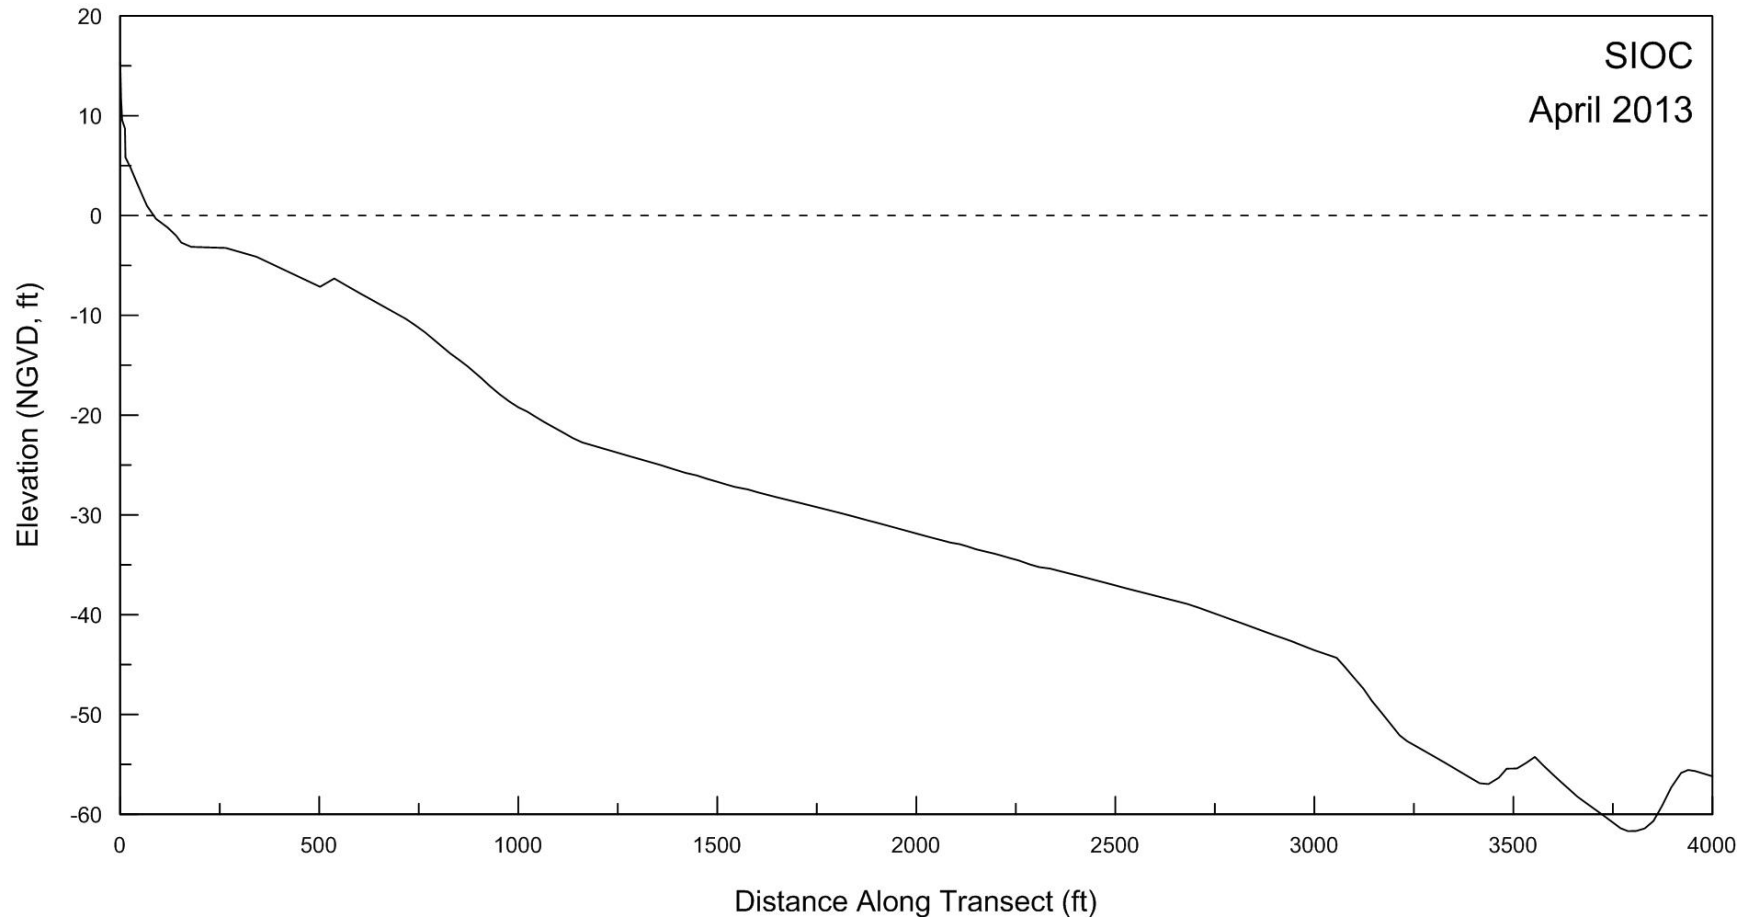
Figure A-7. Beach profile for SIOC surveyed in April 2013.

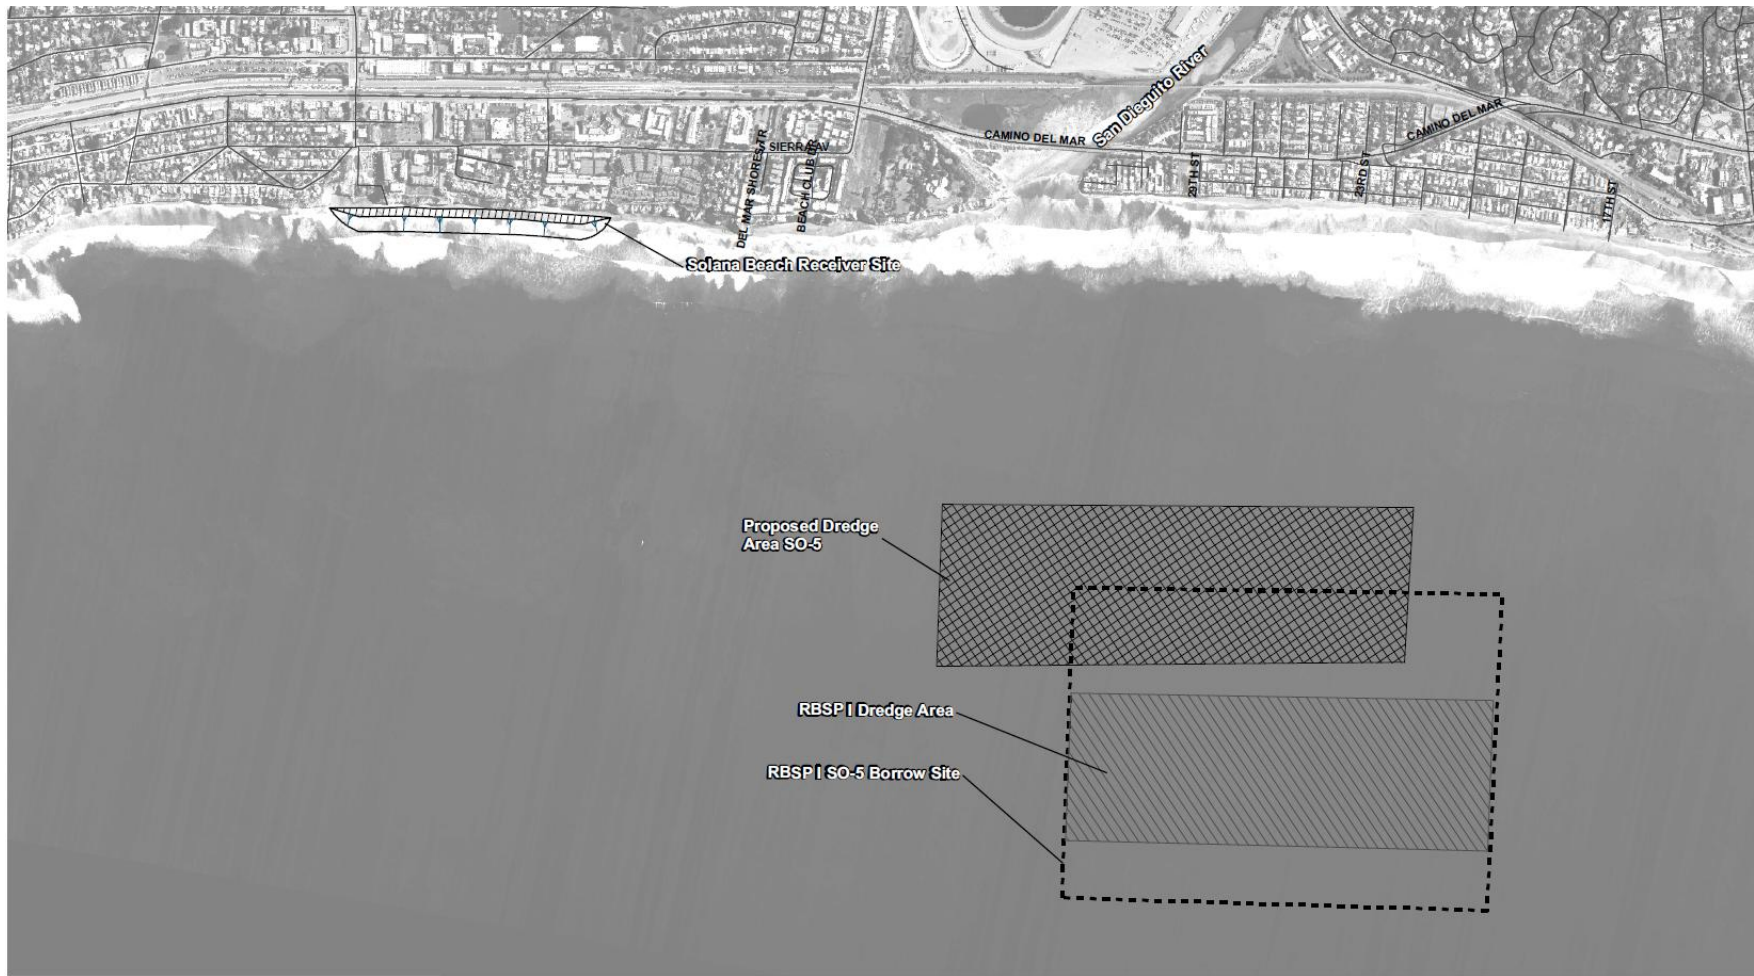
Figure 2-2
 Beach Sand Borrow Site SO-5

Figure C-1. SANDAG Beach Sand Borrow Site SO-5, adapted from the Regional Beach Sand Project II Final EIR.

SANDAG recently completed a beach sand replenishment project along the coast of San Diego County during the end of 2012. Sand source borrow site SO-5 was located offshore of the San Dieguito Wetlands Restoration Project (see Appendix C), within the footprint of the surveyed transects. Per the EIR plan (AECOM, 2011), the maximum dredge depth was -60 ft, MLLW. The results of the Spring 2013 survey presented in Appendix A show the elevation changes due to the borrow site at the offshore end of the profiles (with exception to SIO6, which was not in the dredge footprint).
