SAN DIEGUITO WETLANDS RESTORATION PROJECT

25 JUNE 2015 BEACH PROFILES CITY OF DEL MAR, CALIFORNIA

Data Report

15 July 2015
CE Reference No 15-24

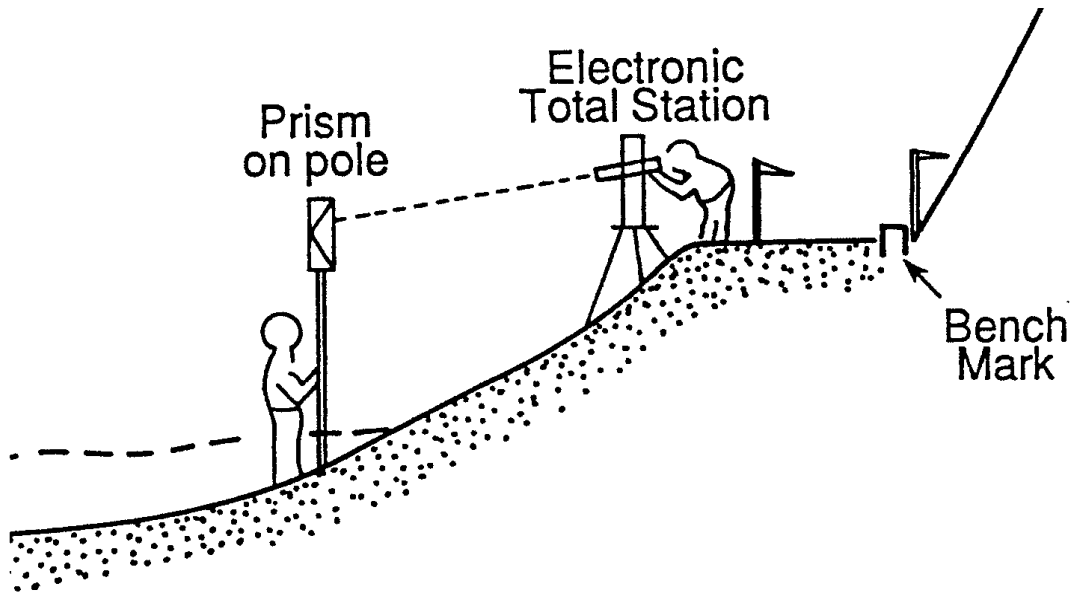
Figure 1. Schematic illustration of the survey method.

The beach profiles were conducted from the benchmarks to wading depth by total station and prism. Data were acquired along each transect from the survey marker to an offshore limit below MLLW (Mean Lower Low Water). Each survey marker (benchmark) was located at the back beach at a fixed point, primarily along a protective seawall. Data were collected at least to -6 ft, MLLW.

The beach and surf zone were surveyed using an electronic total station and survey rod. The total station was used to determine the position and elevation of the beach at each location

occupied by the rod. A Sokkia Set-5A total station and SDR-33 electronic field data logger were utilized to collect the nearshore portion of the profile, providing an accuracy of approximately 2-4 cm both horizontally and vertically. The total station method reflects an infrared beam sent from the device to a prism atop a fixed-length pole, where the instrument measures the slant distance and horizontal and vertical angles to the target (Figure 1). An electronic field data logger is used to store the data, which can then be set to known positions using permanent local benchmarks. Each transect was surveyed from the back beach seaward through the surf zone until the rod no longer protruded above the water surface.

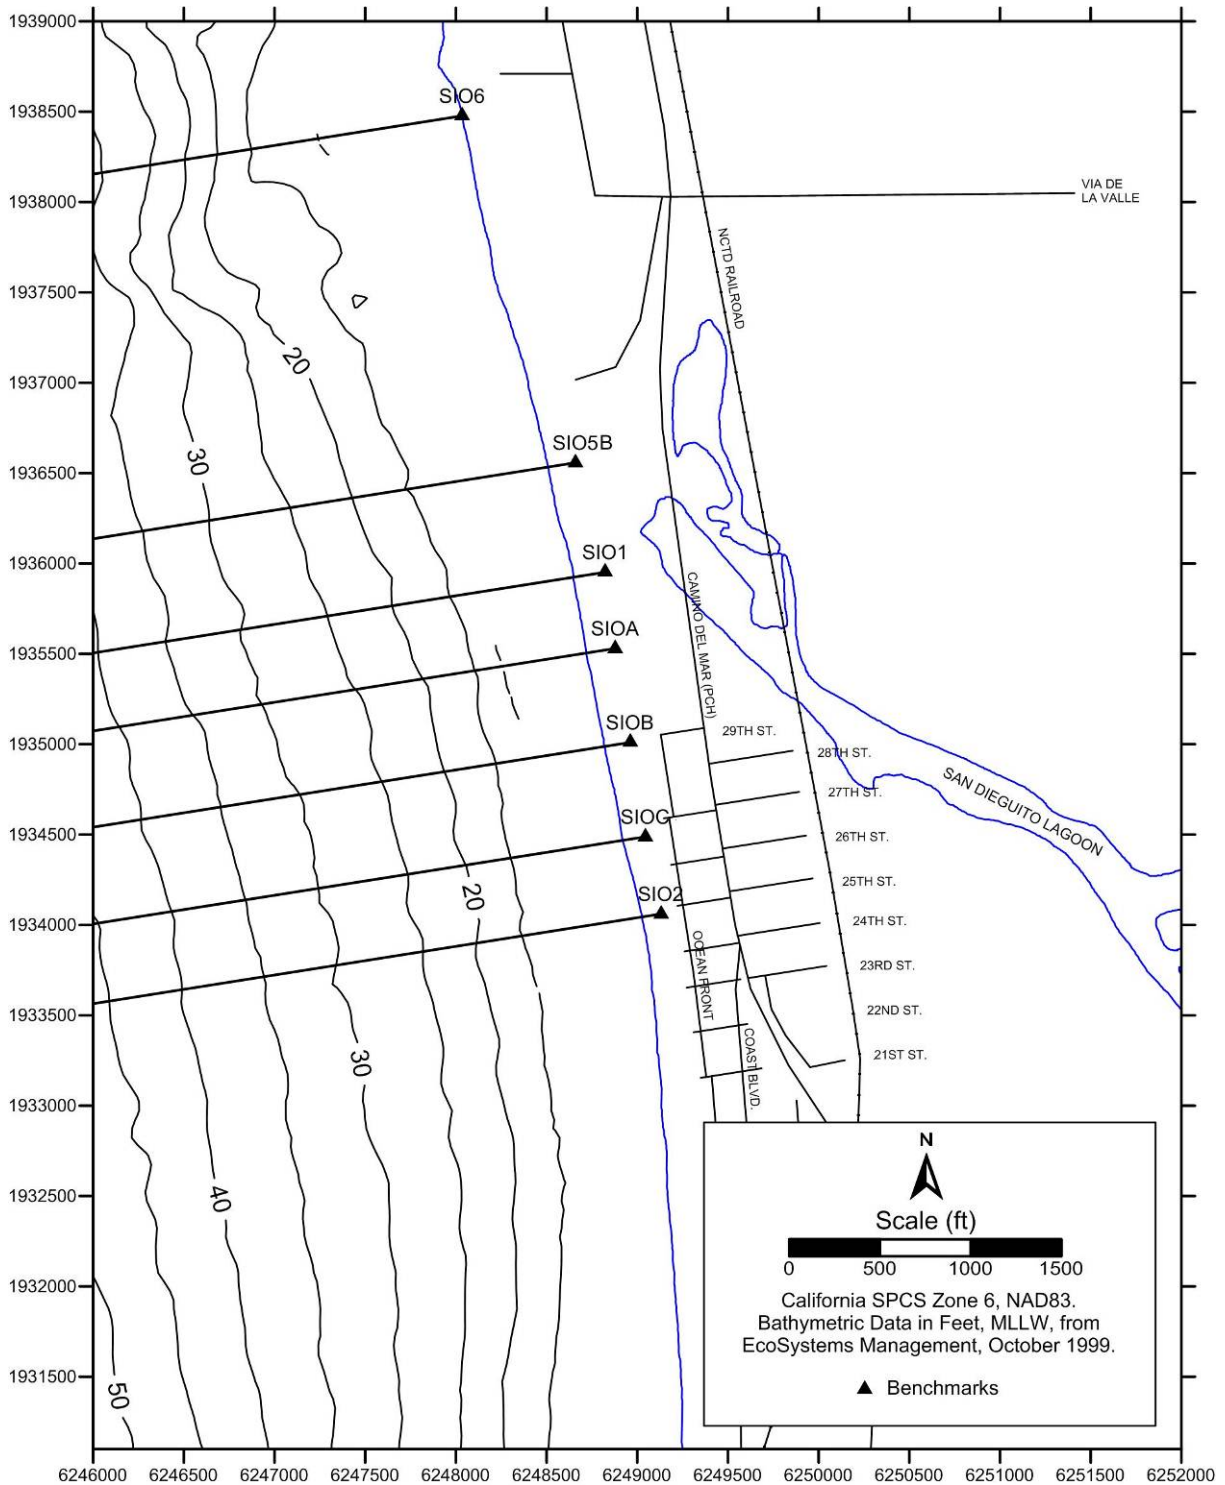
Figure 2. Beach profiles surveyed on 25 June 2015.

The summer 2015 beach profile surveys were performed on 25 June 2015, along the four historic and three newly established profiles (Figure 2). One of the three new profile locations, SIOA, has a data gap between the depths of -5 and -8 ft, NGVD. Multiple attempts were made to fill in this data gap on SIOA, however, strong rip currents in the surf zone created unsafe working conditions precluding our ability to obtain bathymetric readings. The beach profiles are presented in Appendix A. The beach width for each of the profiles is presented in Appendix B.

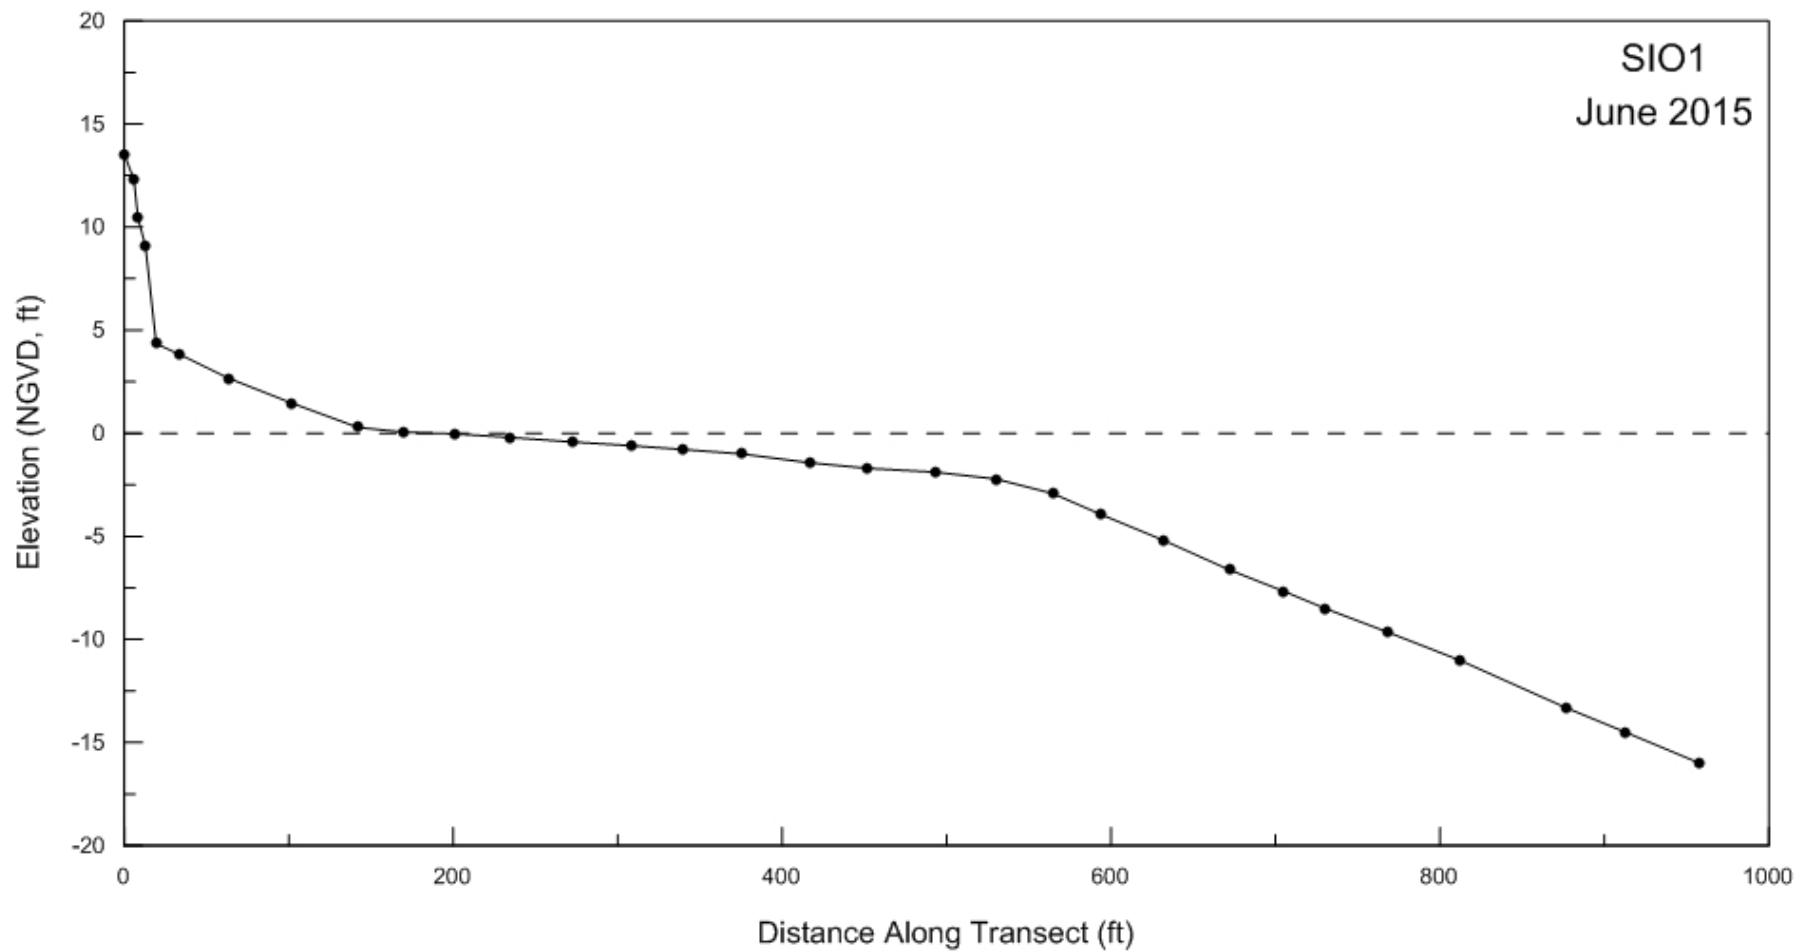
Figure A-1. Beach profile for SIO1 surveyed on 25 June 2015.

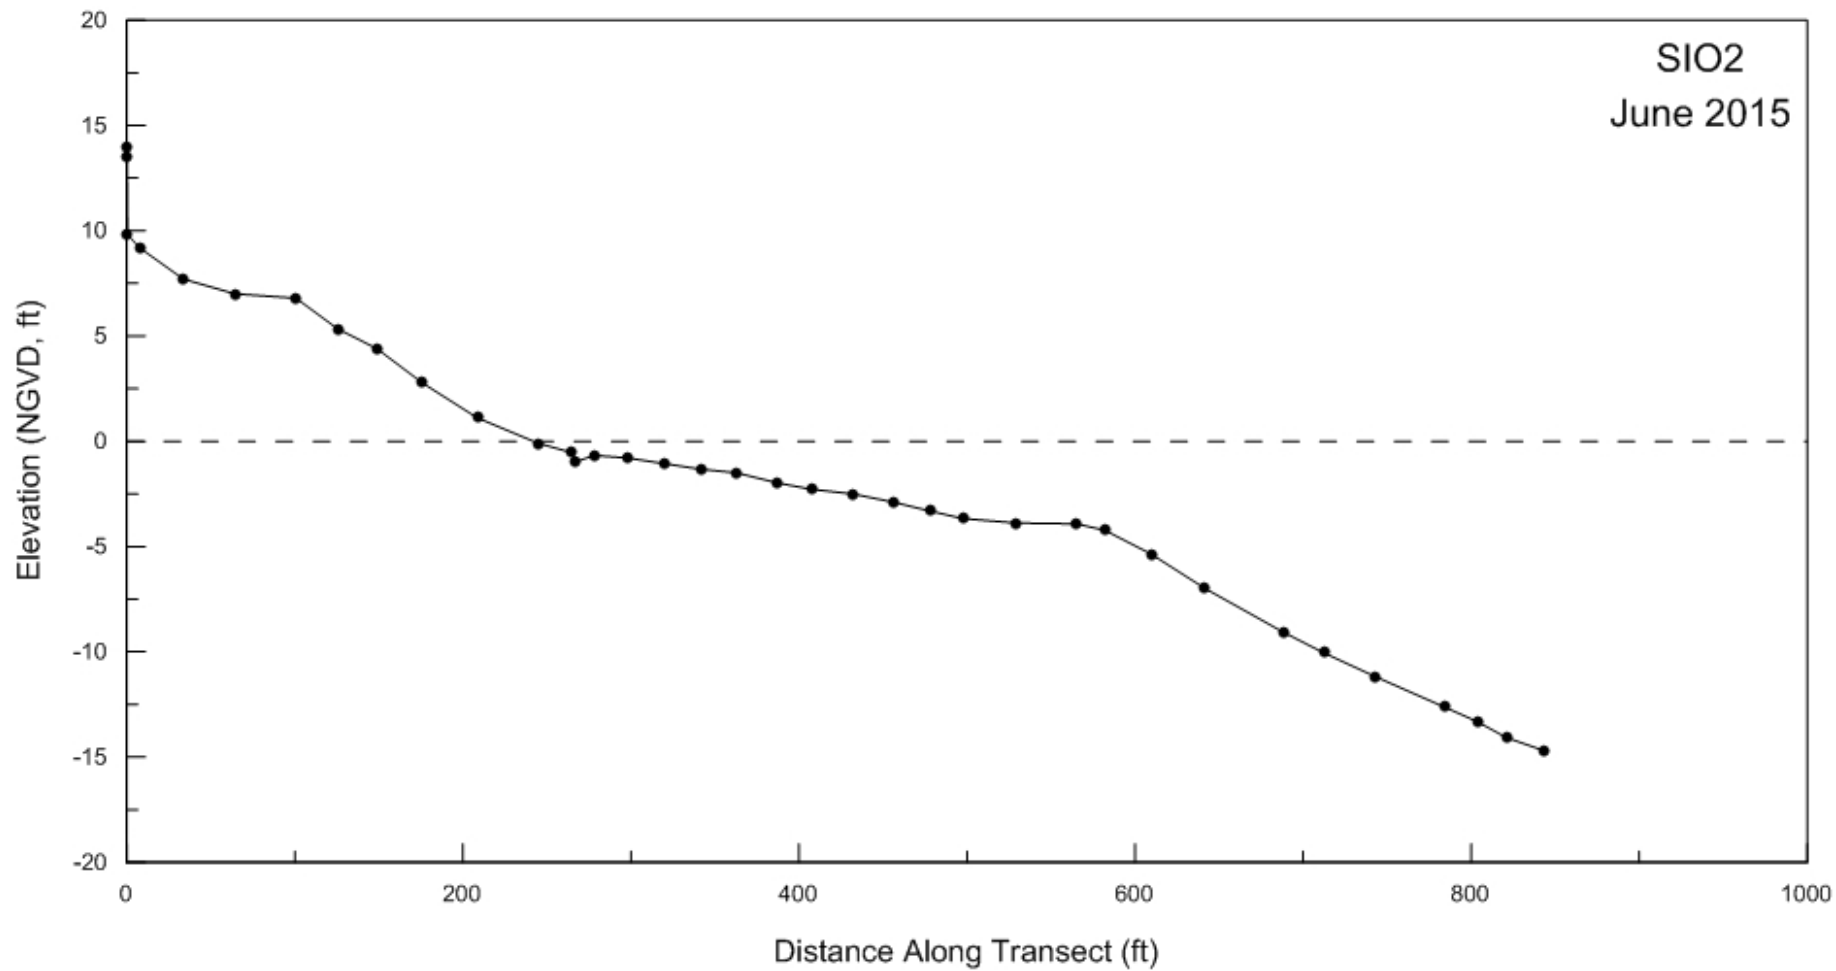
Figure A-2. Beach profile for SIO2 surveyed on 25 June 2015.

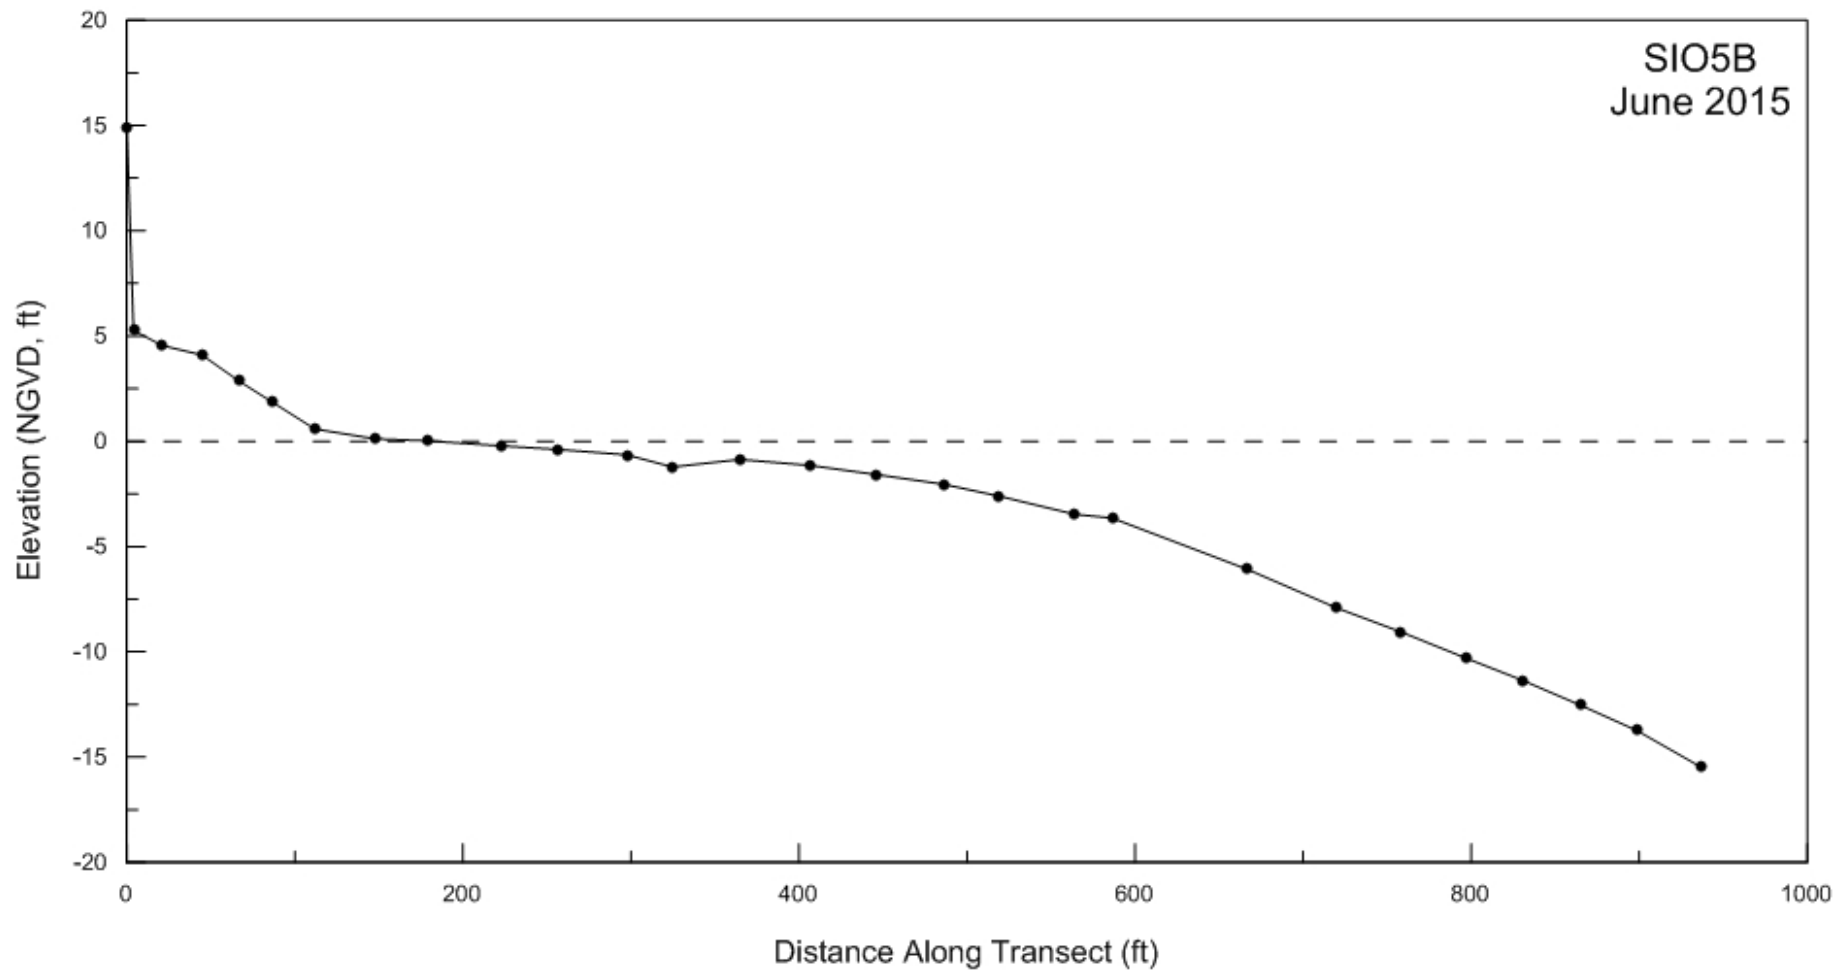
Figure A-3. Beach profile for SIO5B surveyed on 25 June 2015.

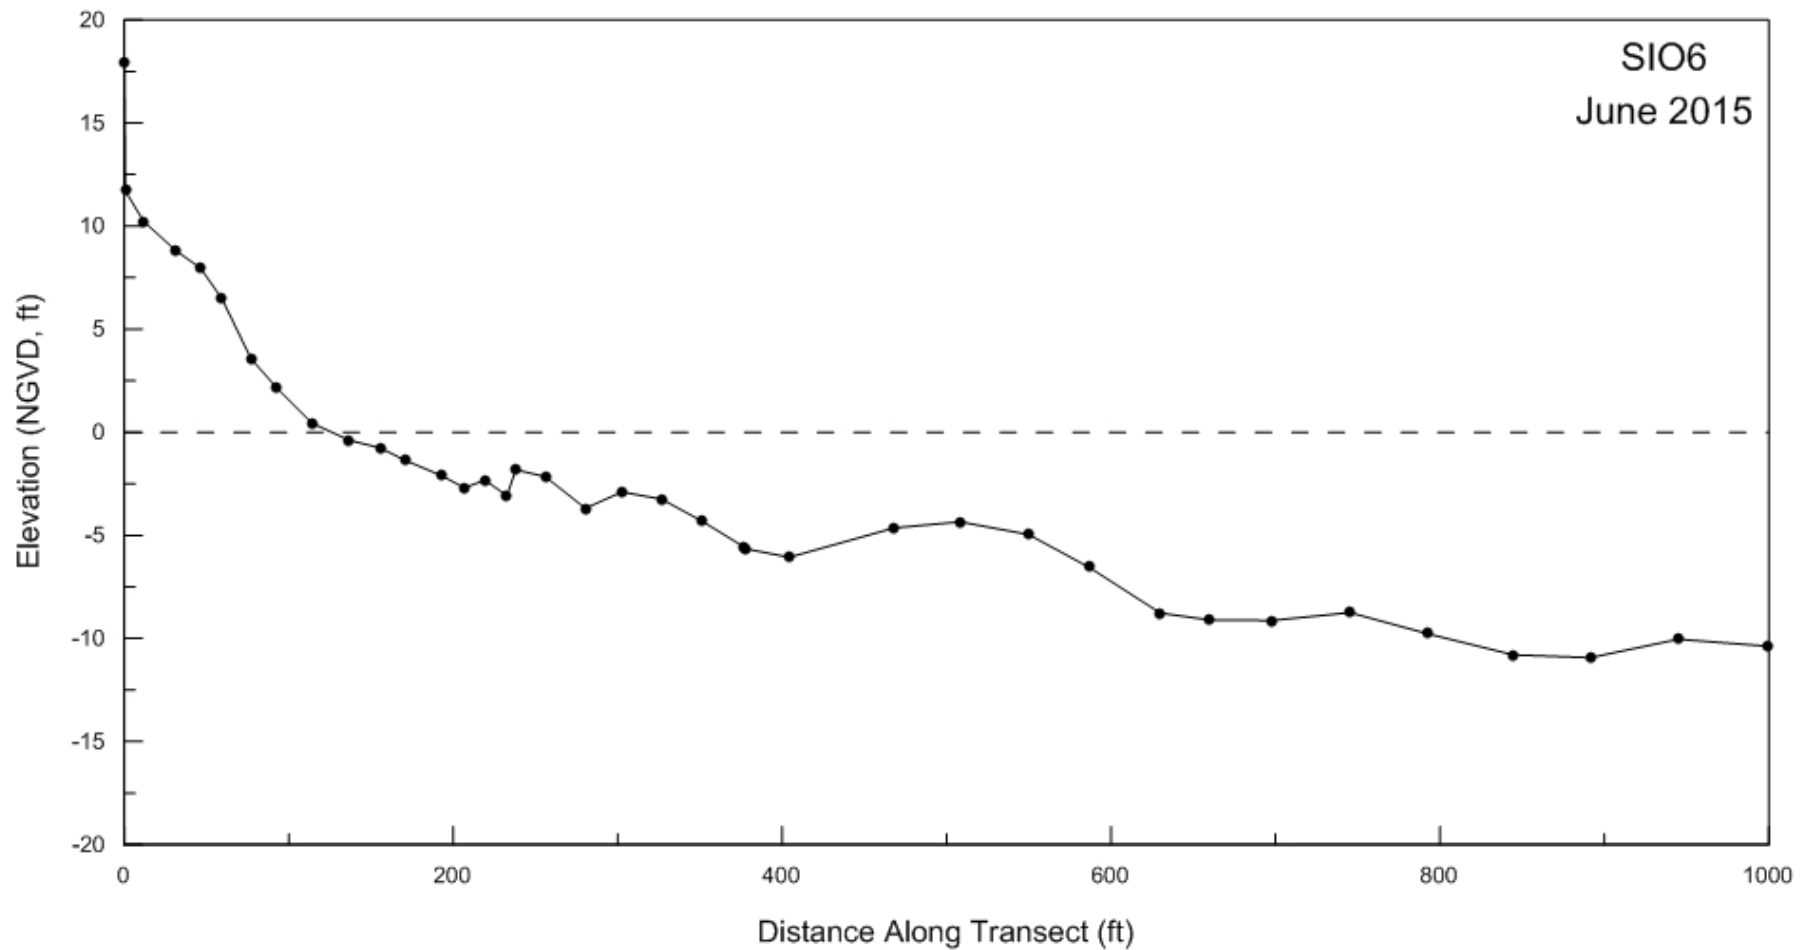
Figure A-4. Beach profile for SIO6 surveyed on 25 June 2015.

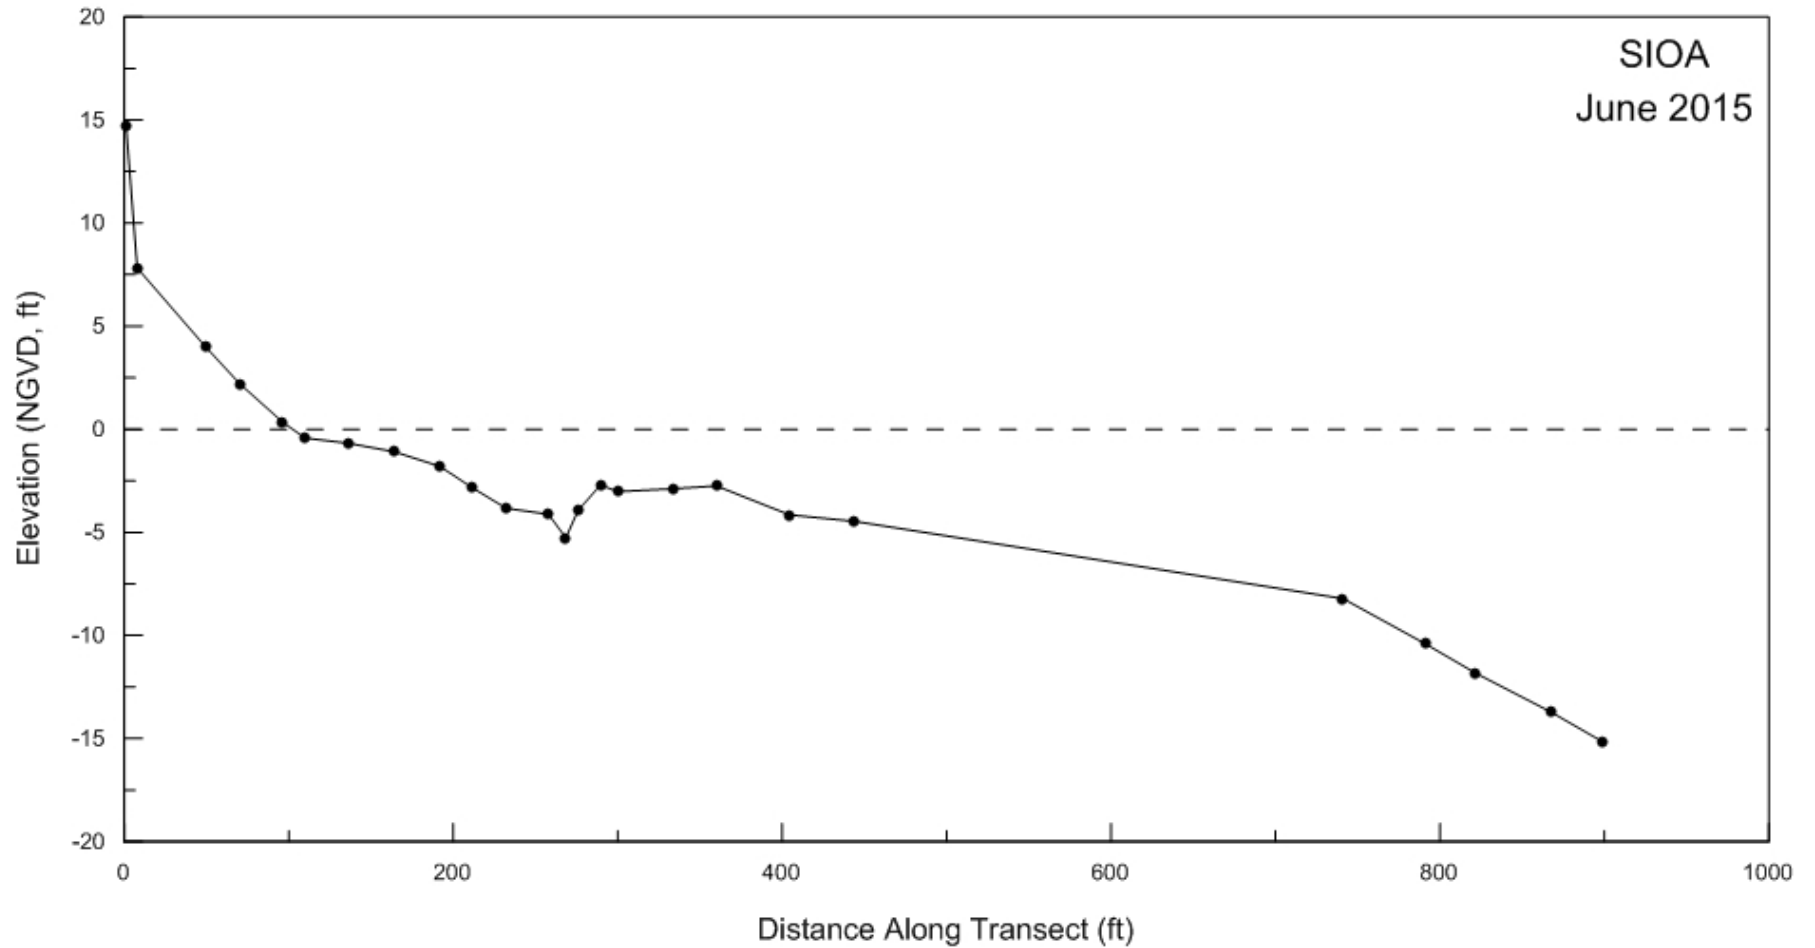
Figure A-5. Beach profile for SIOA surveyed on 25 June 2015. Multiple attempts were made to fill in data gap between -5 and -8 ft, NGVD, strong currents and surf prevented data acquisition in this area.

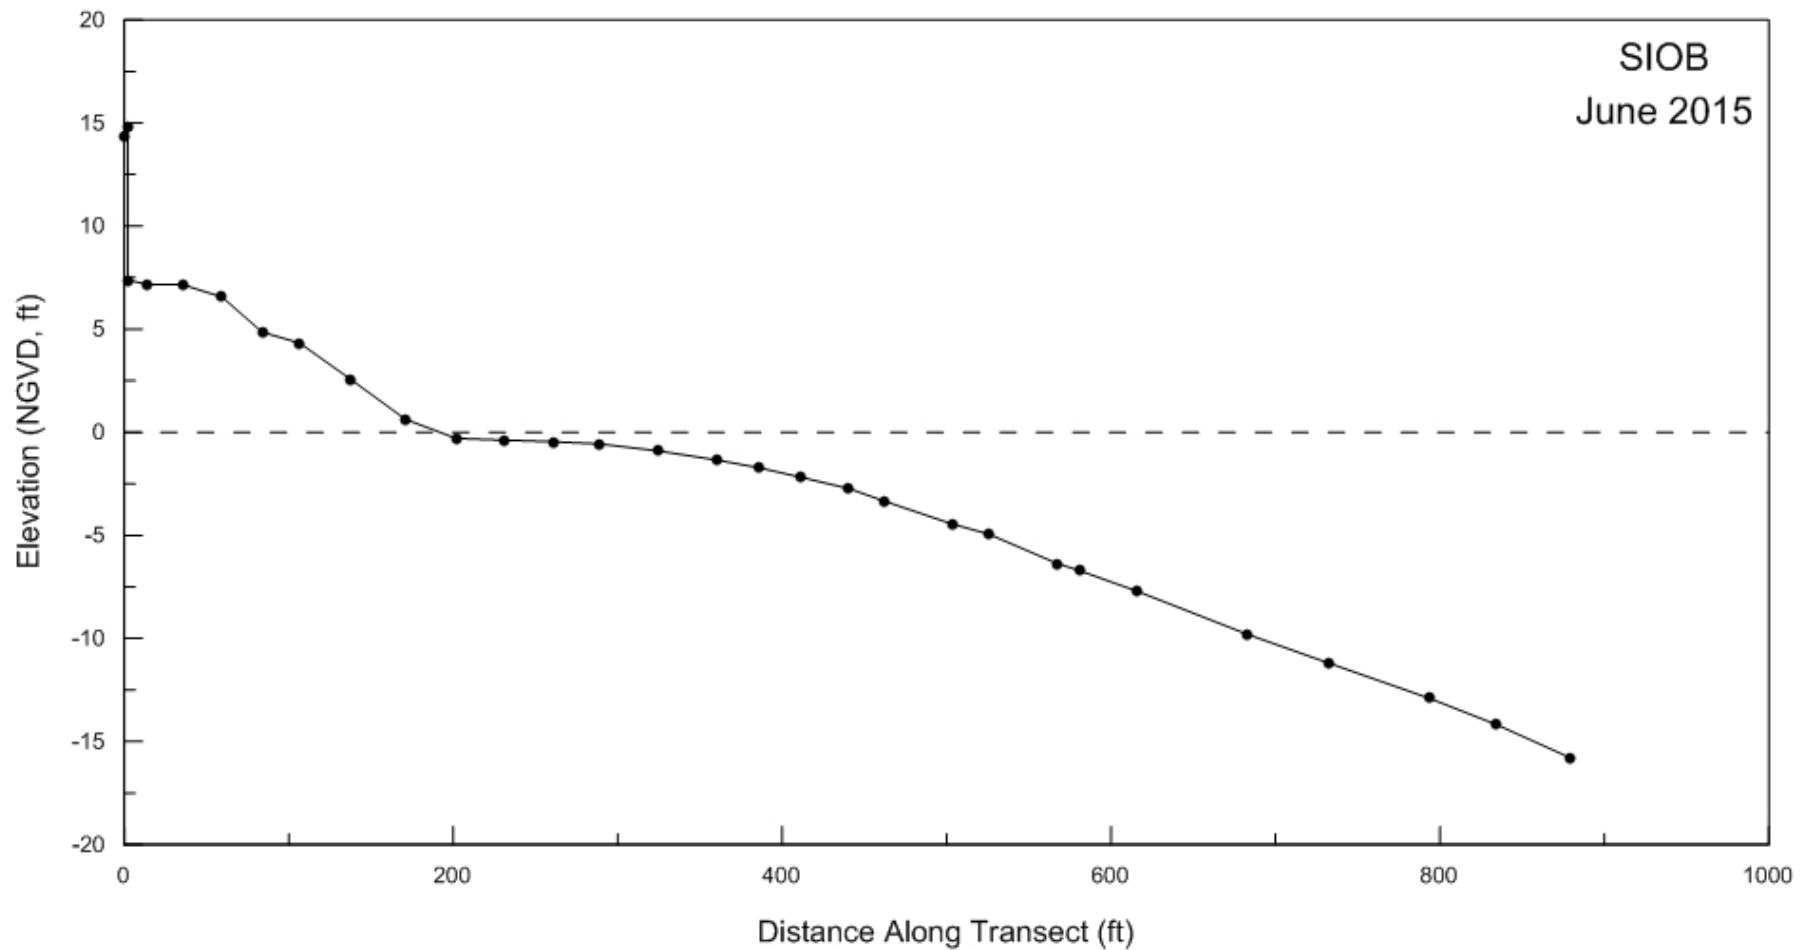
Figure A-6. Beach profile for SIOB surveyed on 25 June 2015.

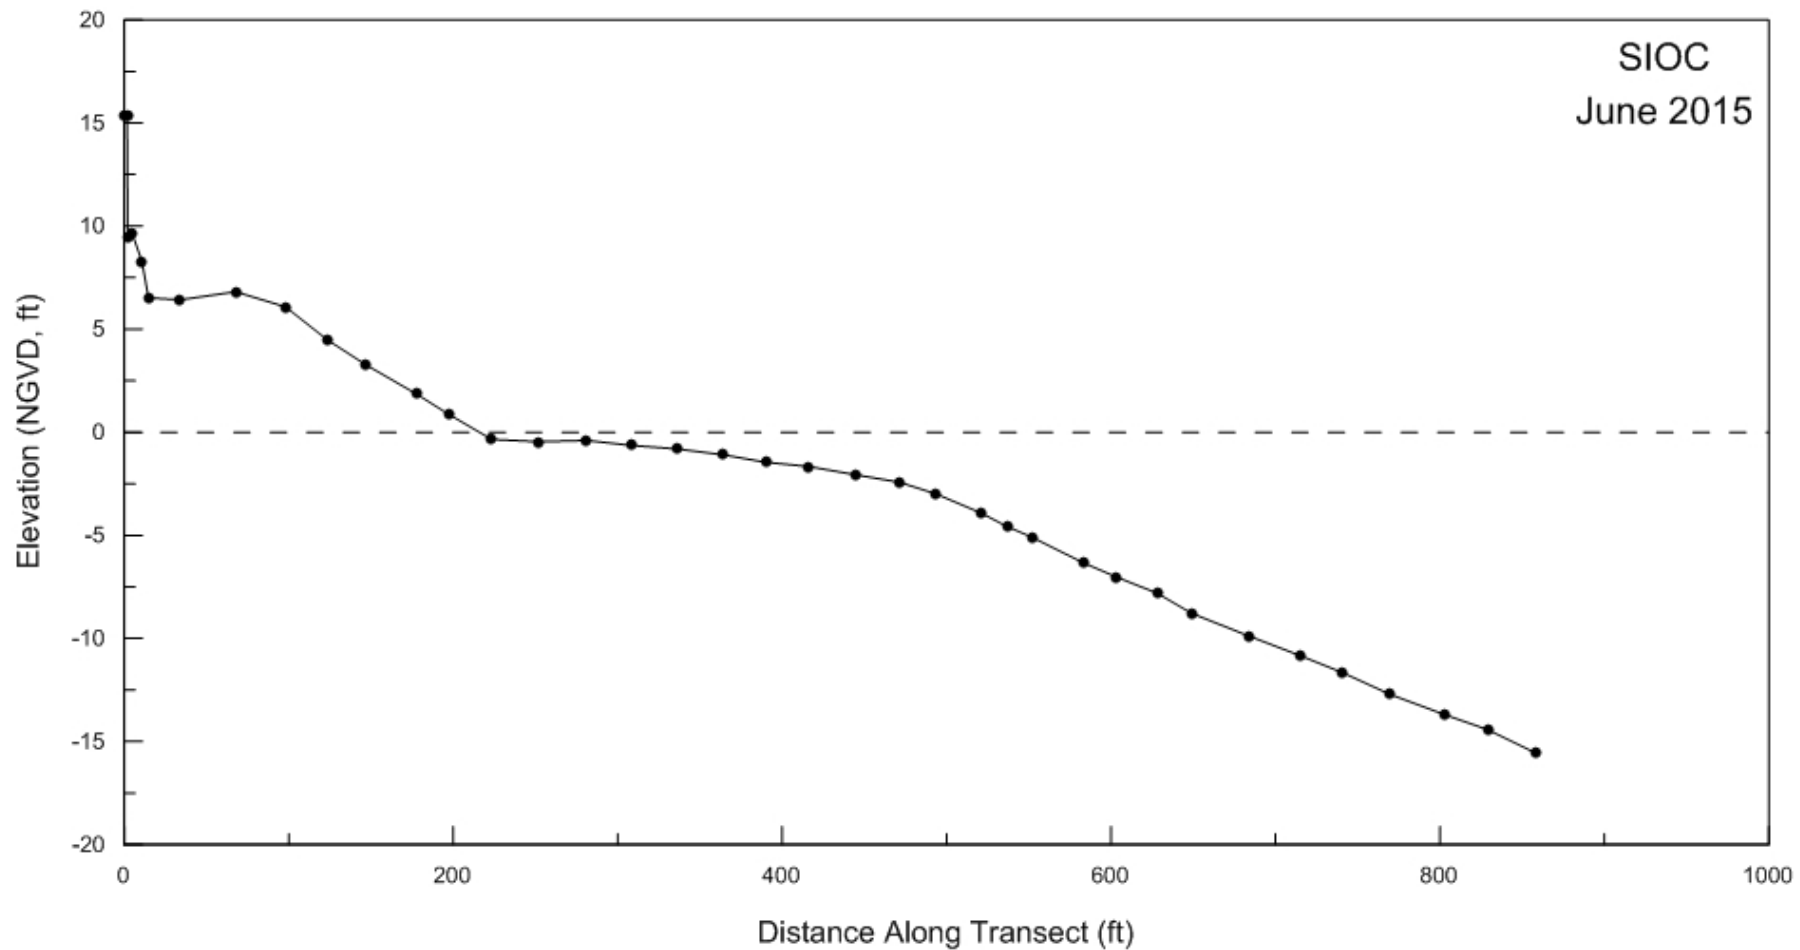
Figure A-7. Beach profile for SIOC surveyed on 25 June 2015.
