SAN DIEGUITO WETLANDS RESTORATION PROJECT

18 JANUARY 2012 BEACH PROFILES CITY OF DEL MAR, CALIFORNIA

Data Report

31 January 2012
CE Reference No. 12-06

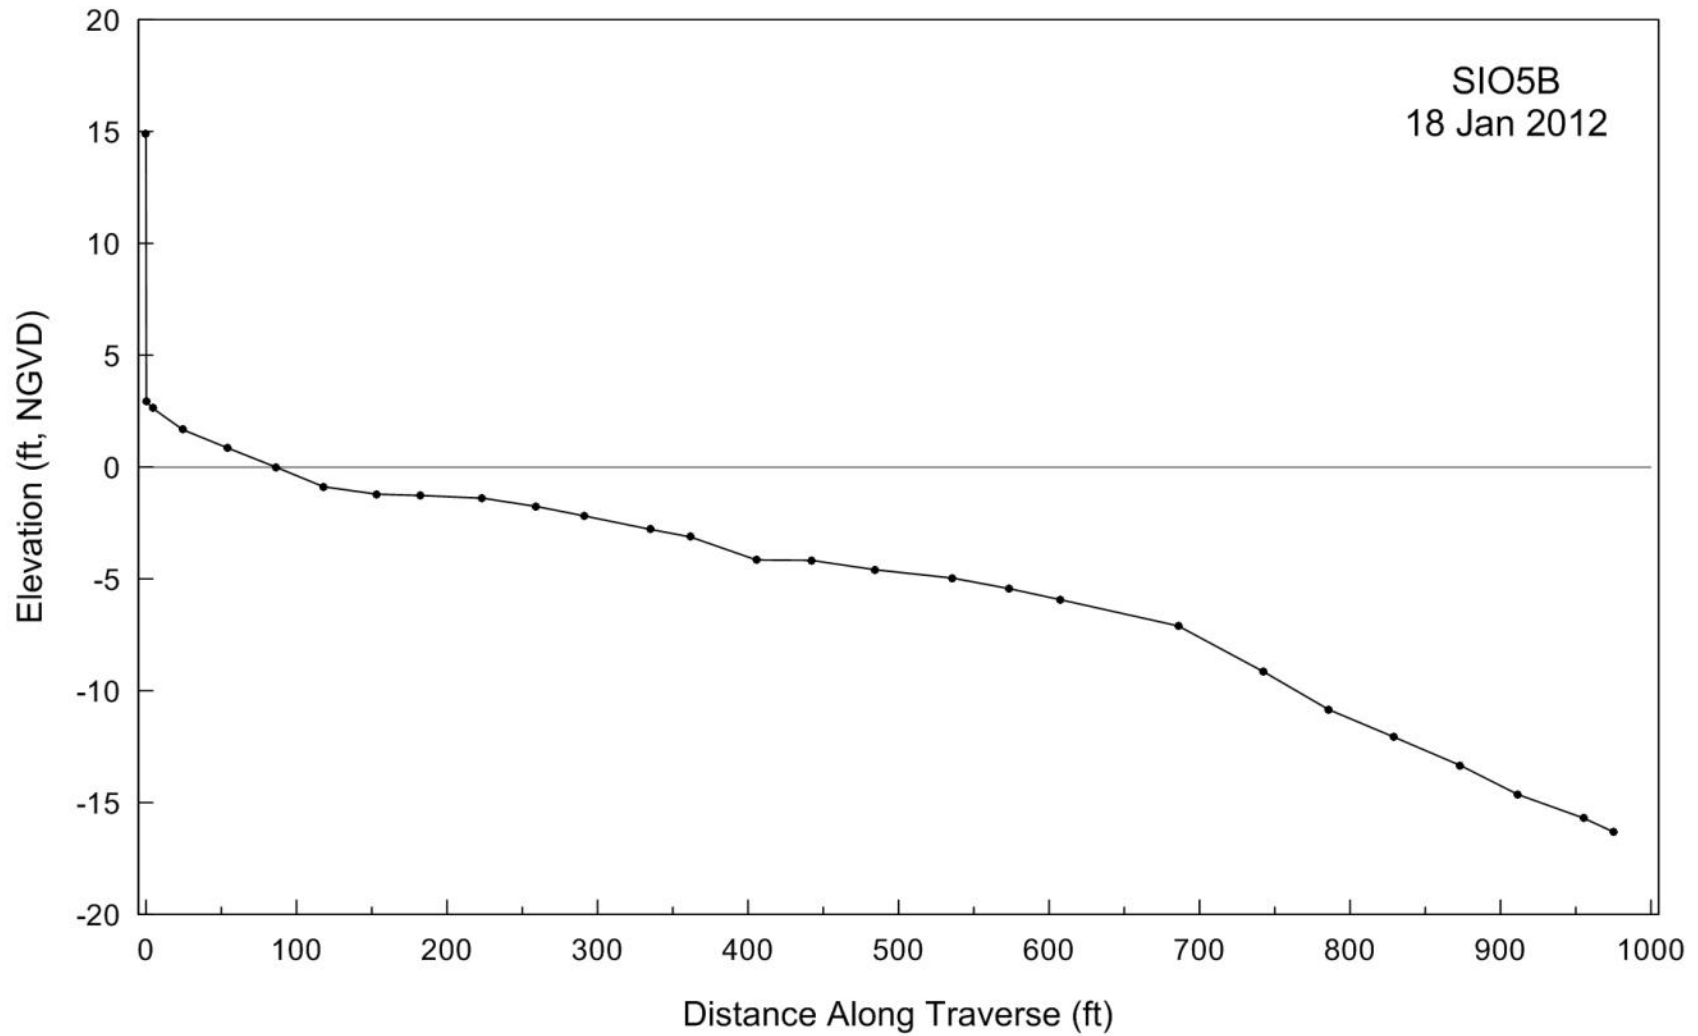
Figure A-3. Beach profile for SIO5B taken on 18 January 2012.
