SAN DIEGUITO WETLANDS RESTORATION PROJECT

30 JANUARY 2017 BEACH PROFILES CITY OF DEL MAR, CALIFORNIA

Data Report

8 February 2017
CE Reference No 17-02

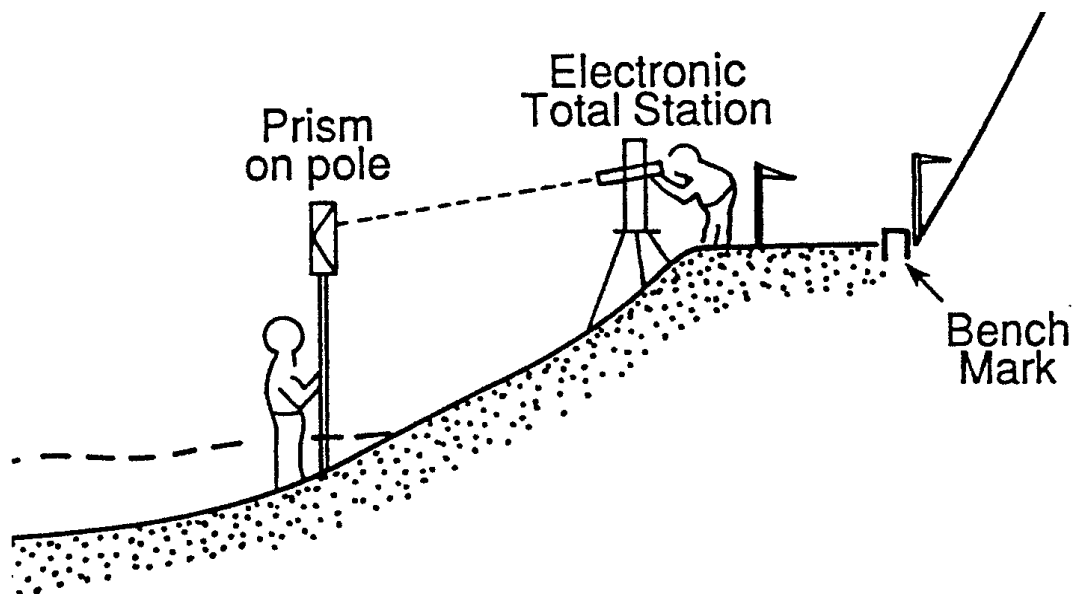
Figure 1. Schematic illustration of the survey method.

The beach profiles were conducted from the benchmarks to wading depth by total station and prism. Data were acquired along each transect from the survey marker to an offshore limit below MLLW (Mean Lower Low Water). Each survey marker (benchmark) was located on the back beach at a fixed point, primarily along a protective seawall. Data were collected to at least -6 ft, MLLW.

The beach and surf zone were surveyed using an electronic total station and survey rod. The total station was used to determine the position and elevation of the beach at each location

occupied by the rod. A Sokkia Set-5A total station and Spectra Precision Ranger electronic field data logger were utilized to collect the nearshore portion of the profile, providing an accuracy of approximately 2-4 cm both horizontally and vertically. The total station method reflects an infrared beam sent from the device to a prism atop a fixed-length pole, where the instrument measures the slant distance and horizontal and vertical angles to the target (Figure 1). An electronic field data logger is used to store the data, which can then be set to known positions using permanent local benchmarks. Each transect was surveyed from the back beach seaward through the surf zone until the rod no longer protruded above the water surface.

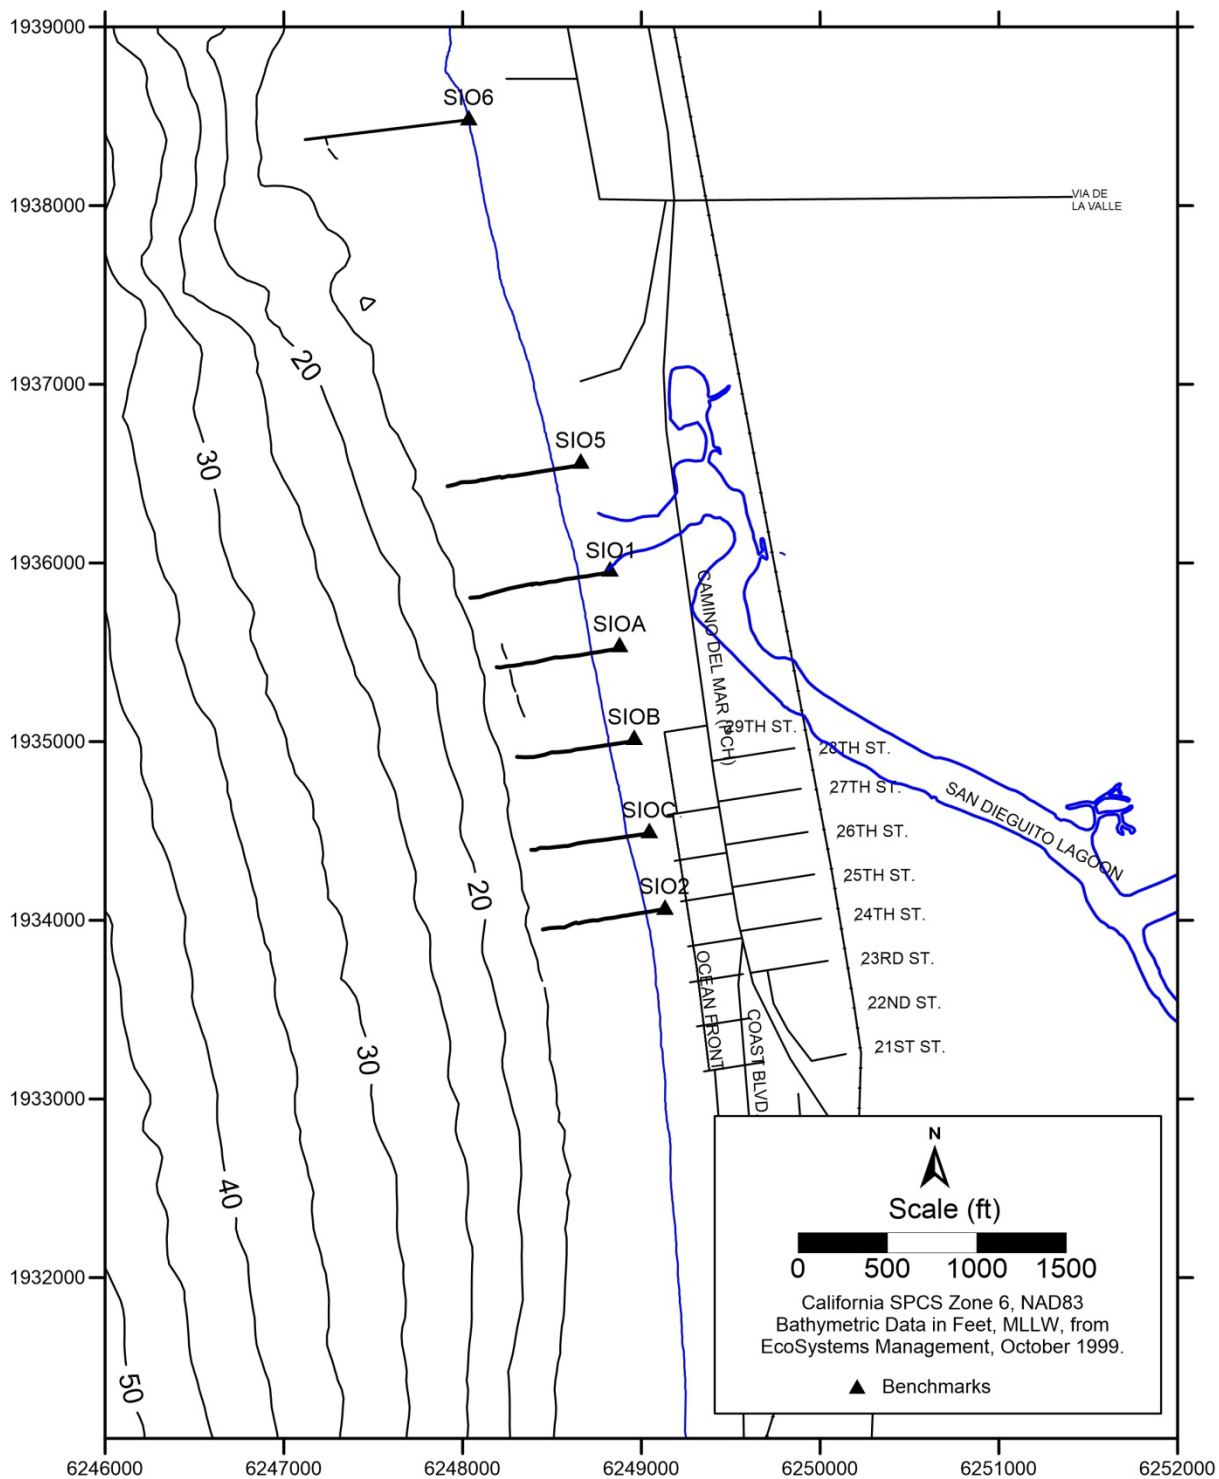
Figure 2. Beach profiles surveyed on 30 January 2017.

The winter 2017 beach profile surveys were performed on 30 January 2017 along the four historic and three newly established profiles (Figure 2). The beach profiles are presented in Appendix A. The beach width for each of the profiles is presented in Appendix B.

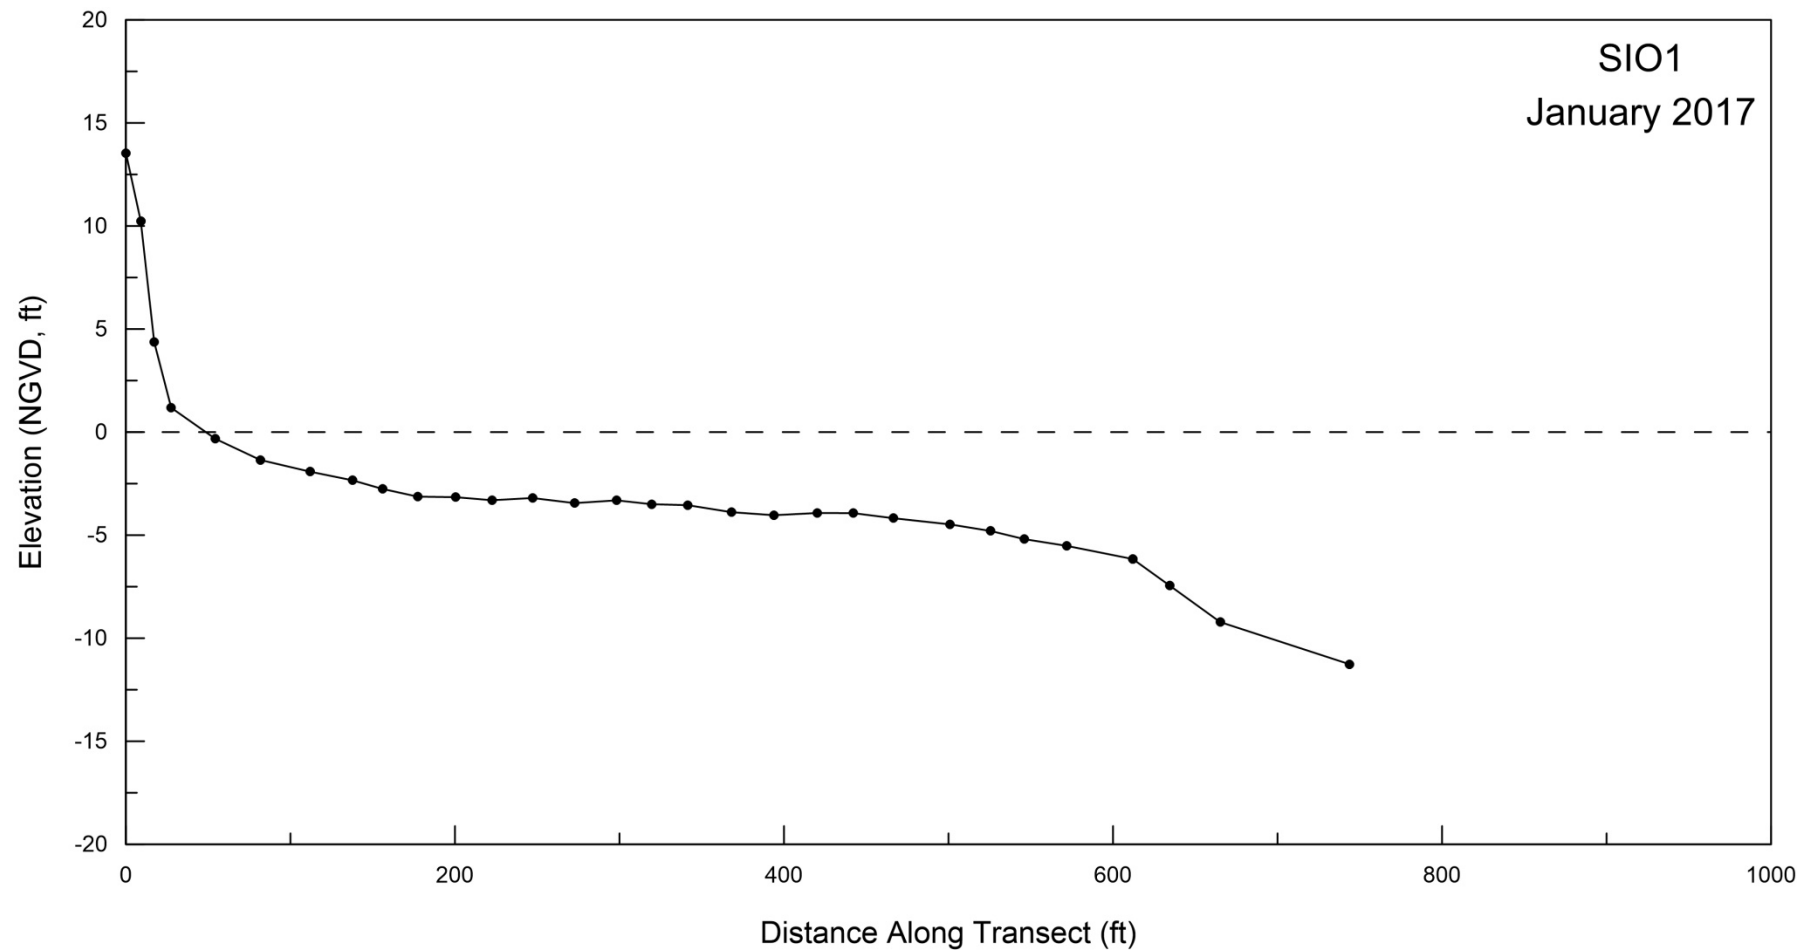
Figure A-1. Beach profile for SIO1 surveyed on 30 January 2017.

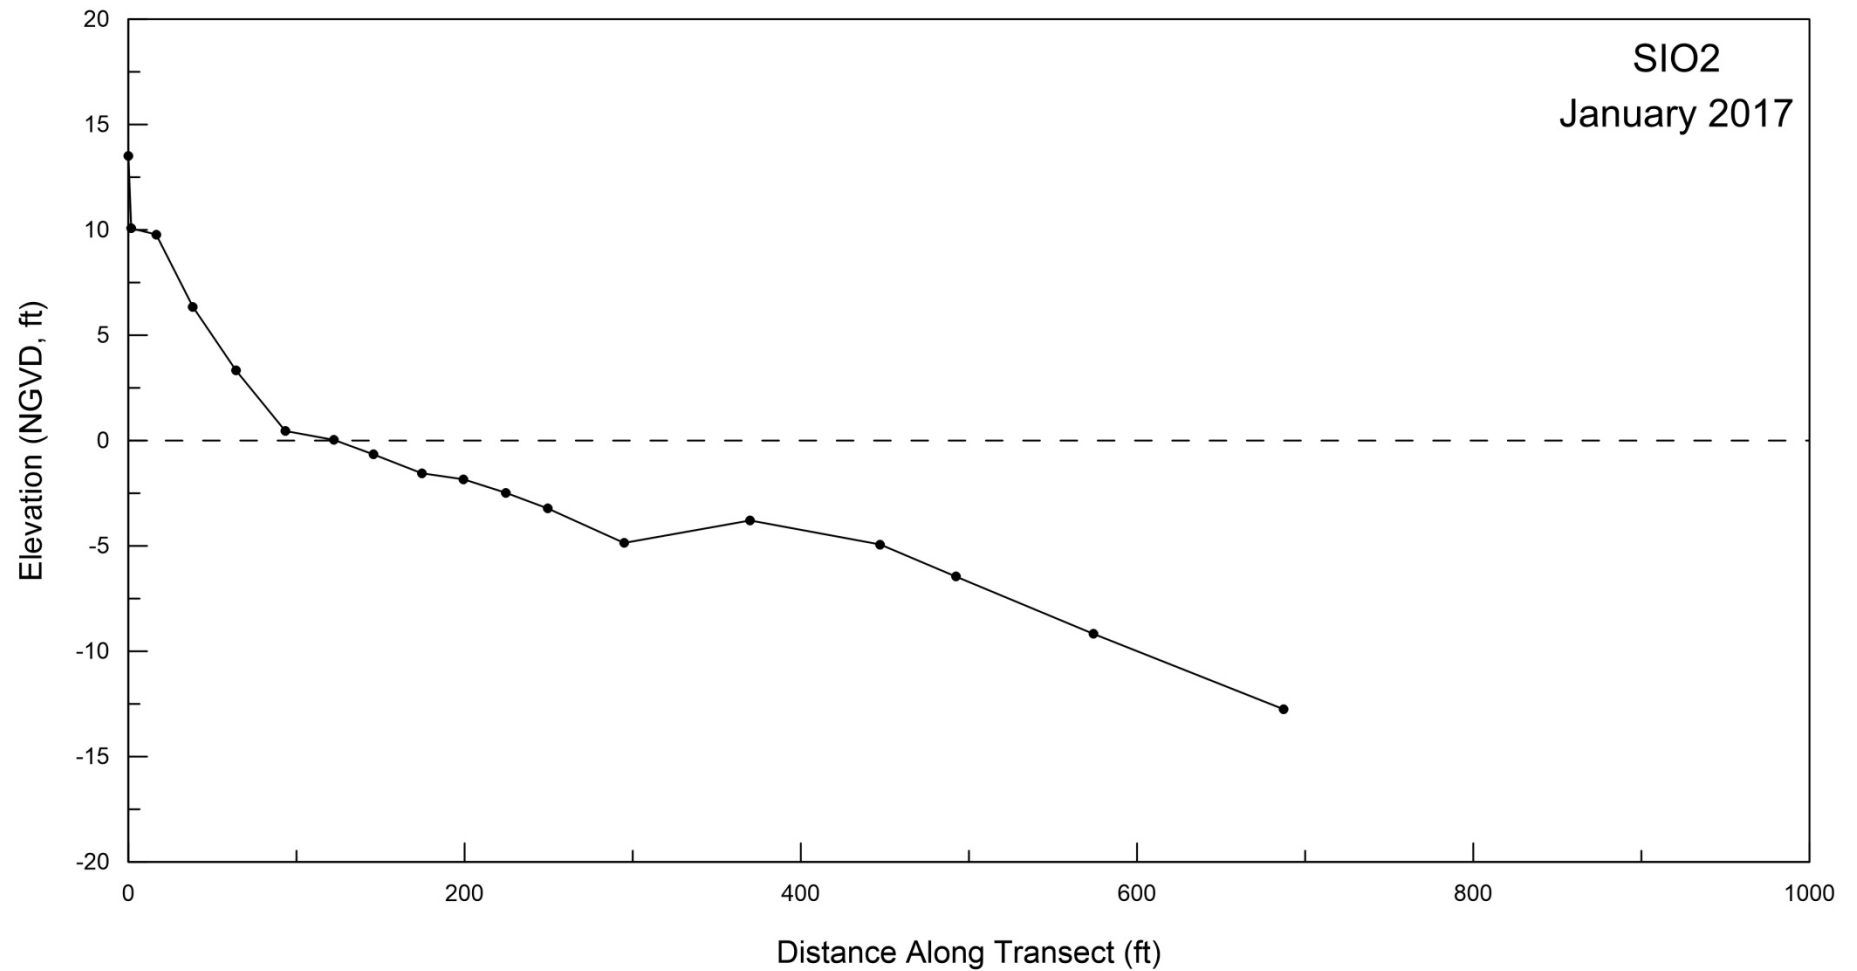
Figure A-2. Beach profile for SIO2 surveyed on 30 January 2017.

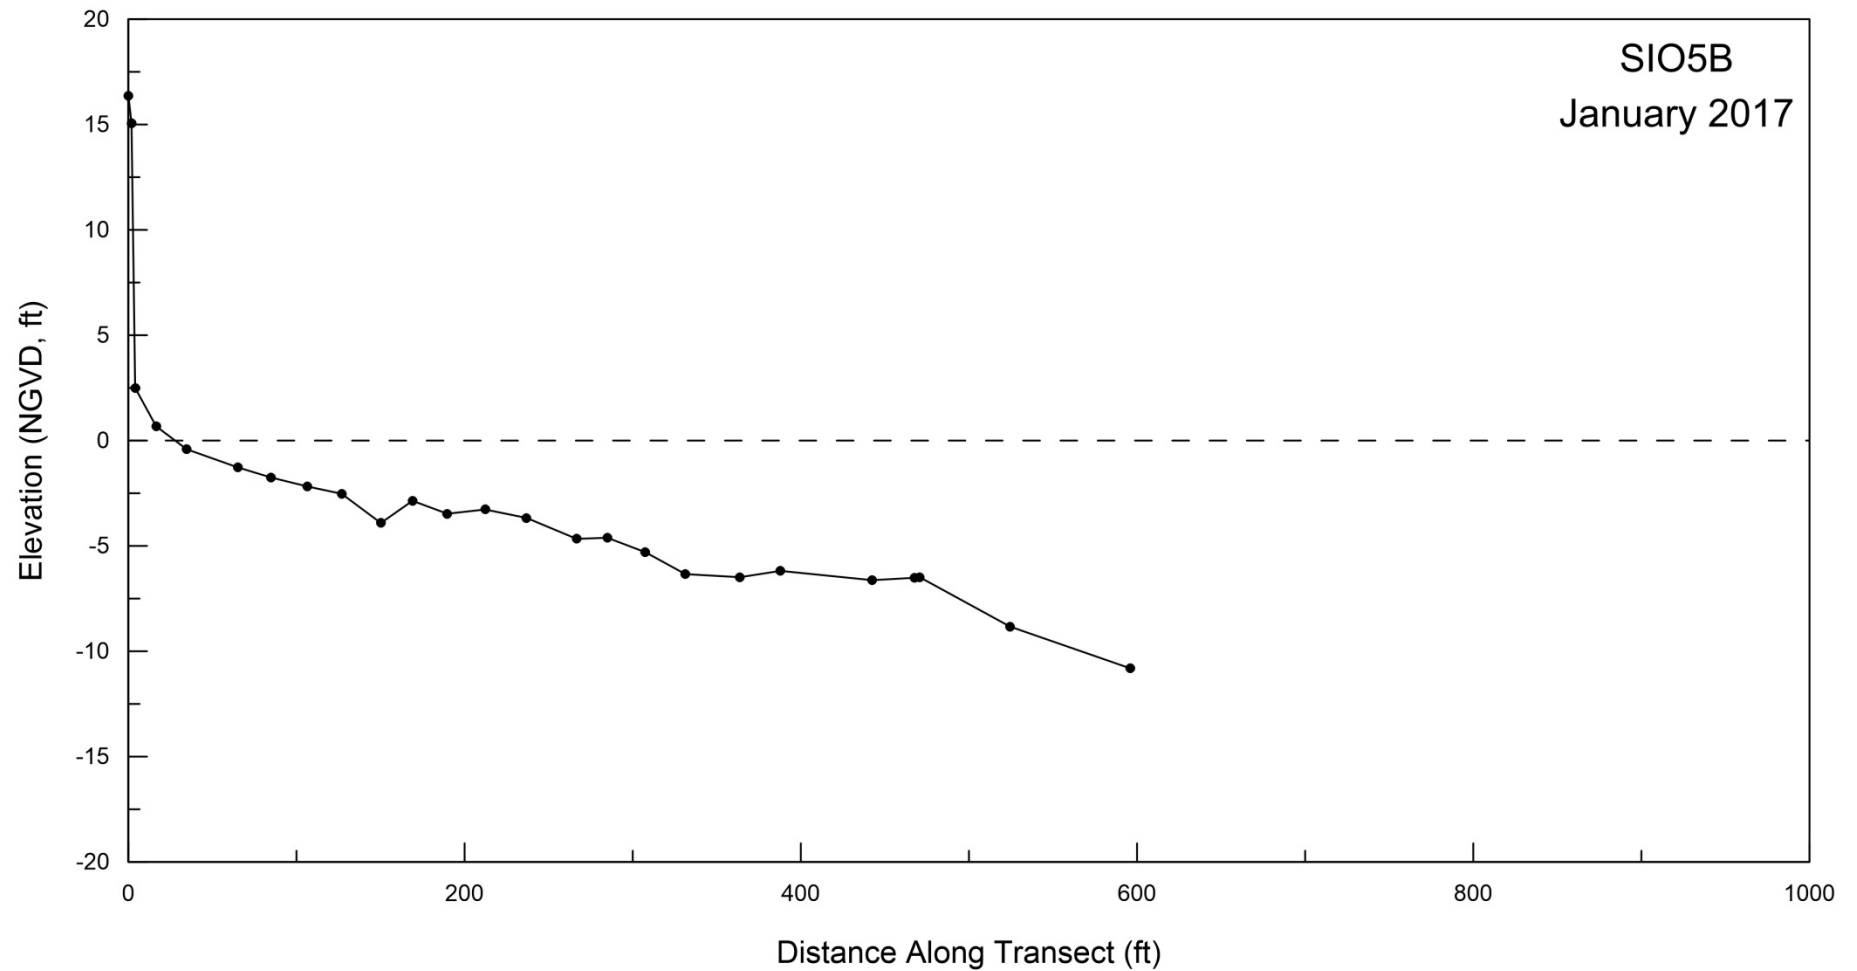
Figure A-3. Beach profile for SIO5B surveyed on 30 January 2017.

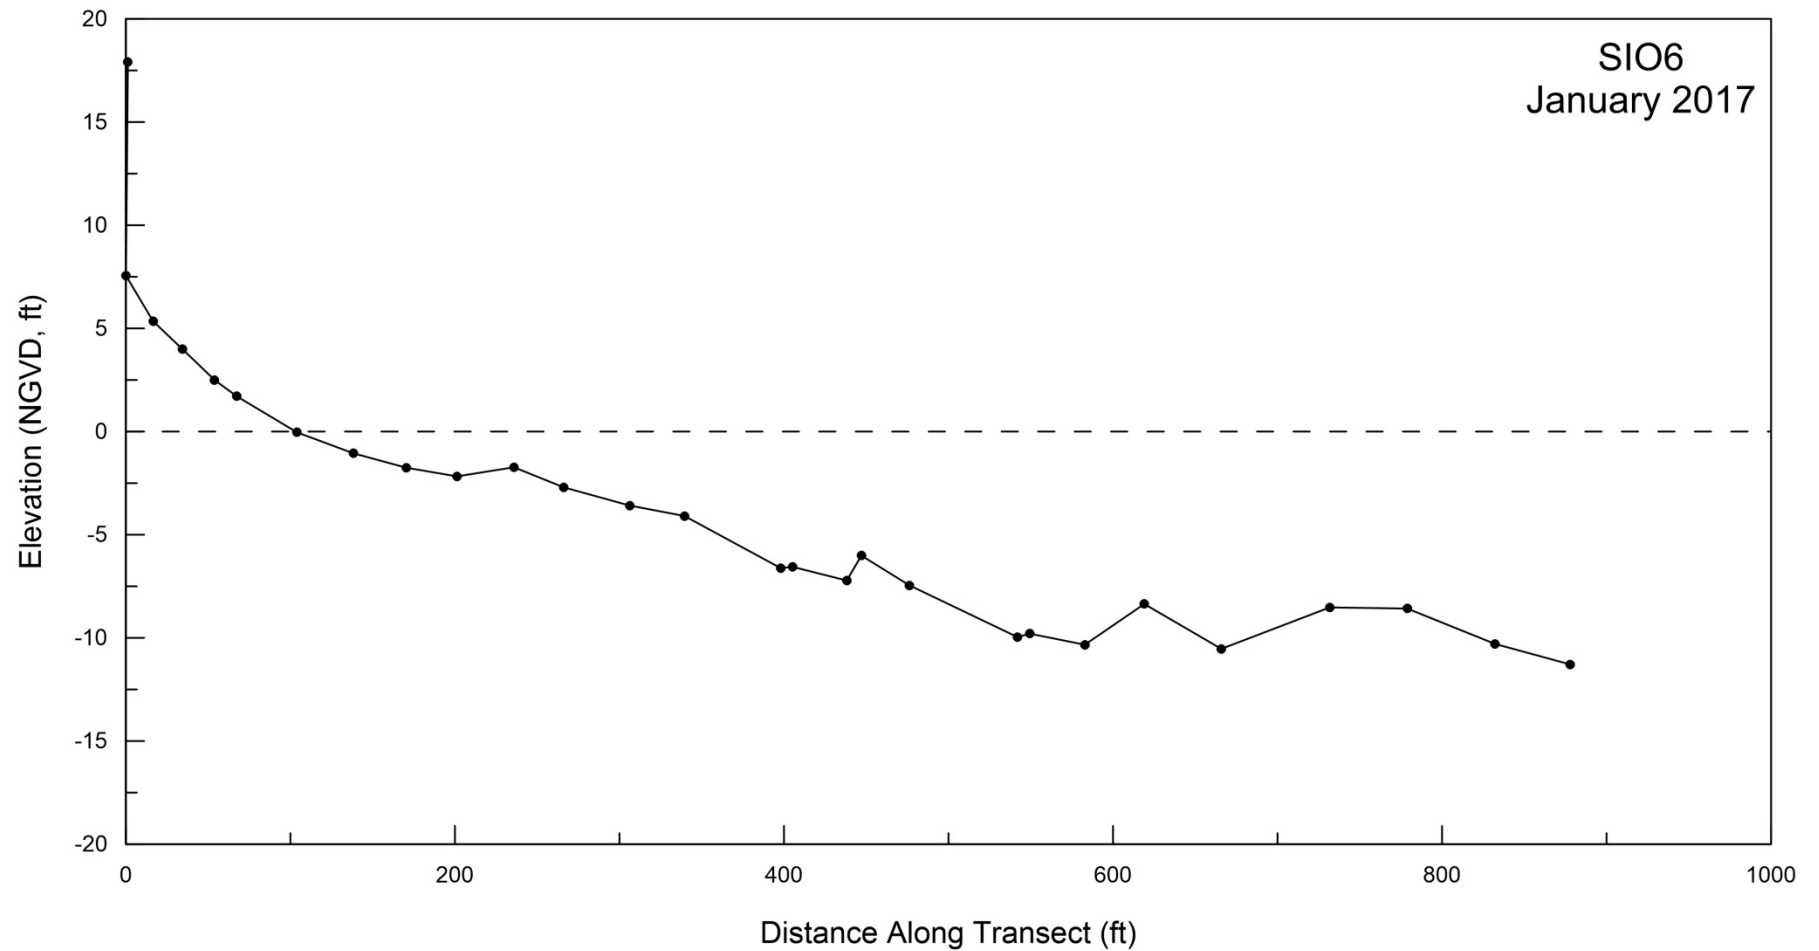
Figure A-4. Beach profile for SIO6 surveyed on 30 January 2017.

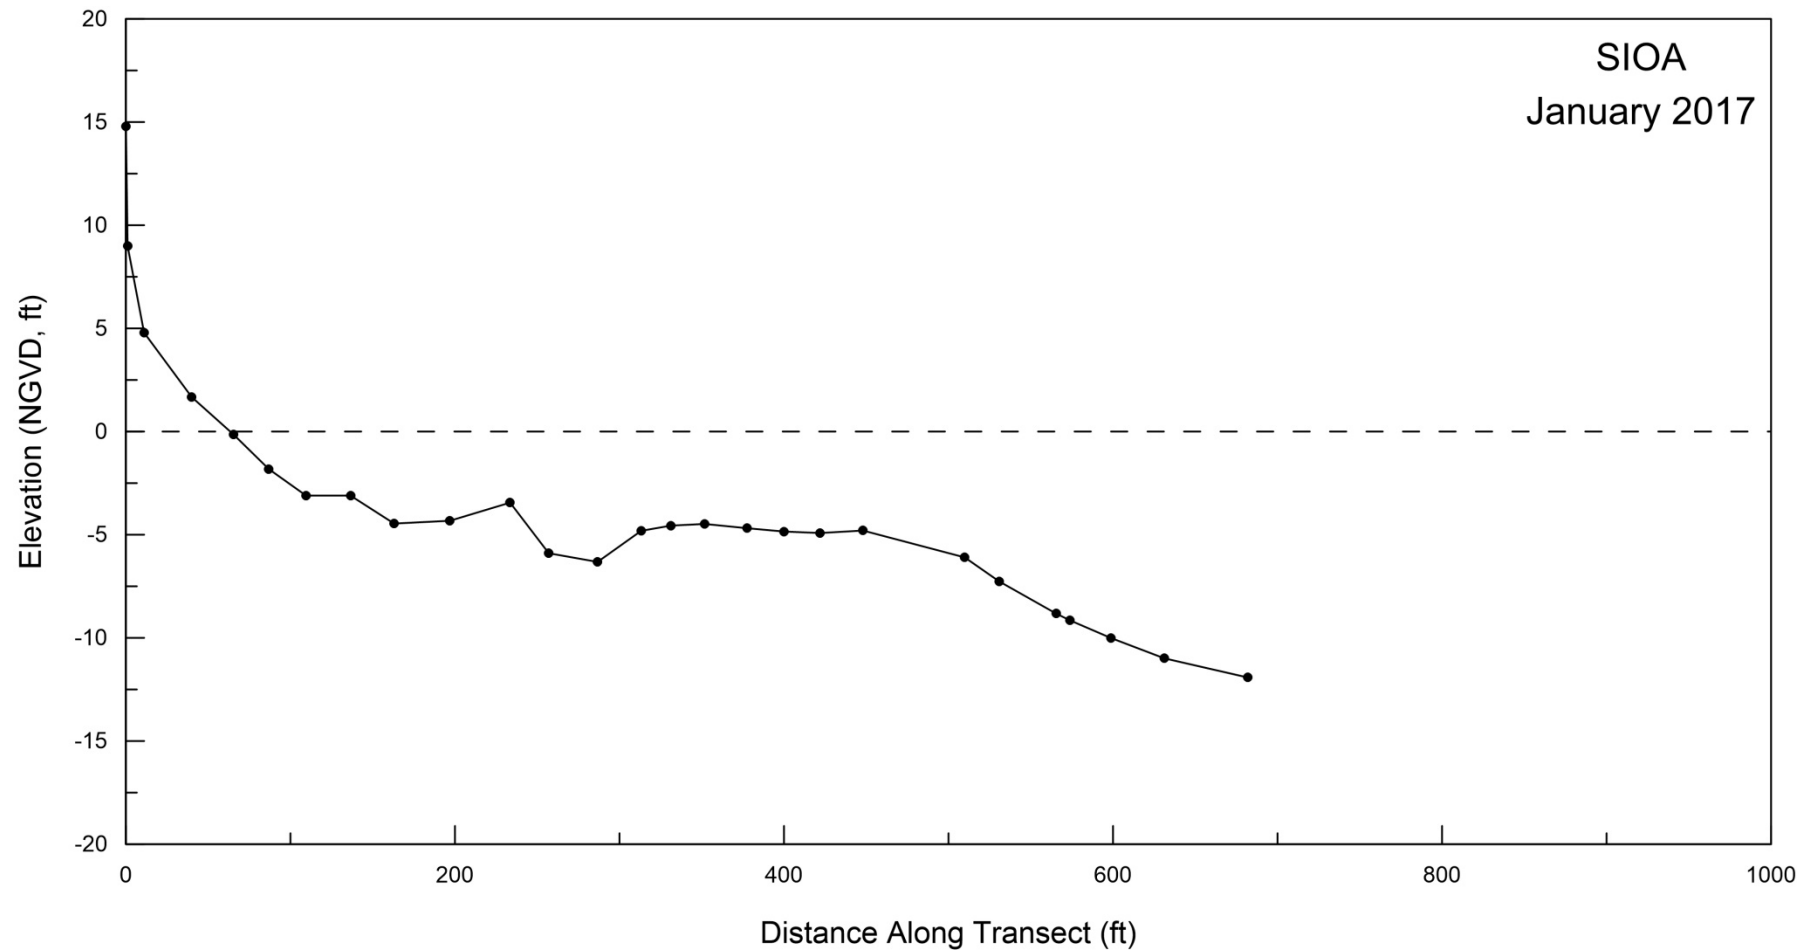
Figure A-5. Beach profile for SIOA surveyed on 30 January 2017.

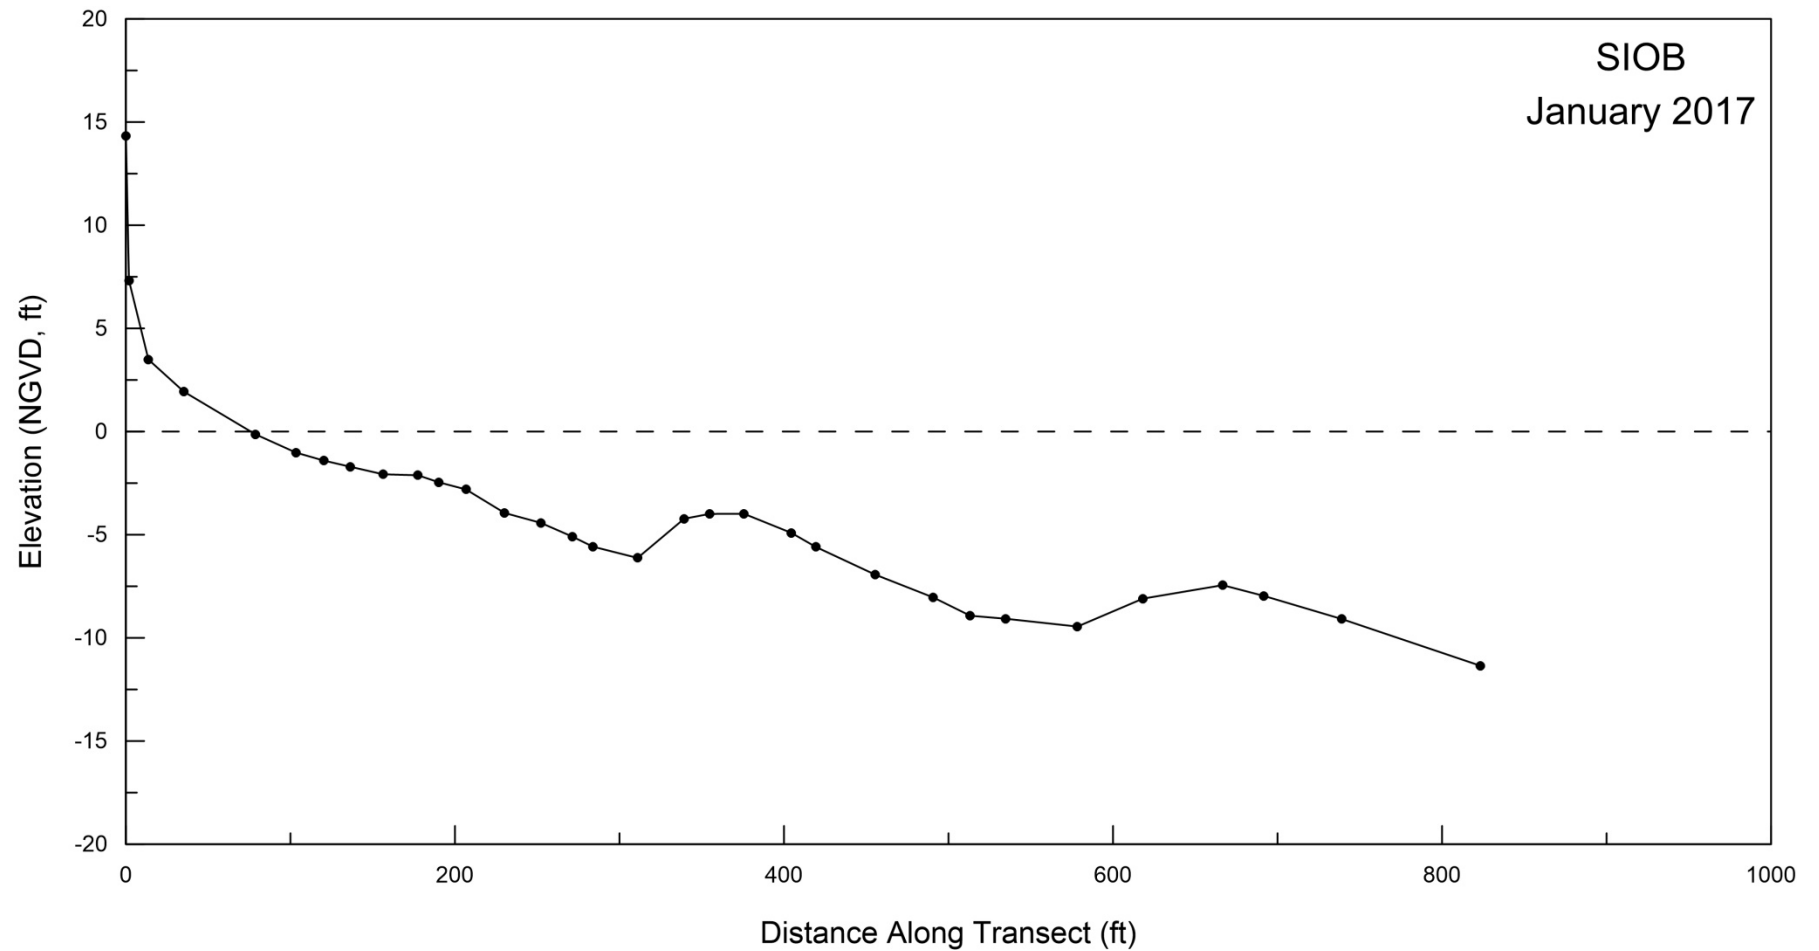
Figure A-6. Beach profile for SIOB surveyed on 30 January 2017.

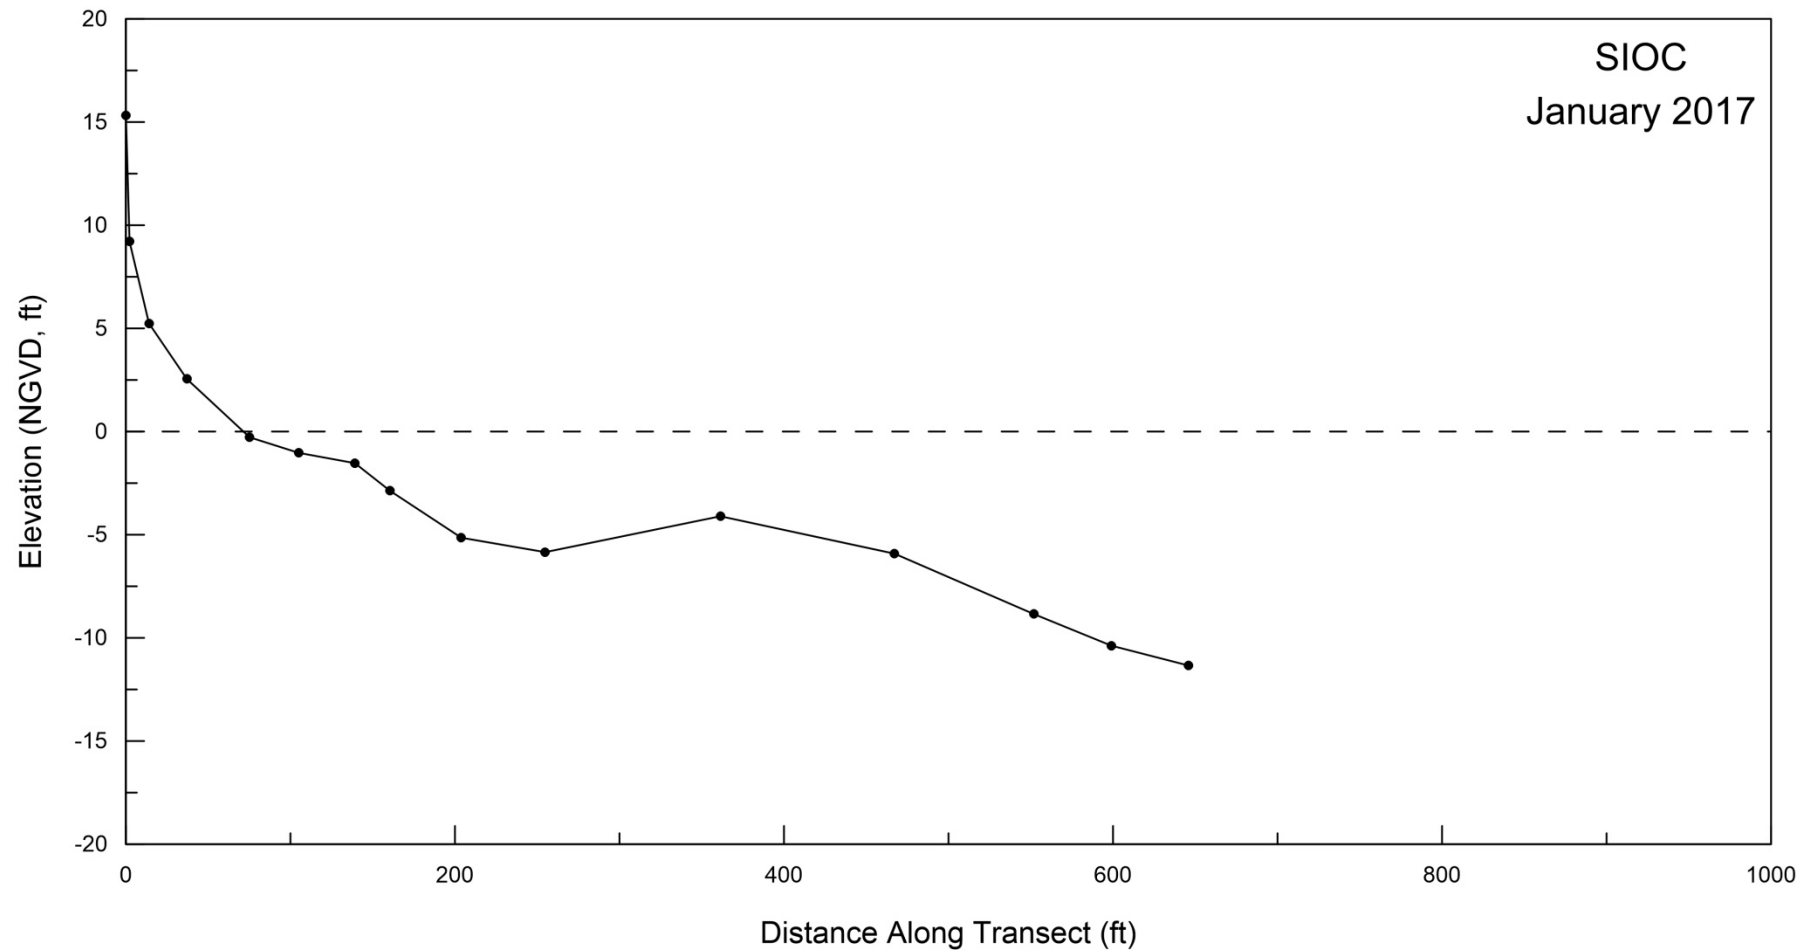
Figure A-7. Beach profile for SIOC surveyed on 30 January 2017.
