**SAN DIEGUITO WETLANDS RESTORATION PROJECT**

**27 SEPTEMBER 2017 BEACH PROFILES  
CITY OF DEL MAR, CALIFORNIA**

**Data Report**

17 October 2017  
CE Reference No 17-21

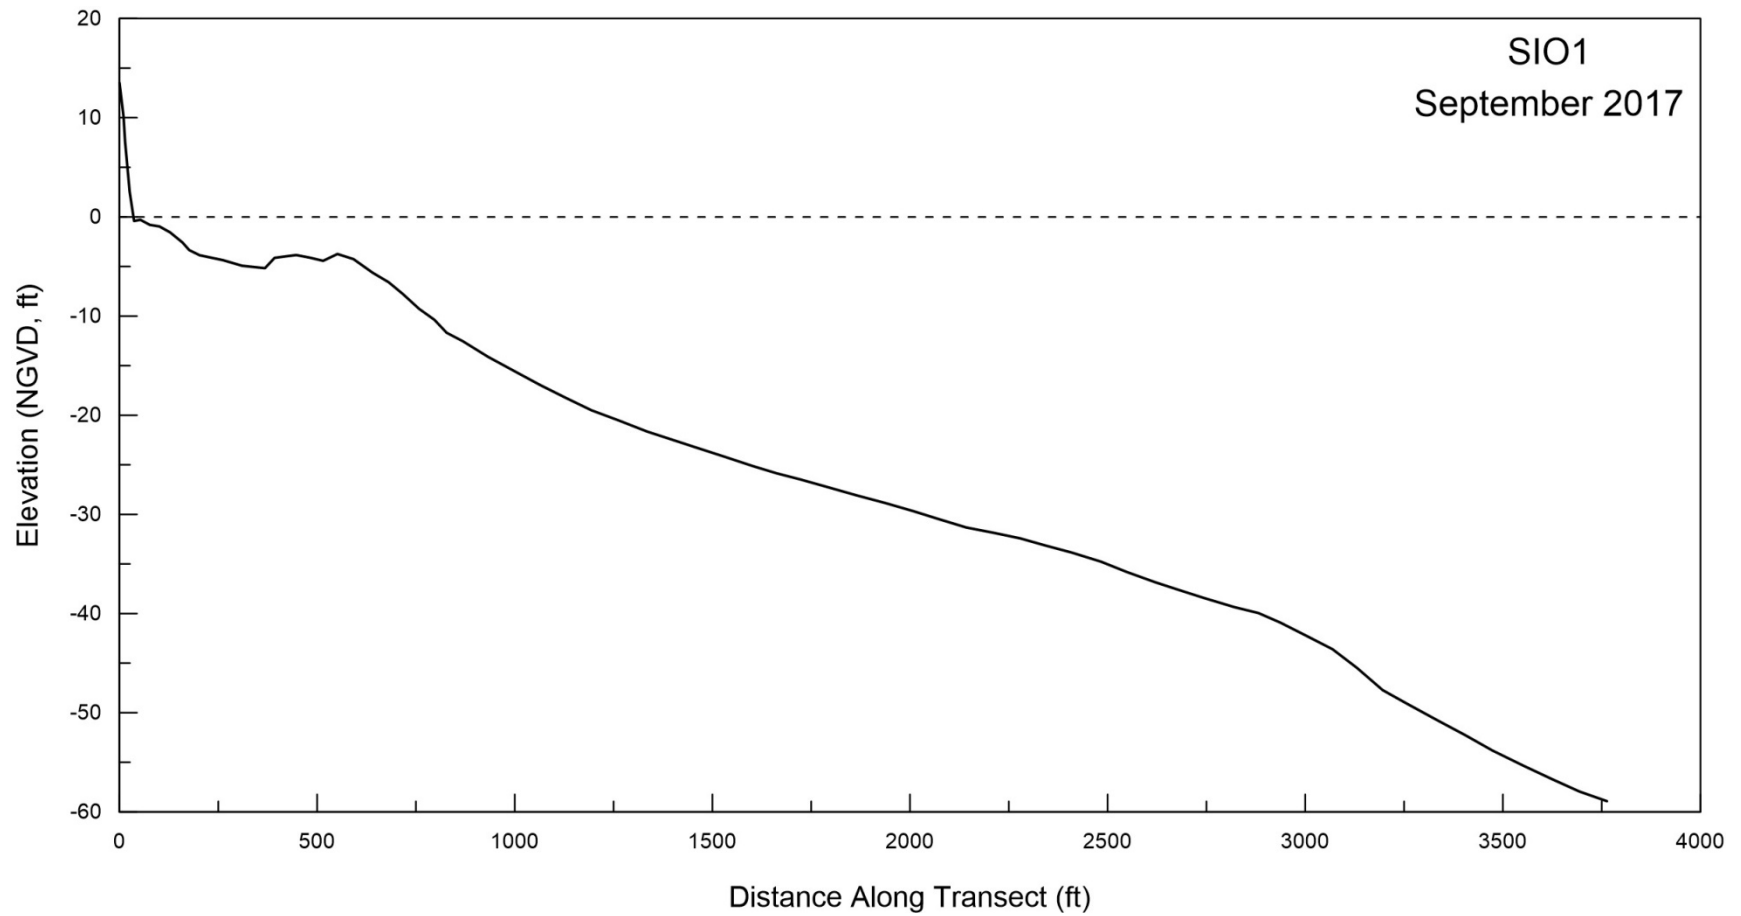
**Figure A-1. Beach profile for SIO1 surveyed on 27 September 2017.**

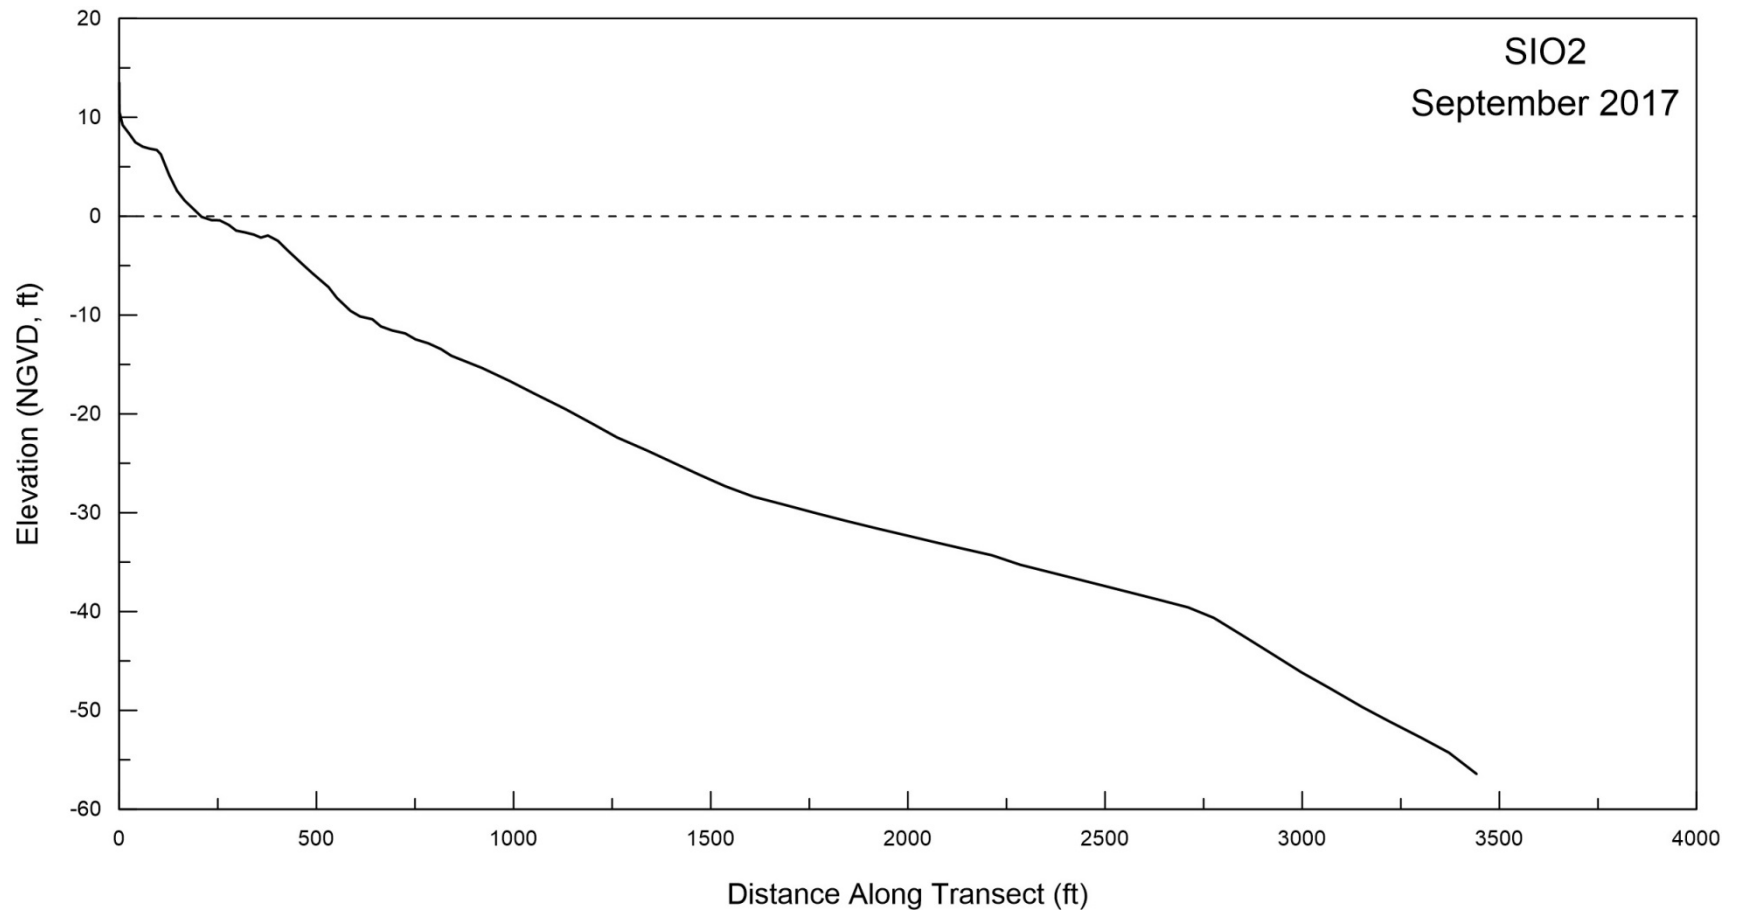
**Figure A-2. Beach profile for SIO2 surveyed on 27 September 2017.**

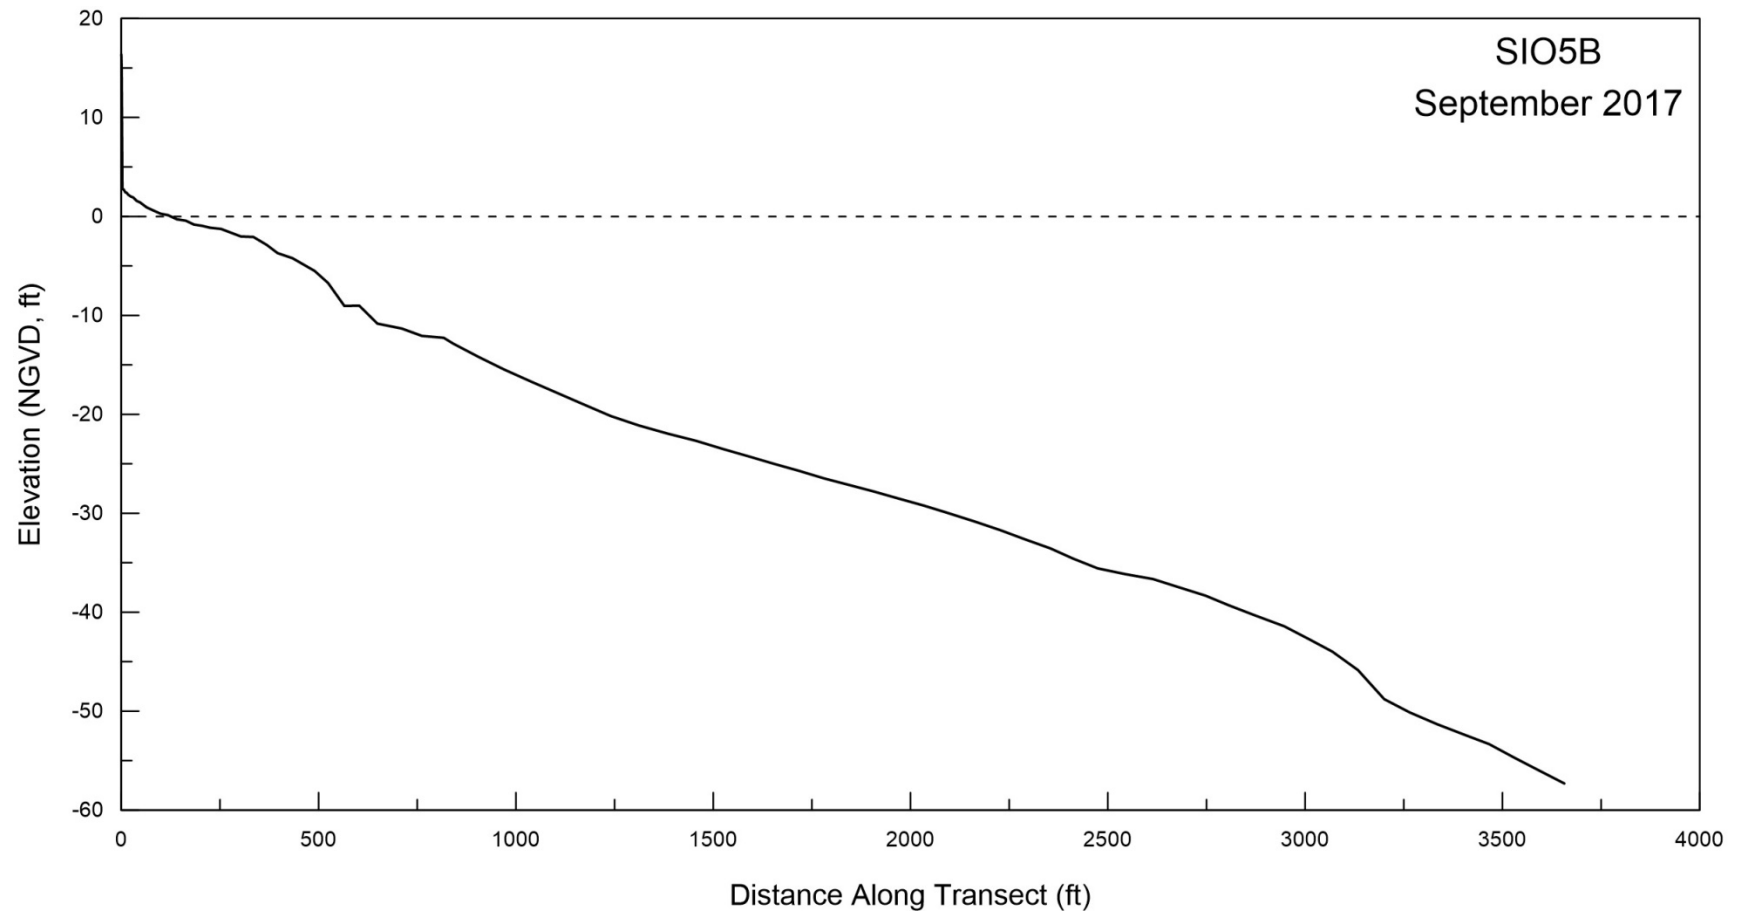
**Figure A-3. Beach profile for SIO5B surveyed on 27 September 2017.**

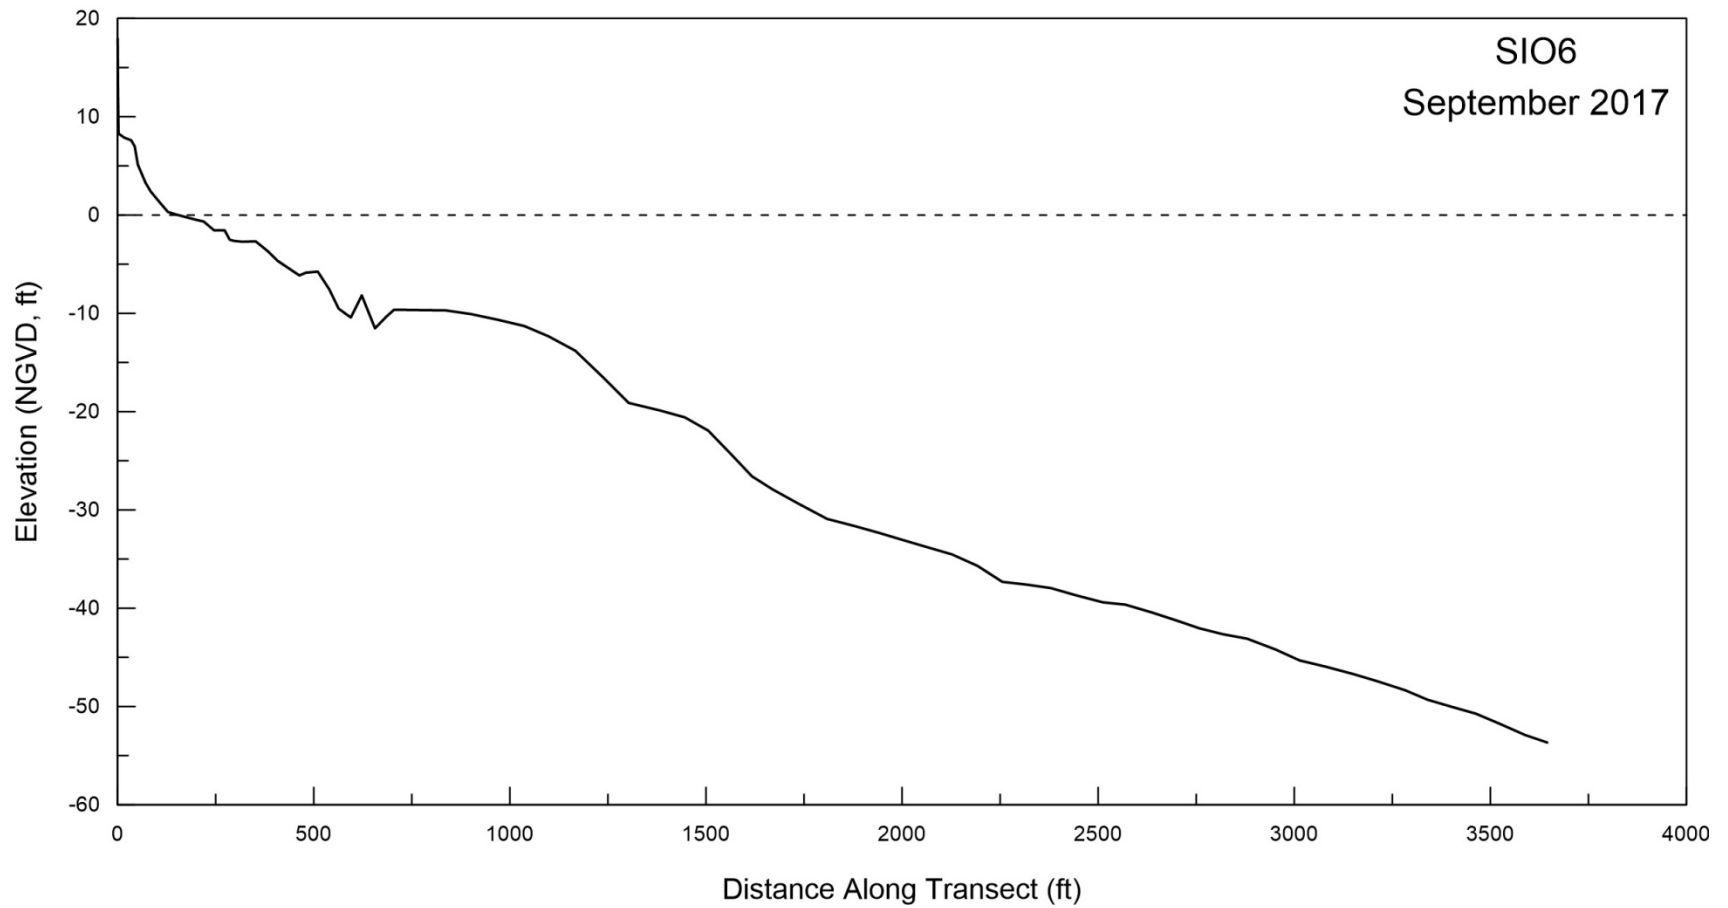
**Figure A-4. Beach profile for SIO6 surveyed on 27 September 2017.**

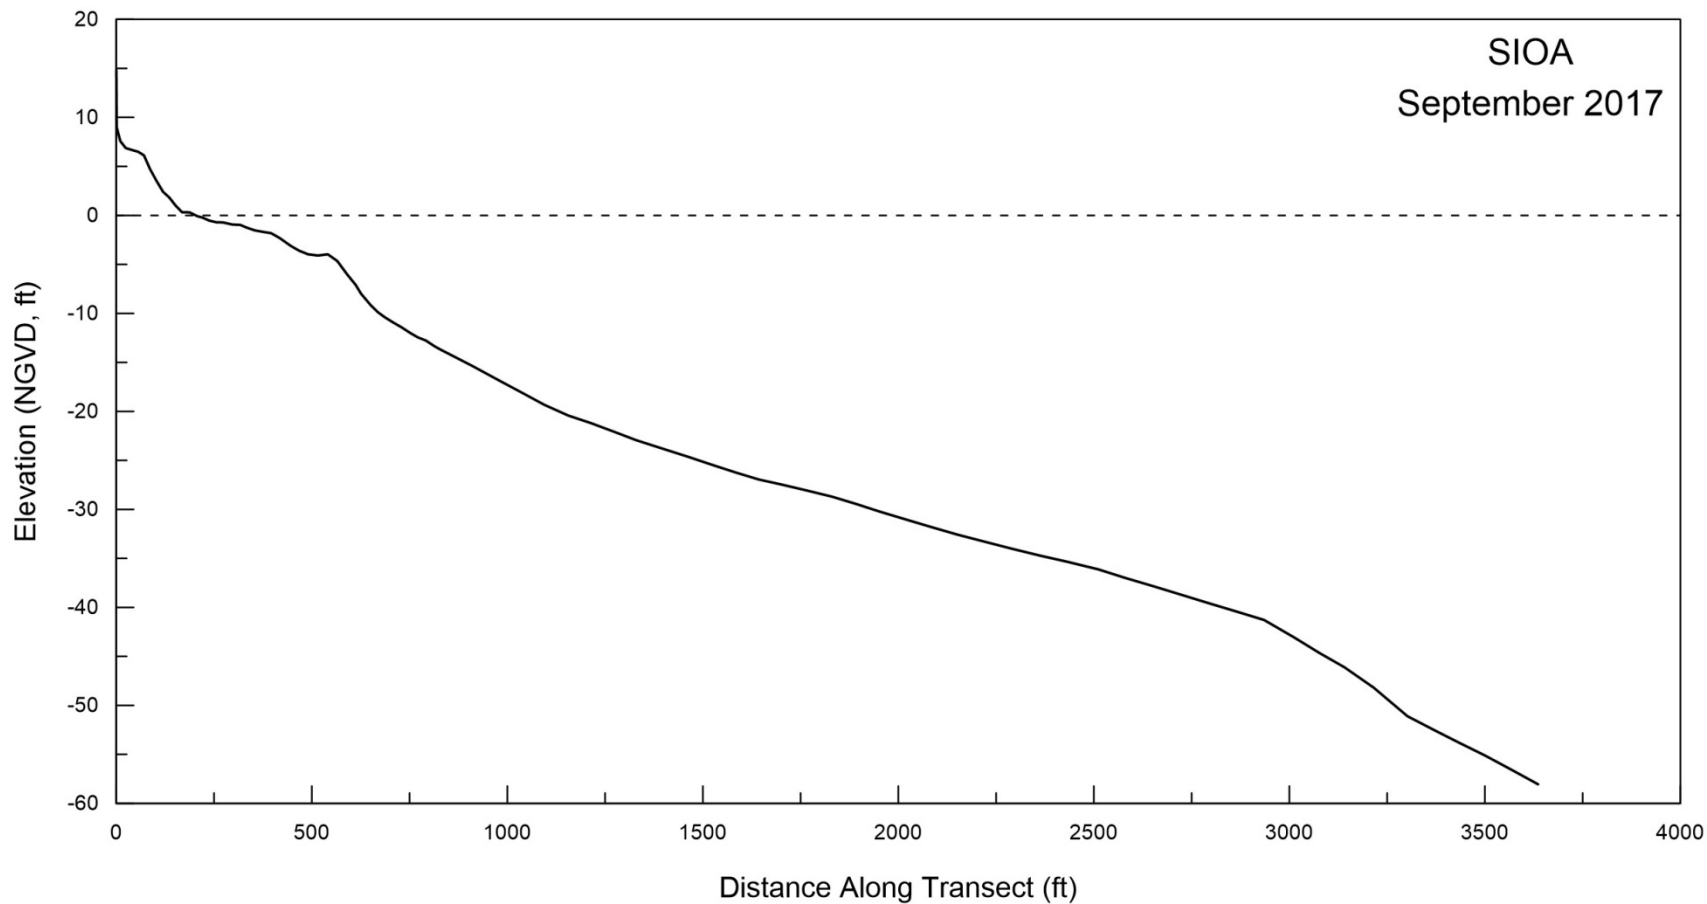
**Figure A-5. Beach profile for SIOA surveyed on 27 September 2017.**

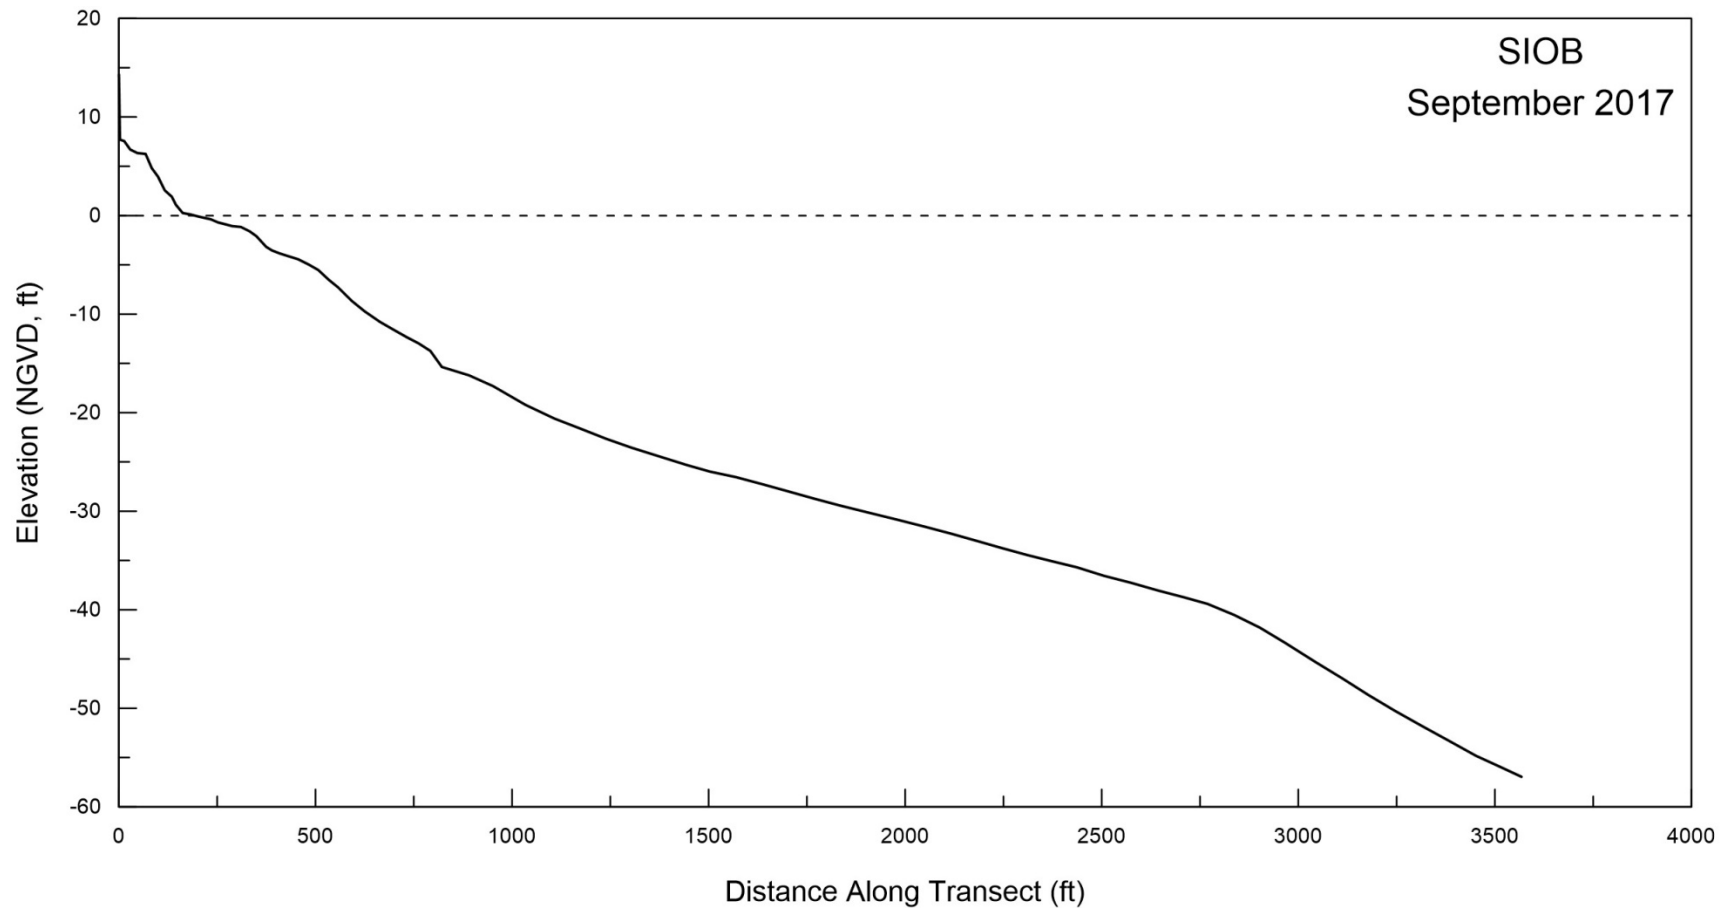
**Figure A-6. Beach profile for SIOB surveyed on 27 September 2017.**

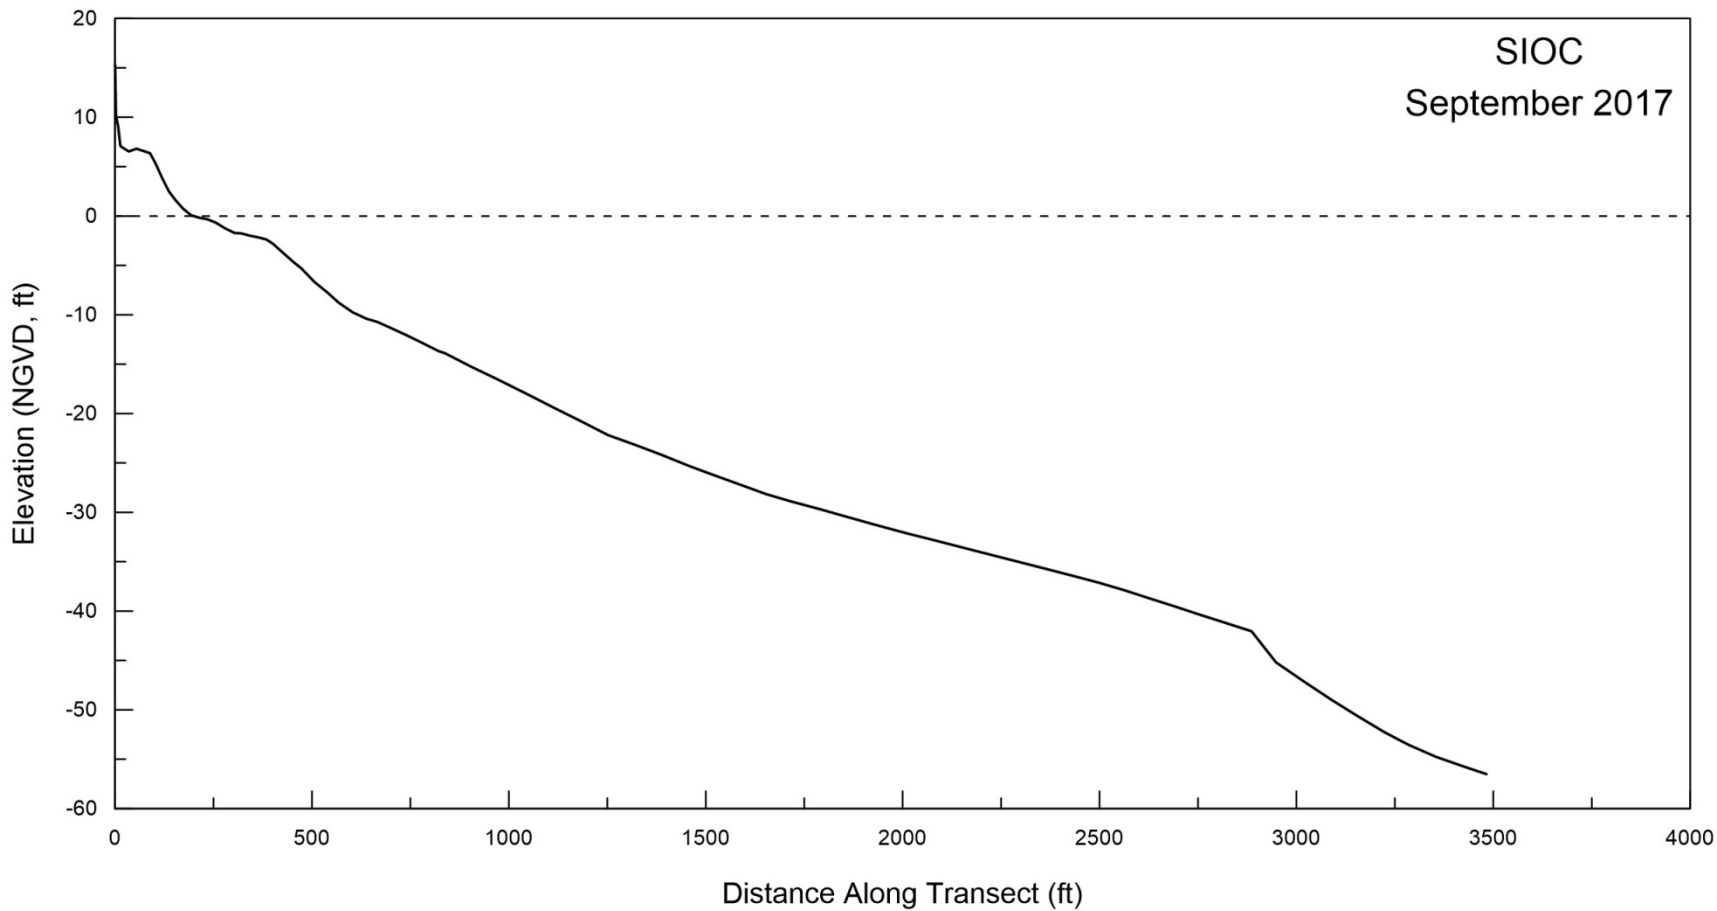
**Figure A-7. Beach profile for SIOC surveyed on 27 September 2017.**
